JTB00552NAS6

TECHNICAL BULLETIN

415-01: Information and Entertainment Systems

InControl® Touch Pro™ Features May Not Function As Expected; Phase 4 Updates

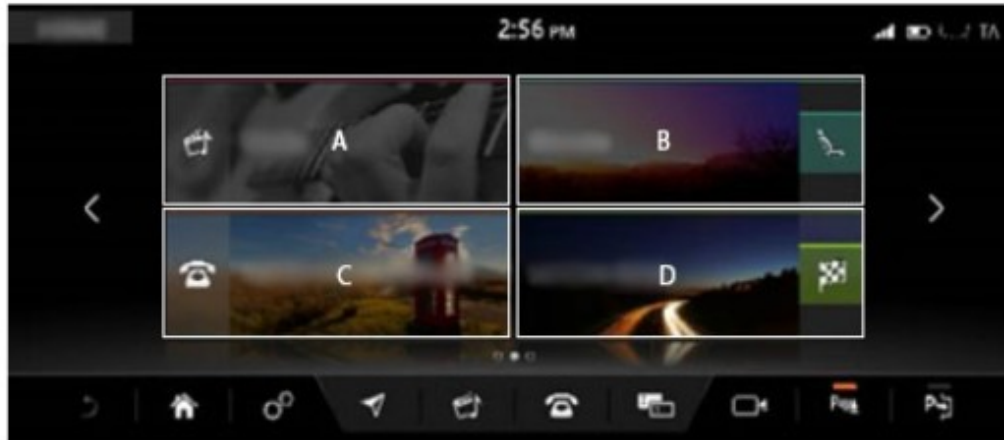
E229092

Vehicles with Single-Screen System - current 4-tile look & feel home screen:

A major part of this update is to the look & feel of the single-screen InControl Touch Pro system, which will change to match that of the InControl Touch Pro Duo system. After this software update is finished, it CANNOT be reversed.
