SERVICE BULLETIN

Classification: EL18-005a	Reference: NTB18-041a	Date: July 19, 2018
------------------------------	--------------------------	------------------------

2017-2018 ROGUE, ROGUE HYBRID AND ROGUE SPORT; UNEXPECTED OPERATION OF AEB, FEB OR FCW

APPLIED VEHICLES: 2017-2018 Rogue (T32)
 2017-2018 Rogue Sport (J11)
 2017-2018 Rogue Hybrid (T32)

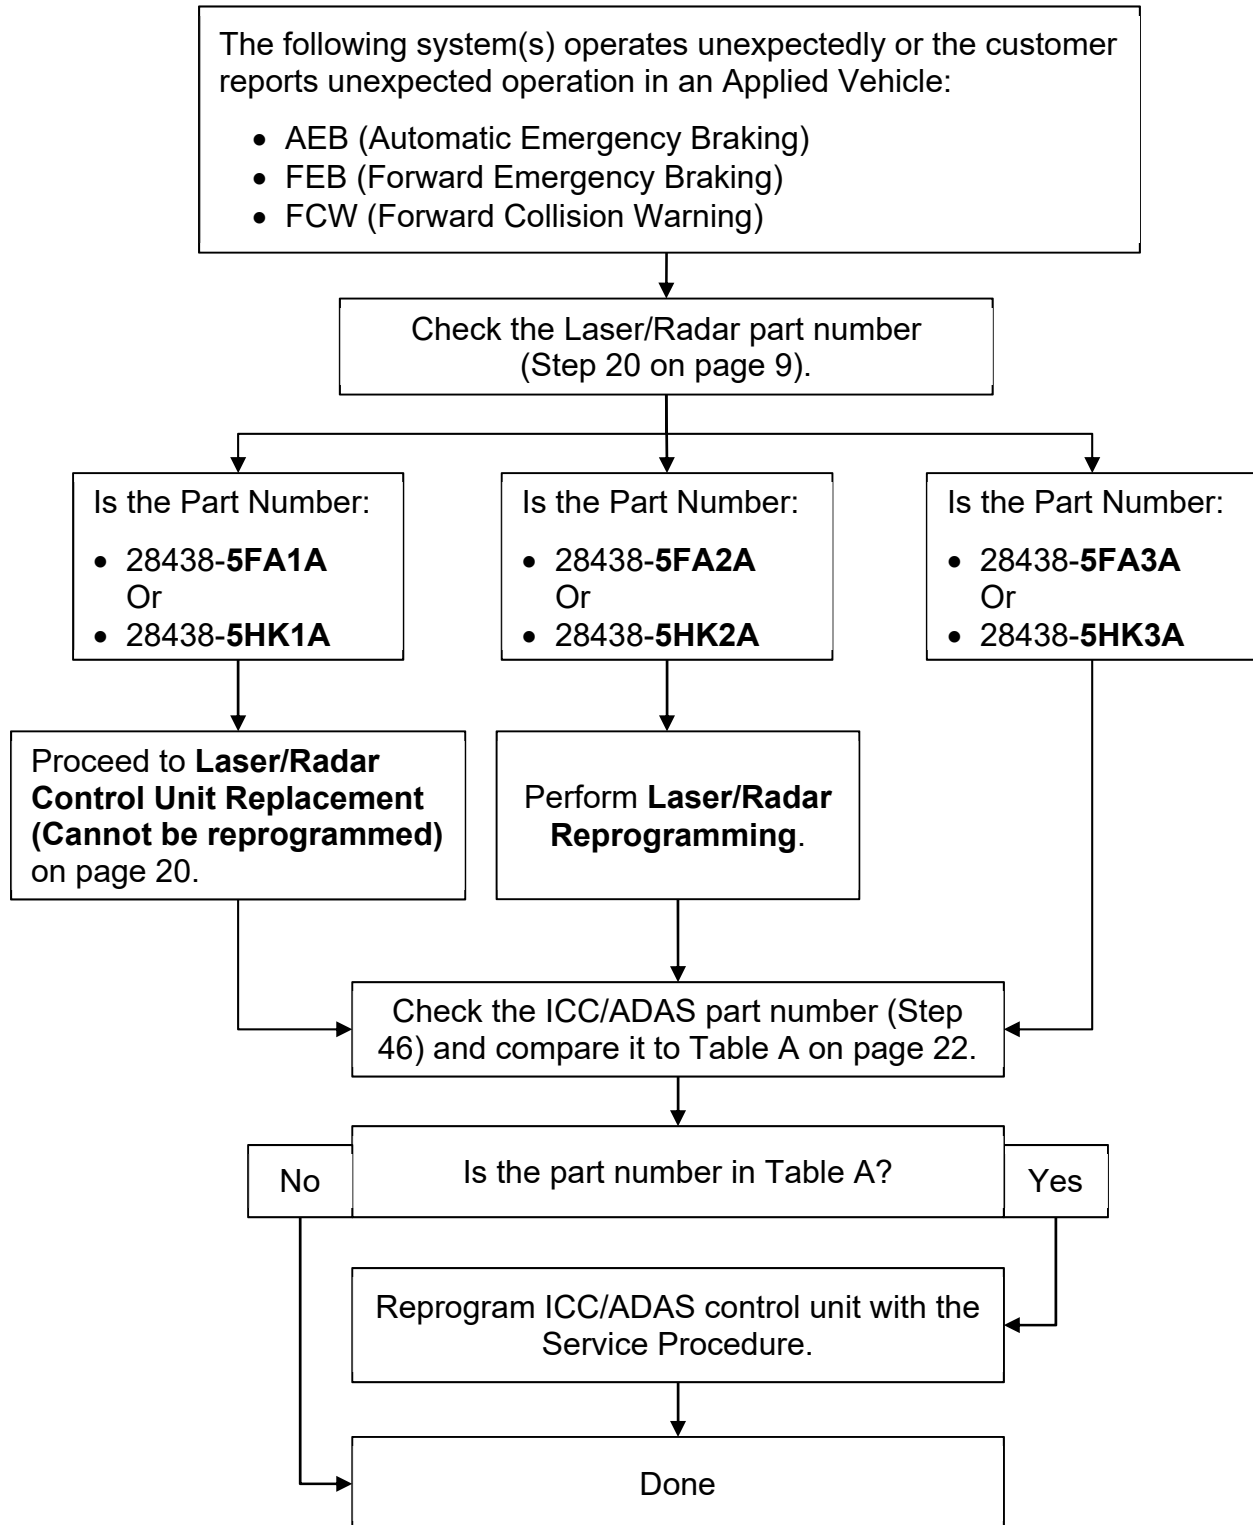
Repair Overview

NOTE: If neither reprogramming, nor the replacement of the Laser/Radar control unit were performed, refer to the Electronic Service Manual (ESM) for further diagnostic information.

42. If the Flow Chart on Page 2 indicates that a reprogram is not available for the Laser/Radar control unit.

IMPORTANT: LASER/RADAR control unit reprogramming or replacement must be performed first (if indicated by the flow chart on page 9) before proceeding.

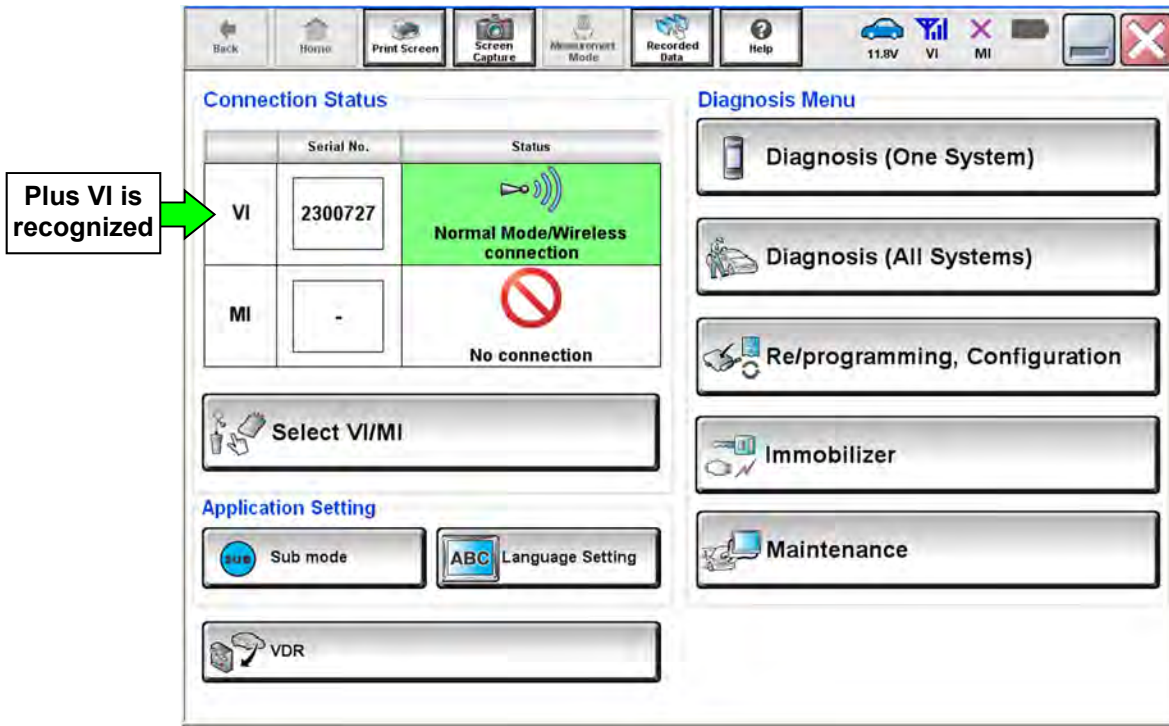
Figure 1

9. Wait for the plus VI to be recognized.
- Serial number will display when the plus VI is recognized.

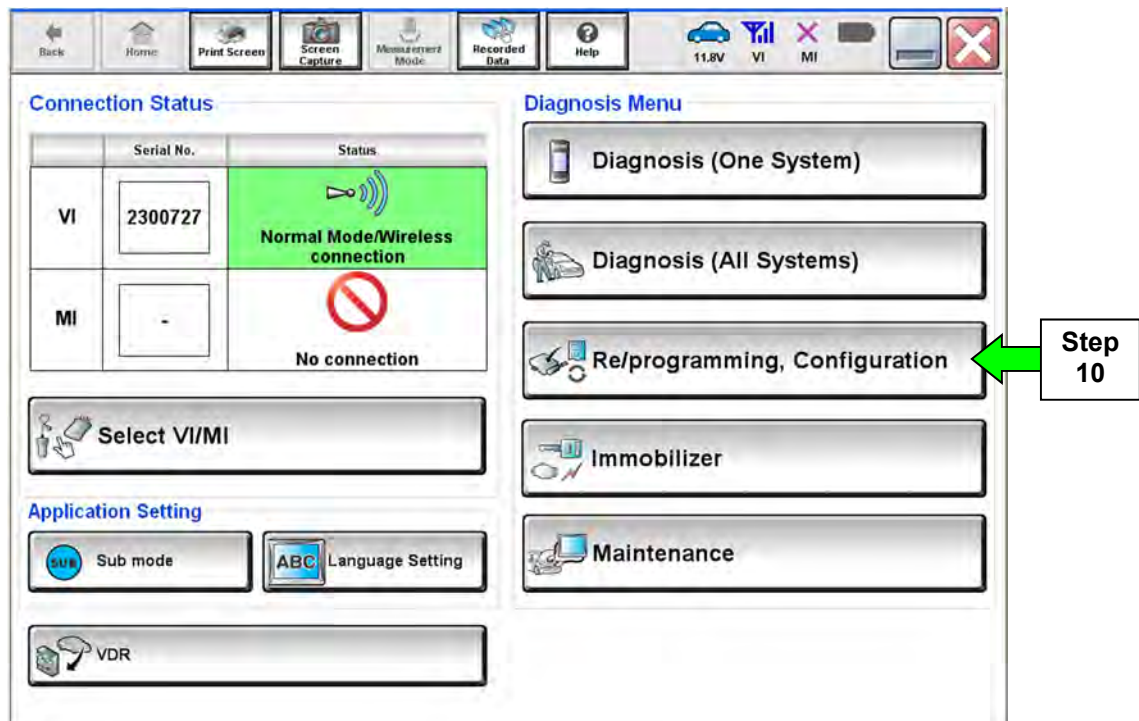
Figure 2

10. Select **Re/programming, Configuration**.

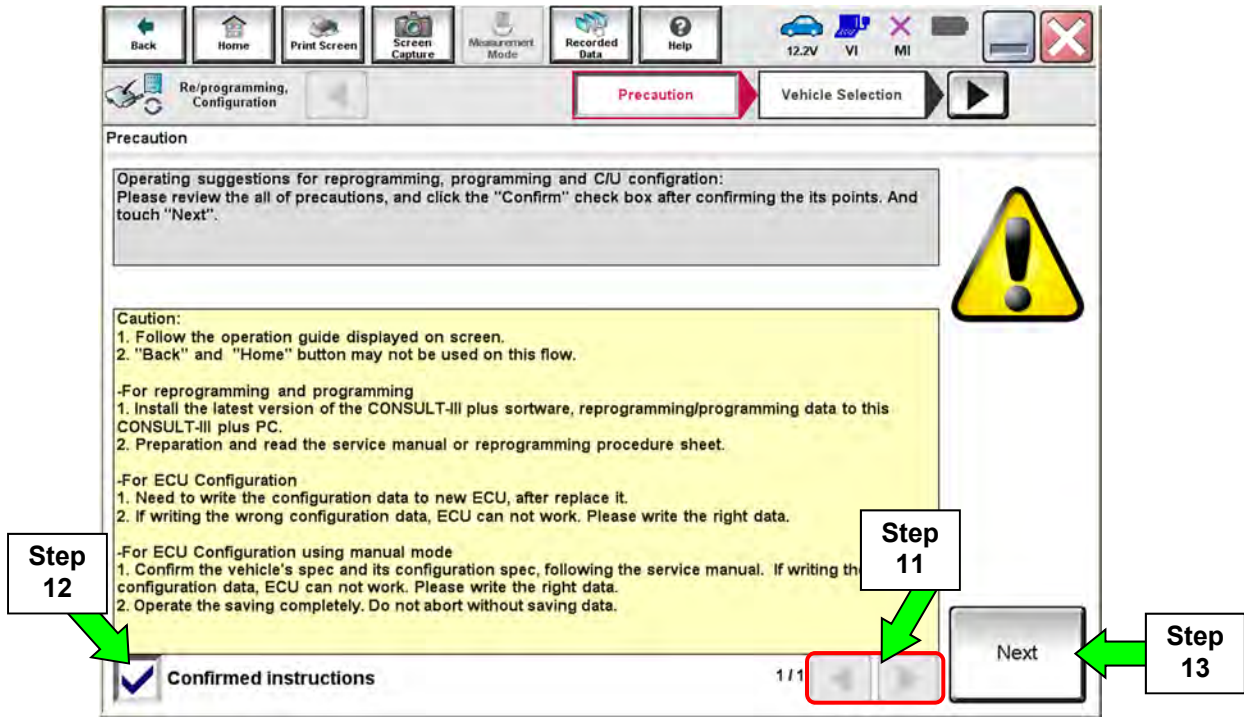
Figure 3

11. Use arrows (if needed) to view and read all precautions.
12. Check the box confirming the precautions have been read.
13. Select **Next**.

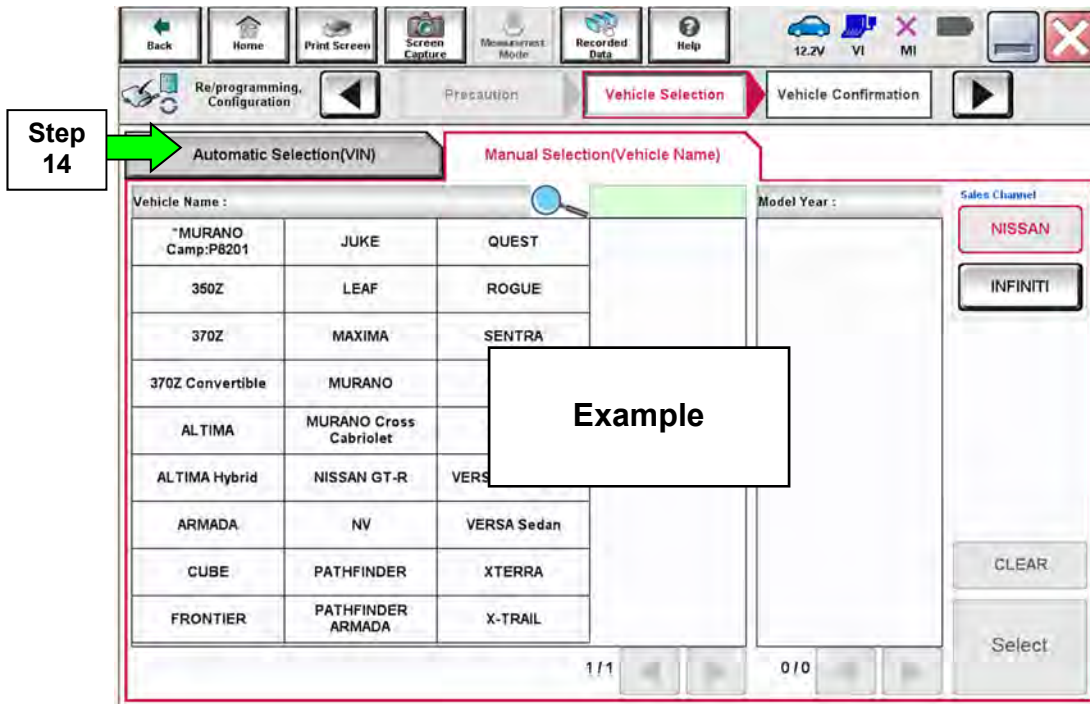
14. Select **Automatic Selection(VIN)**.

- If the screen in Figure 4 does not display, skip to step 15.

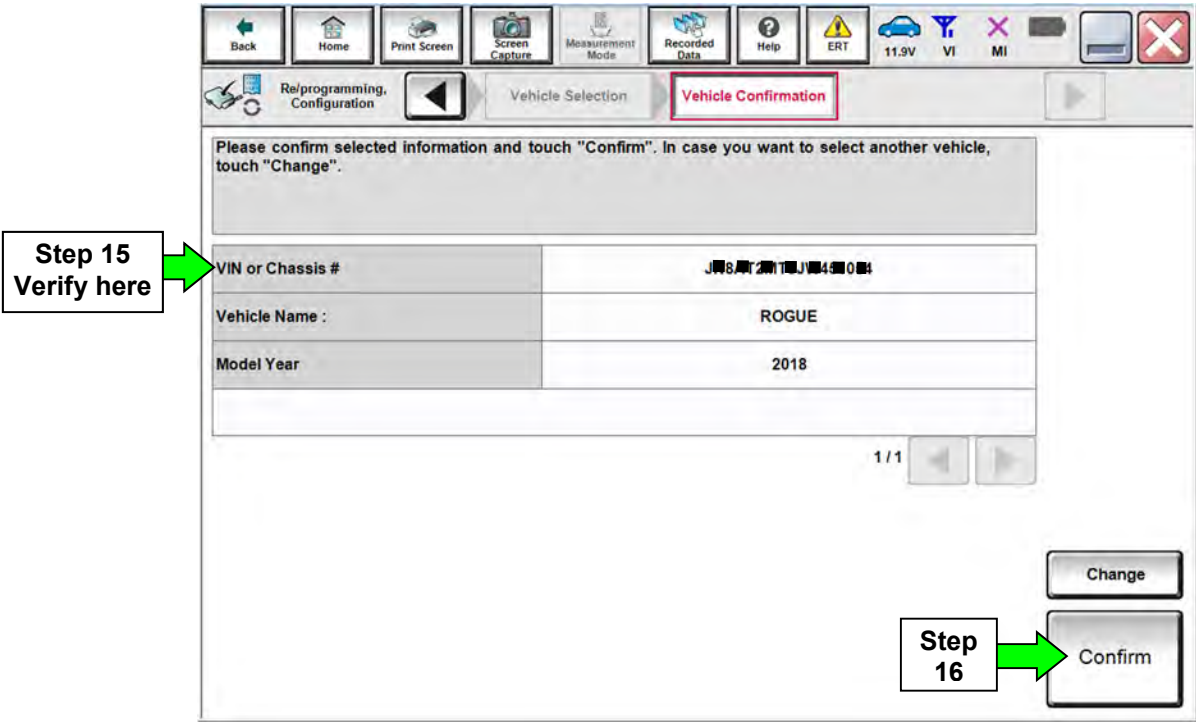
Figure 5

15. Make sure **VIN or Chassis #** matches the vehicle's VIN.

16. If the correct VIN is displayed, select **Confirm**.

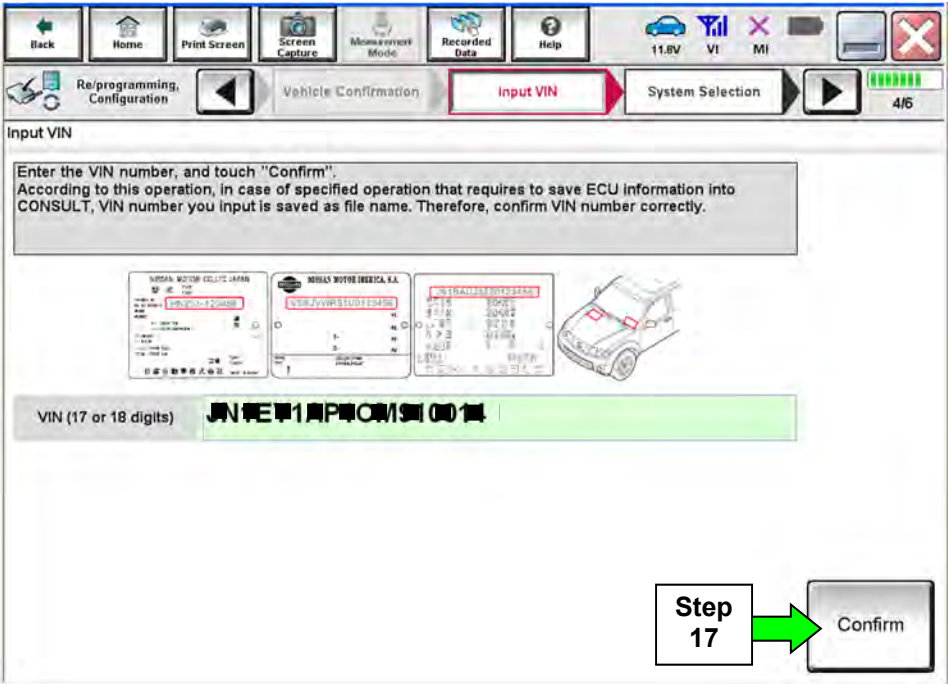
Figure 6

17. Select **Confirm**.

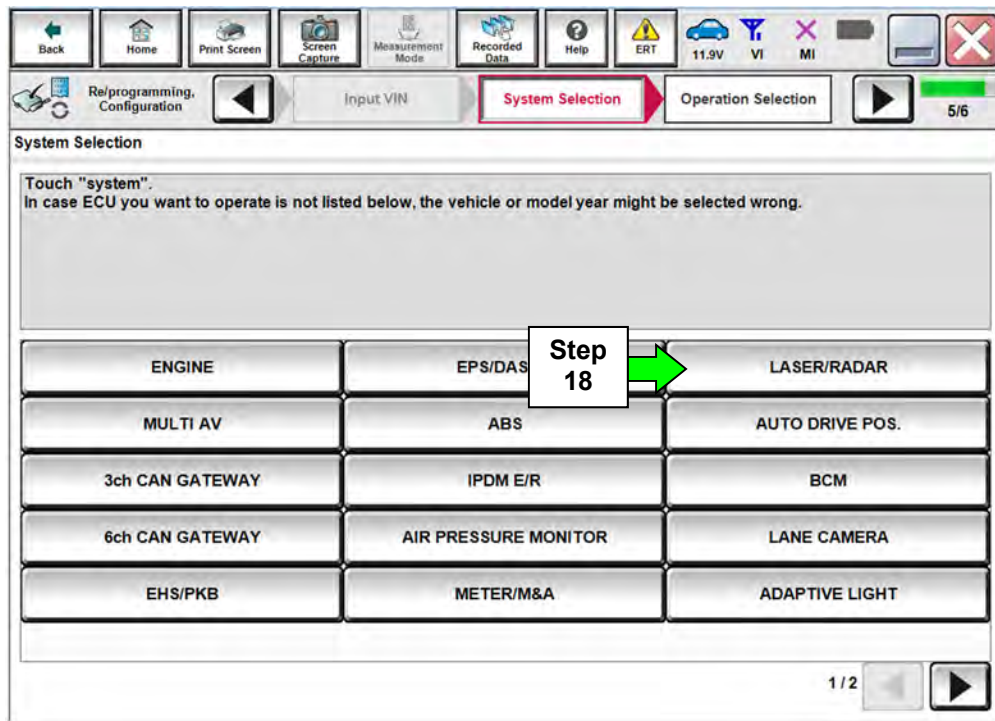
Figure 7

18. Select **LASER/RADAR**.

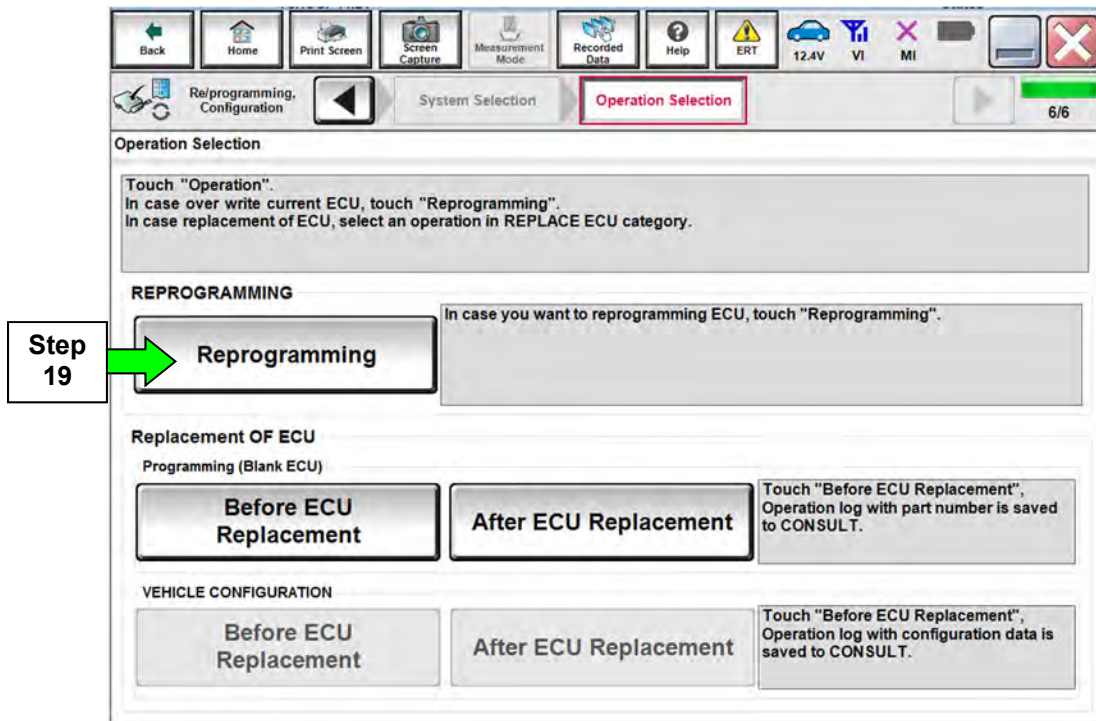
Figure 8

19. Select **Reprogramming**.

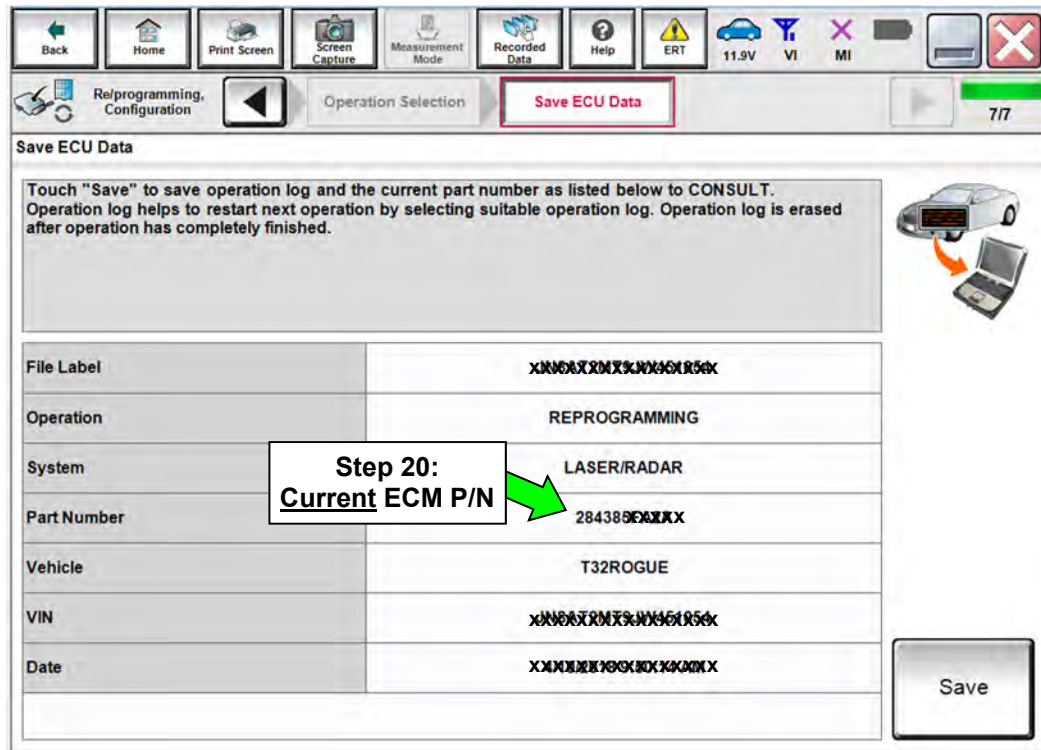
Figure 9

20. When you get to the screen shown in Figure 9, confirm that a reprogram or new control unit is available with the flow chart below.

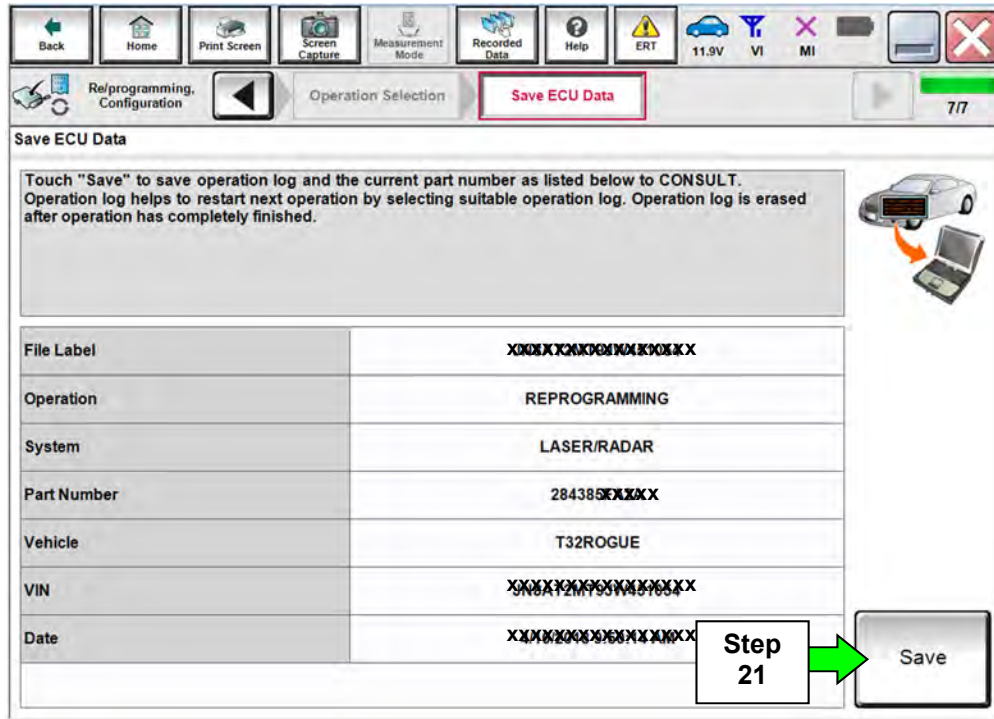
Figure 10

21. Select **Save**.

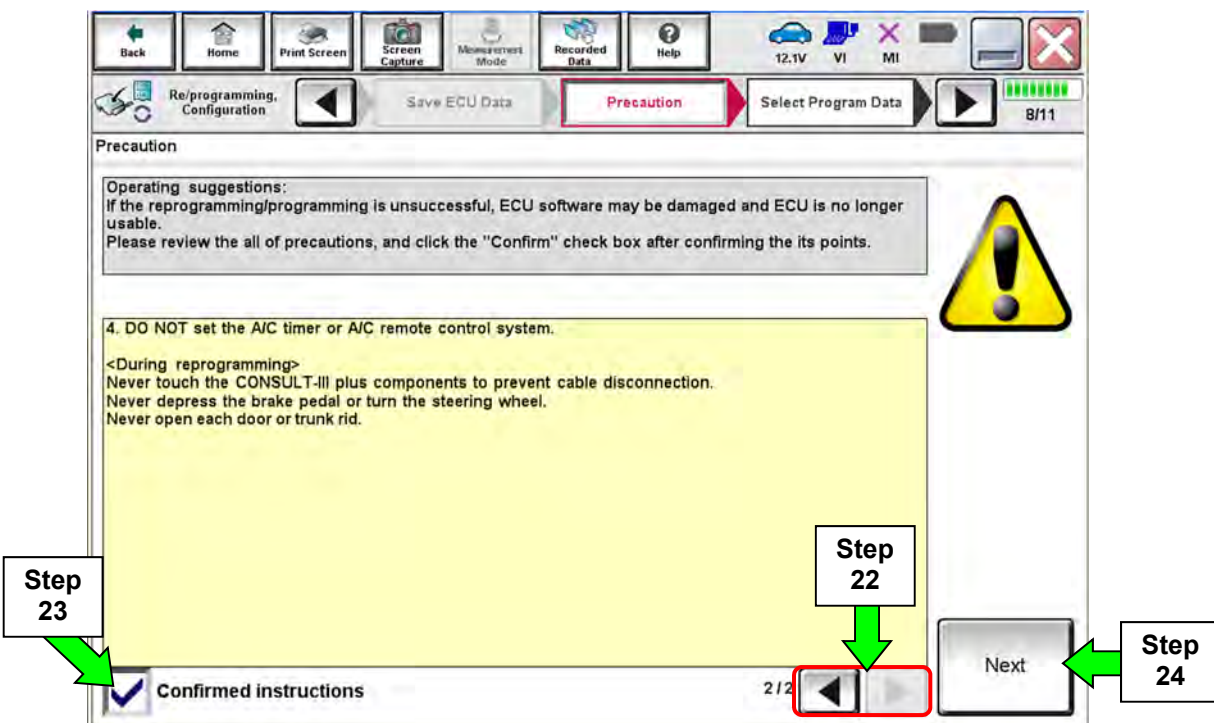
Figure 11

22. Use arrows (if needed) to view and read all precautions.

23. Check the box confirming the precautions have been read.

24. Select **Next**.

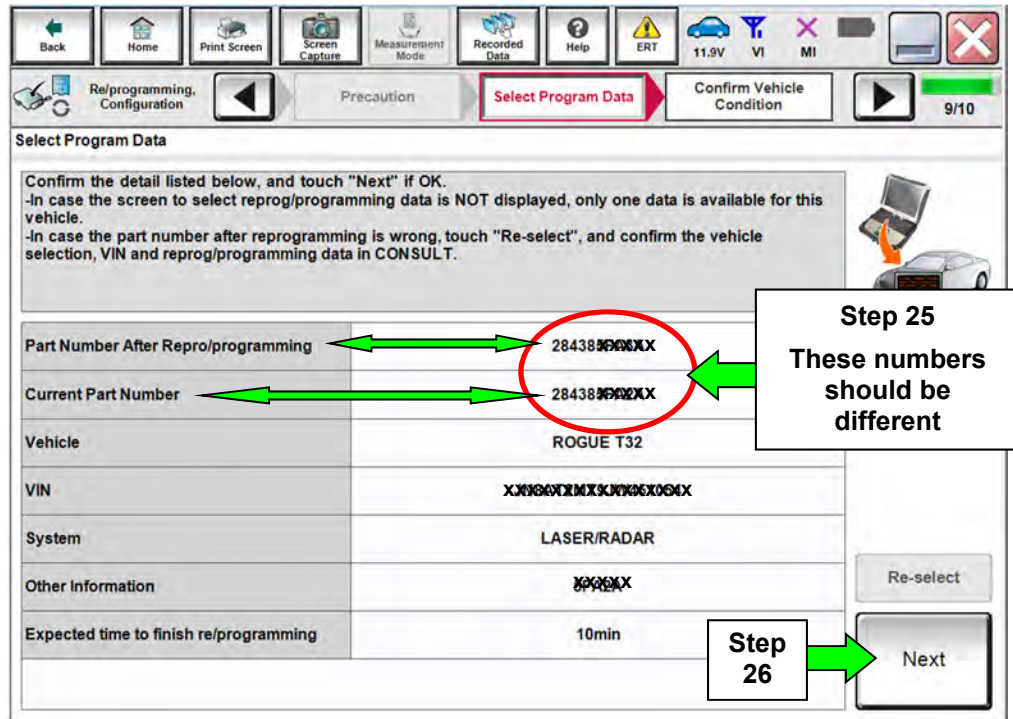
Figure 12

25. Read the **Current Part Number** and **Part Number After Reprogramming**. They should be different.

26. Select **Next**.

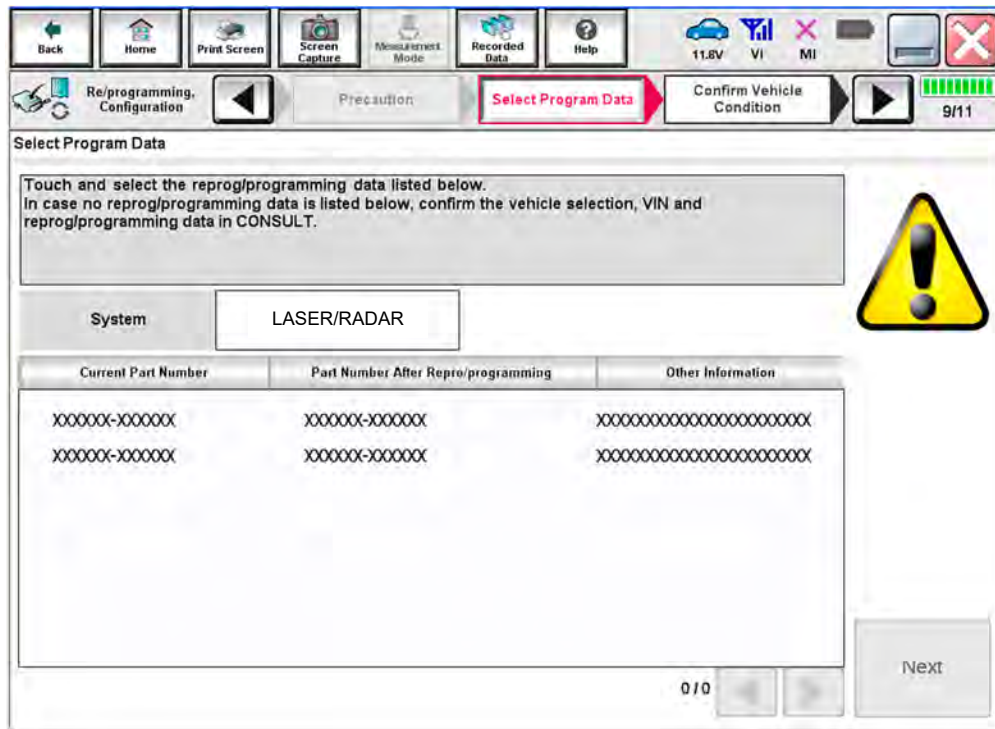
- In some cases, more than one new P/N for reprogramming is available.
 - If more than one new P/N is available, the screen in Figure 13 displays.
 - Select and use the reprogramming option that does **not** have the message “Caution! Use ONLY with NTBXX-XXX”.
- If you get this screen and it is blank (no reprogramming listed), it means there is no reprogramming available for the Laser/Radar control unit in this vehicle. Proceed to **ICC/ADAS Reprogramming**.

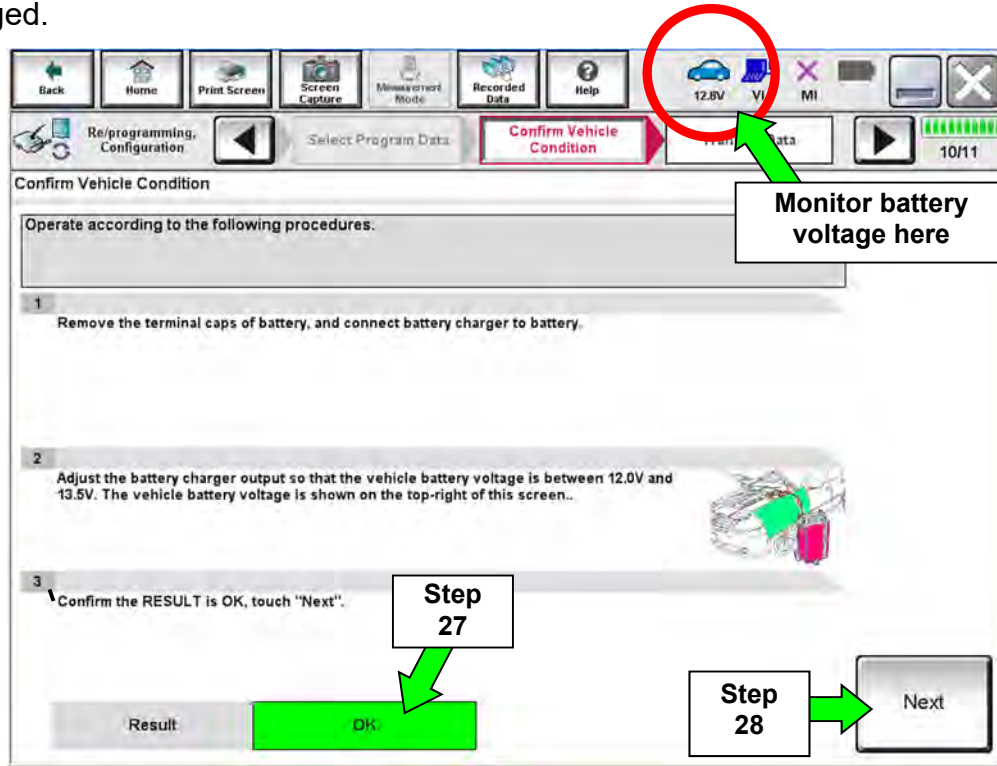
Figure 14

27. Make sure **OK** is highlighted **green** (battery voltage must be between **12.0 and 15.5 Volts**).

28. Select **Next**.

IMPORTANT: Battery voltage must stay between **12.0 and 15.5 Volts** during reprogramming or ECM reprogramming may be interrupted and ECM/TCM may be damaged.

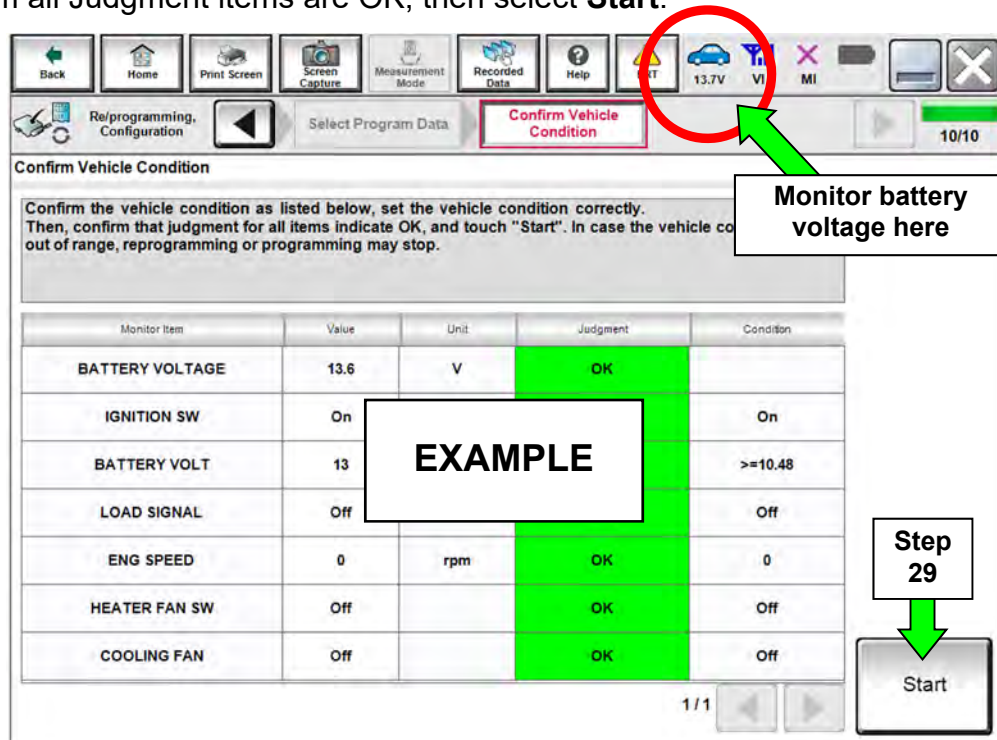
Figure 15

29. Confirm all Judgment items are OK, then select **Start**.

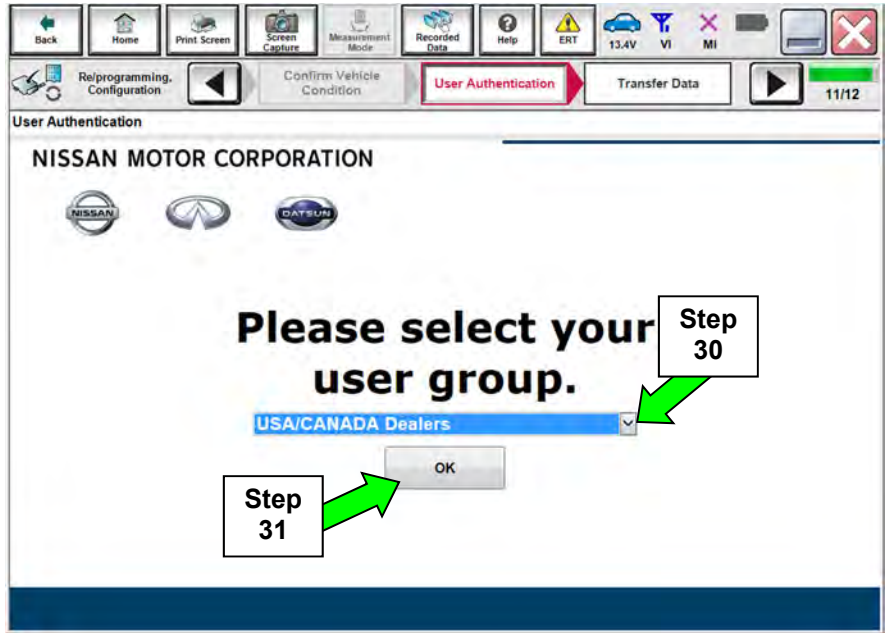
Figure 16

30. Select **USA/CANADA Dealers**.

31. Select **OK**.

- The above screen may not display if the CONSULT PC has remained ON since the last reprogramming.
- If the CONSULT PC is not connected to the Internet, the screen in Figure 17 will display.

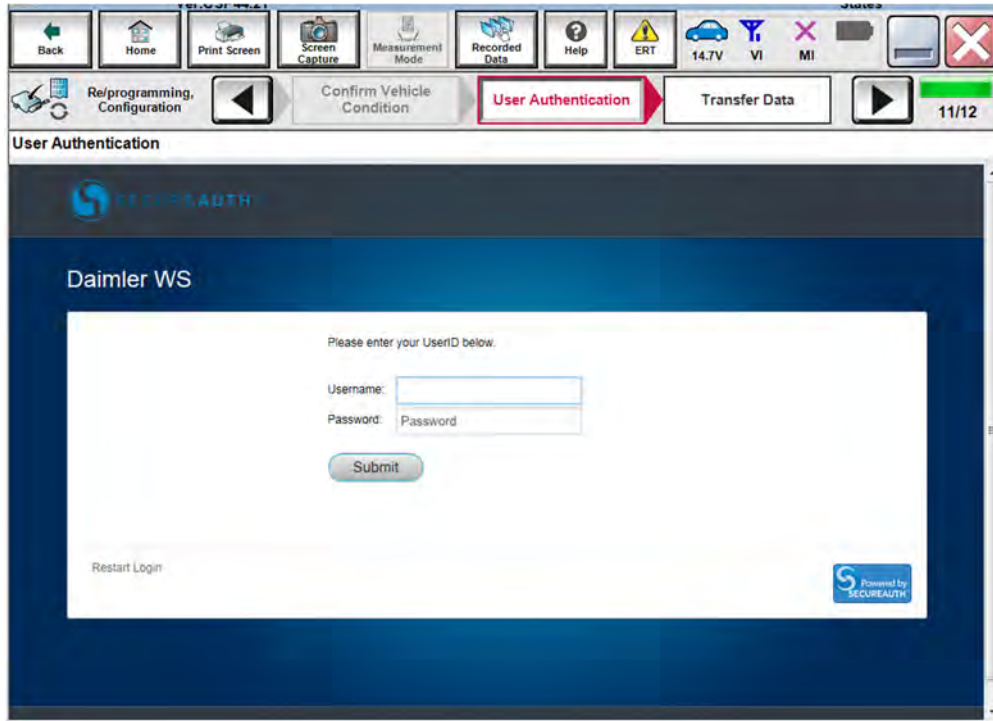
Figure 18

NOTE: In the next steps, the reprogramming process will begin when **Submit** is selected.

32. Enter your **Username** and **Password**.

- The CONSULT PC must be connected to the Internet via cable or Wi-Fi.
- If you do not know your User Name and Password, contact your Service Manager.

33. Select **Submit**.

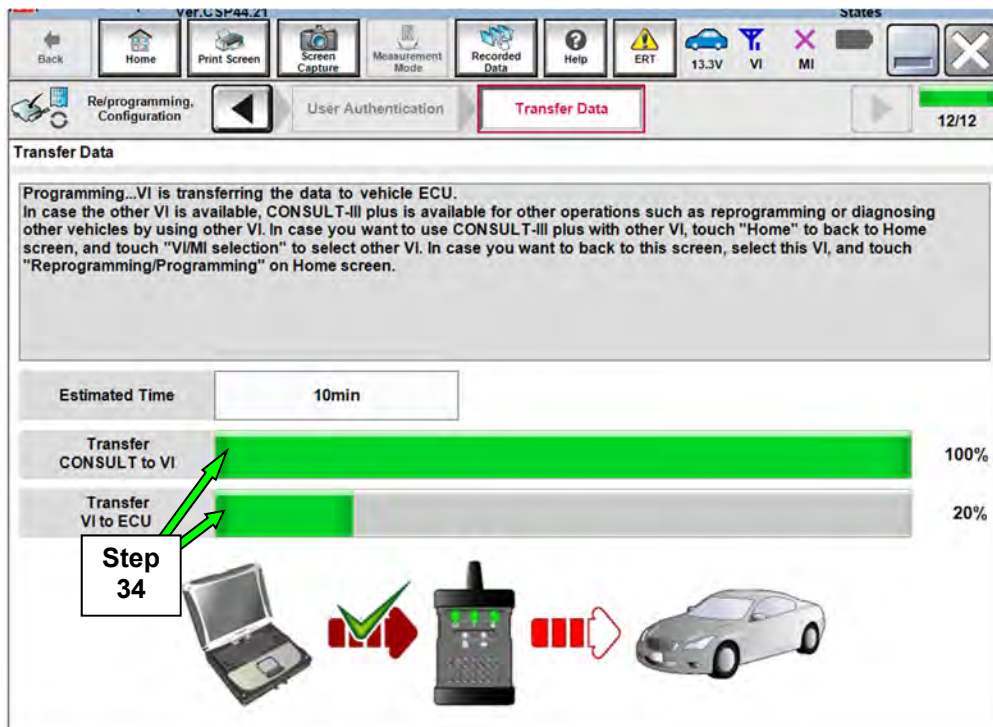
Figure 19

34. Wait for both progress bars to complete.

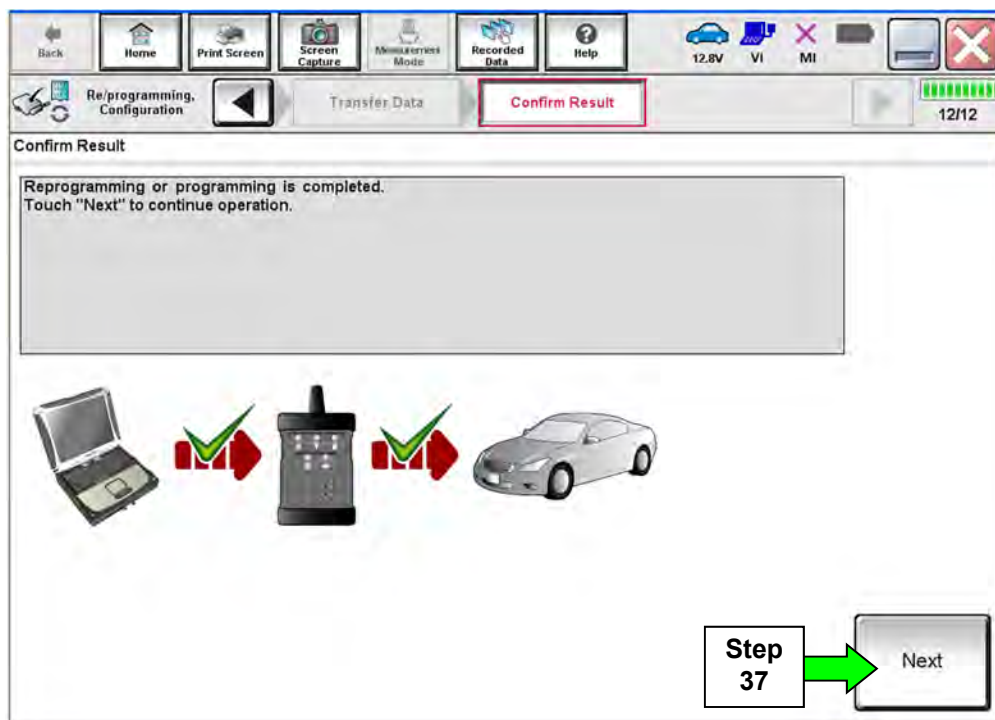
35. When the screen in Figure 20 displays, the reprogramming is complete.

NOTE: If the screen in Figure 20 does not display (indicating that reprogramming did not complete), refer to the information on the next page.

36. Disconnect the battery charger from the vehicle.

37. Select **Next**.

NOTE: Additional steps/operations are required before C-III plus will provide the final reprogramming confirmation report. Continue with the reprogramming procedure on page 18.

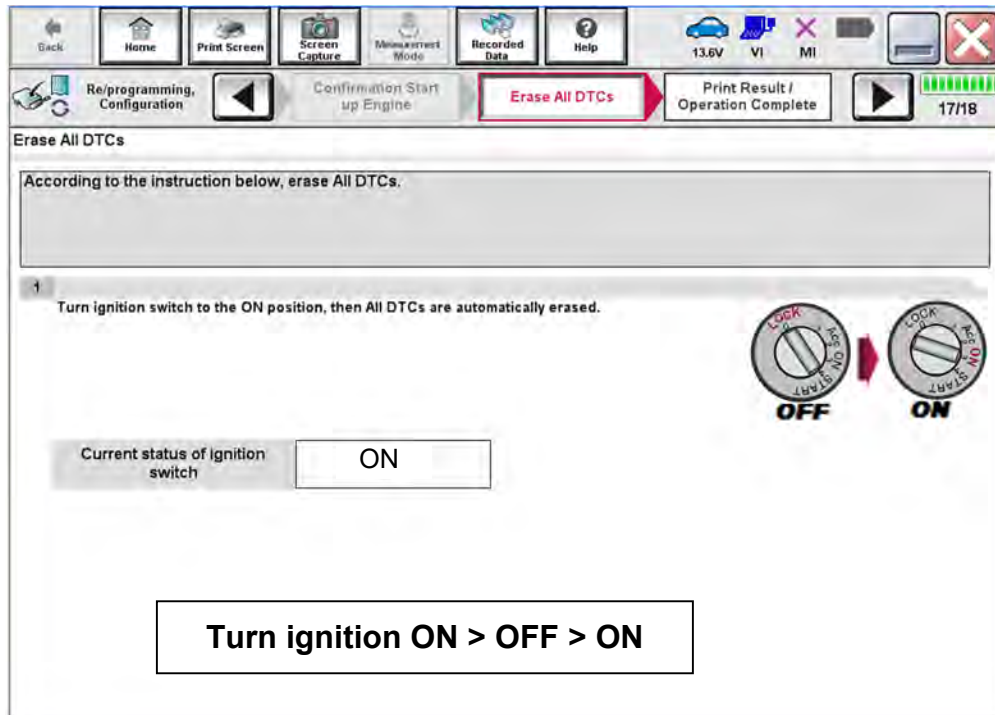
Figure 23

38. **Erase all DTCs** as follows:

- a. Turn the ignition OFF.
- b. Turn the Ignition ON.
- c. Wait for DTC erase to complete.

51. Follow the on on-screen instructions to erase DTCs.
 - If needed, refer to step 38 on page 18 for further details.
52. When the entire reprogramming process is complete, the screen in Figure 32 will display.
53. Verify the before and after part numbers are different.
54. Print a copy of this screen (Figure 32) and attach it to the repair order for warranty documentation.
55. Select **Confirm**.

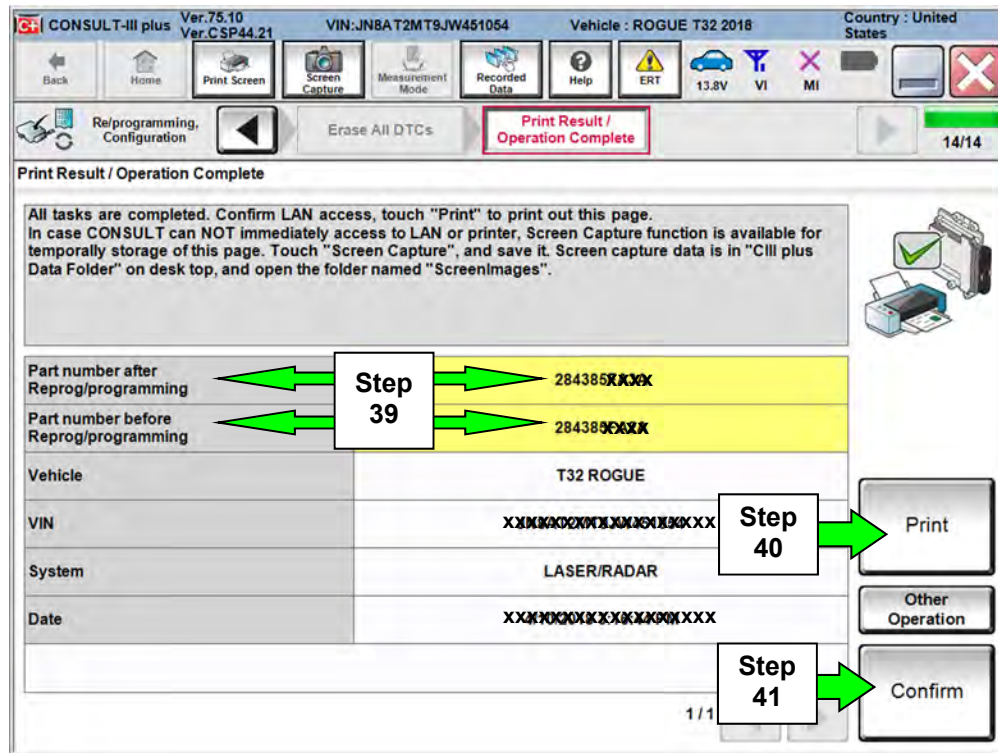
Figure 24

39. Verify the before and after part numbers are different.

40. Print a copy of this screen (Figure 24) and attach it to the repair order.

NOTE: If you cannot print the screen:

- a. Select Screen Capture.
 - b. Name the file.
 - c. Save the file in My Documents.
- A copy of the screen is now saved in the CONSULT PC. It can be retrieved and printed at a later time.

41. Select **Confirm**.

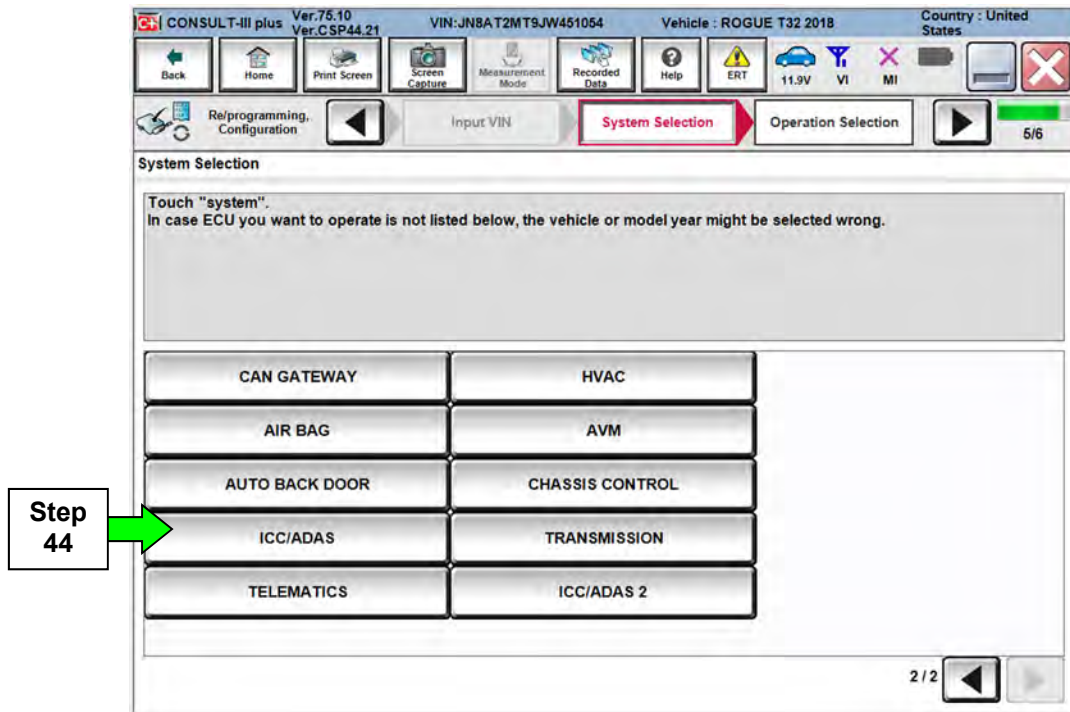
Figure 25

43. Refer to steps 1-17 starting on page 3 to navigate to Figure 25.

44. Select **ICC/ADAS**.

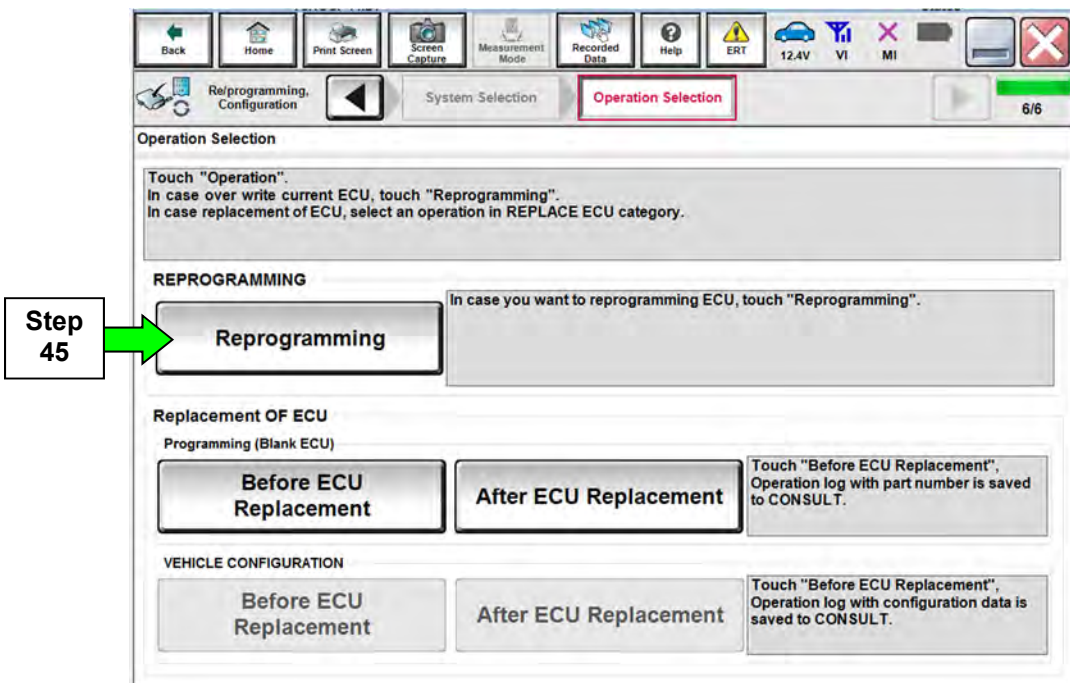
Figure 26

45. Select **Reprogramming**.

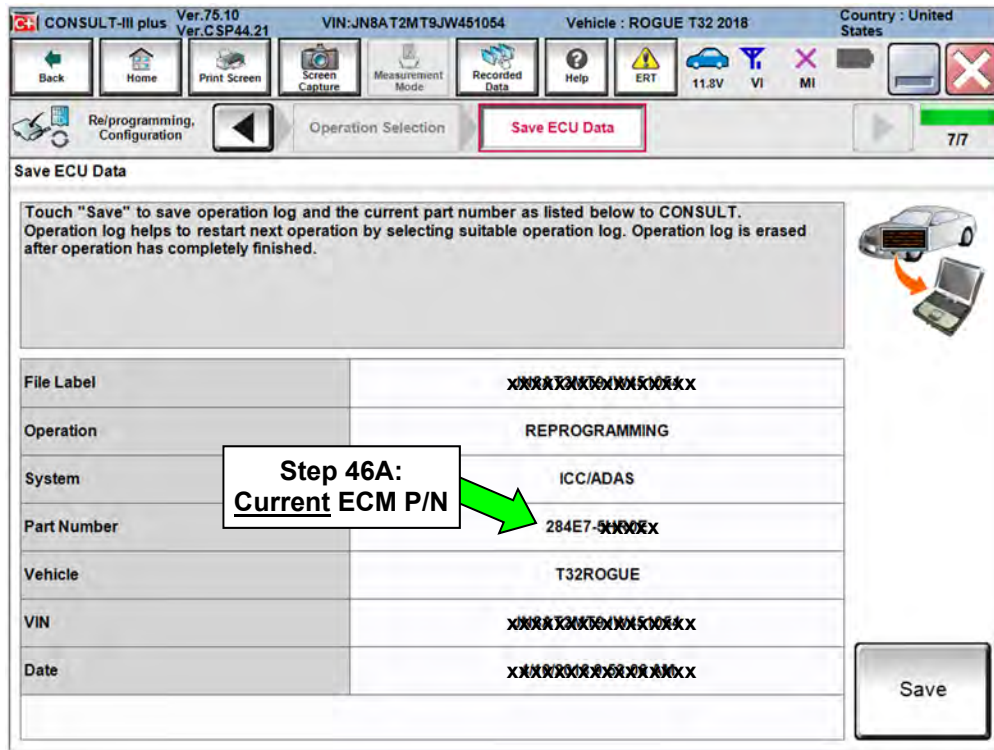
Figure 27

46. When you get to the screen shown in Figure 27, confirm that a reprogram is available as follows.

A. Find the ICC/ADAS **Part Number** and write it on the repair order.

NOTE: This is the current ICC/ADAS Part Number (P/N).

B. Compare the P/N you wrote down to the numbers in the **Current ICC/ADAS Part Number** column in **Table A**.

- If there is a match, continue with the reprogramming procedure.
- If there is not a match in Table A, proceed to step 56.

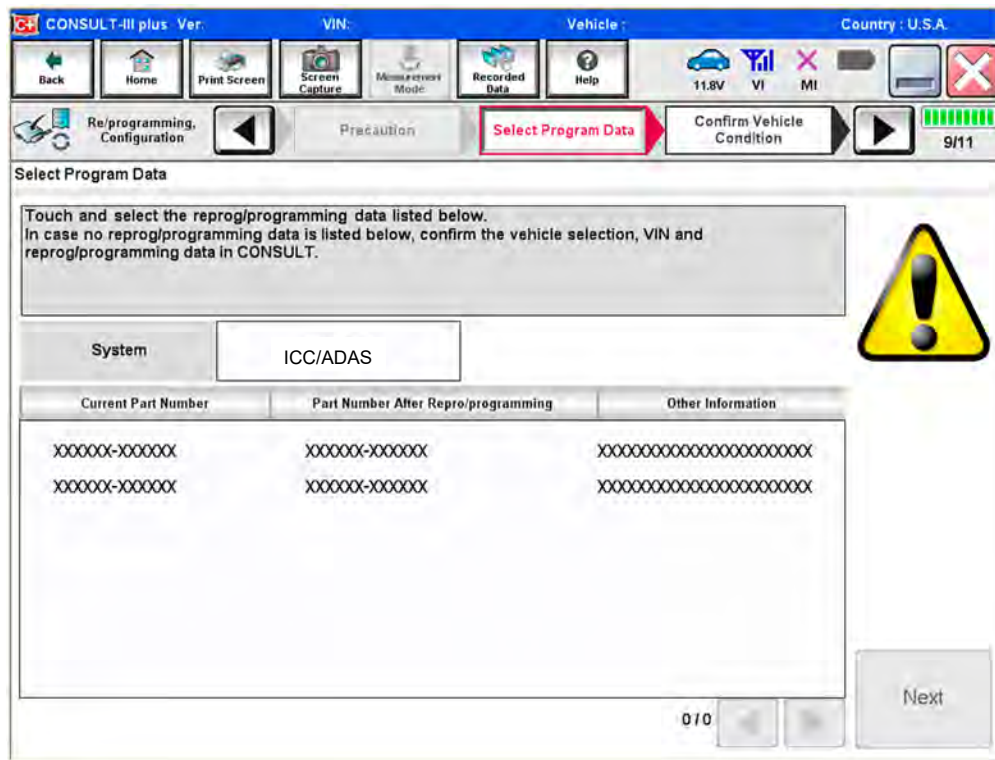
- In some cases, more than one new P/N for reprogramming is available.
 - If more than one new P/N is available, the screen in Figure 28 displays.
 - Select and use the reprogramming option that does **not** have the message “Caution! Use ONLY with NTBXX-XXX”.
- If you get this screen and it is blank (no reprogramming listed), it means there is no reprogramming available for this vehicle. Close C-III plus and refer back to ASIST for further diagnosis.

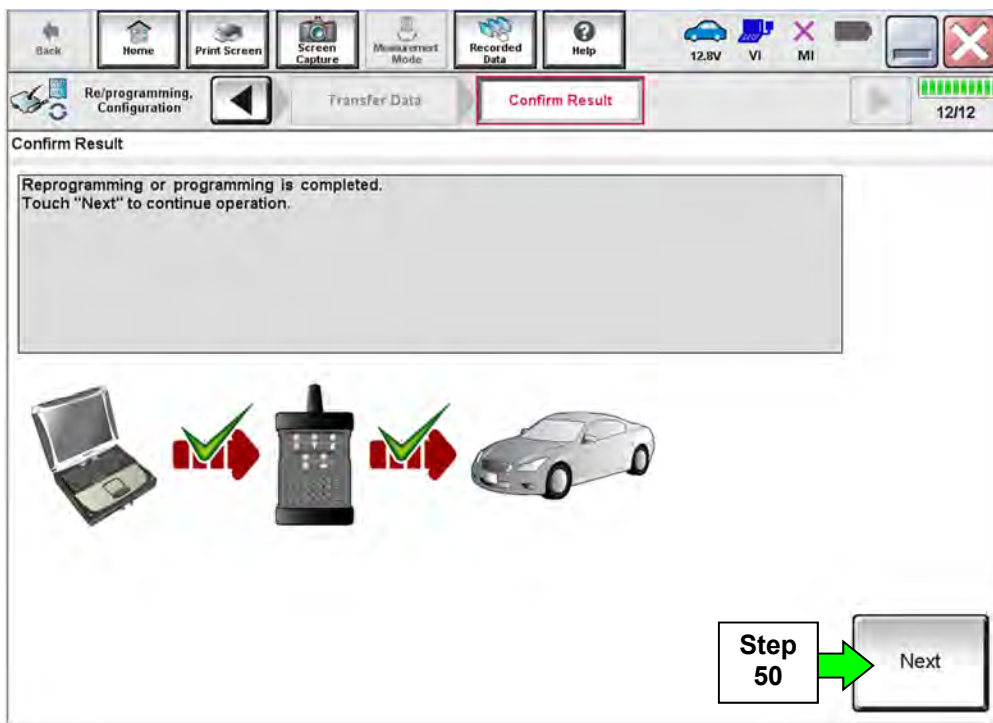
48. When the screen in Figure 29 displays, reprogramming is complete.

NOTE: If the screen in Figure 29 does not display (indicating that reprogramming did not complete), refer to ICC/ADAS recovery on the next page.

49. Disconnect the GR8 (battery charger) from the vehicle.

50. Select **Next**.
