SERVICE BULLETIN

Classification: EL18-005a	Reference: NTB18-041a	Date: July 19, 2018
------------------------------	--------------------------	------------------------

2017-2018 ROGUE, ROGUE HYBRID AND ROGUE SPORT; UNEXPECTED OPERATION OF AEB, FEB OR FCW

APPLIED VEHICLES: 2017-2018 Rogue (T32)
 2017-2018 Rogue Sport (J11)
 2017-2018 Rogue Hybrid (T32)

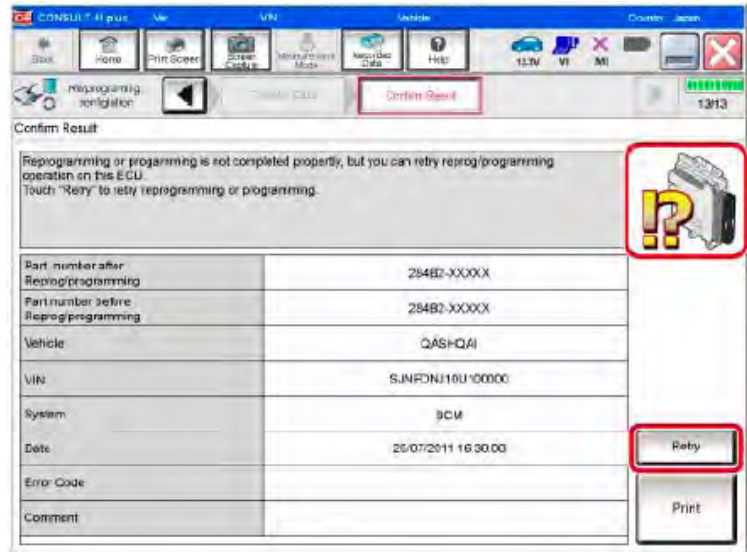
Figure 30

If reprogramming does not complete and the “!?” icon displays as shown in Figure 30:

- Check battery voltage (12.0 - 15.5 V).
- Ignition is ON, engine OFF.
- External Bluetooth® devices are OFF.
- All electrical loads are OFF.
- **Select retry and follow the on screen instructions.**
- **“Retry” may not go through on first attempt and can be selected more than once.**

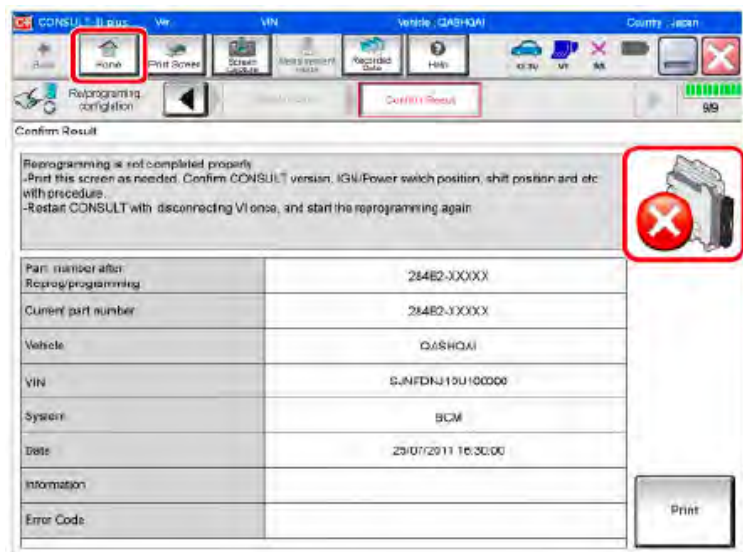
Figure 31

If reprogramming does not complete and the “X” icon displays as shown in Figure 31:

- Check battery voltage (12.0 - 15.5 V).
- CONSULT A/C adapter is plugged in.
- Ignition is ON, engine OFF.
- Transmission is in Park.
- All C-III plus / VI cables are securely connected.
- All C-III plus updates are installed.
- **Select Home, and restart the reprogram procedure from the beginning.**

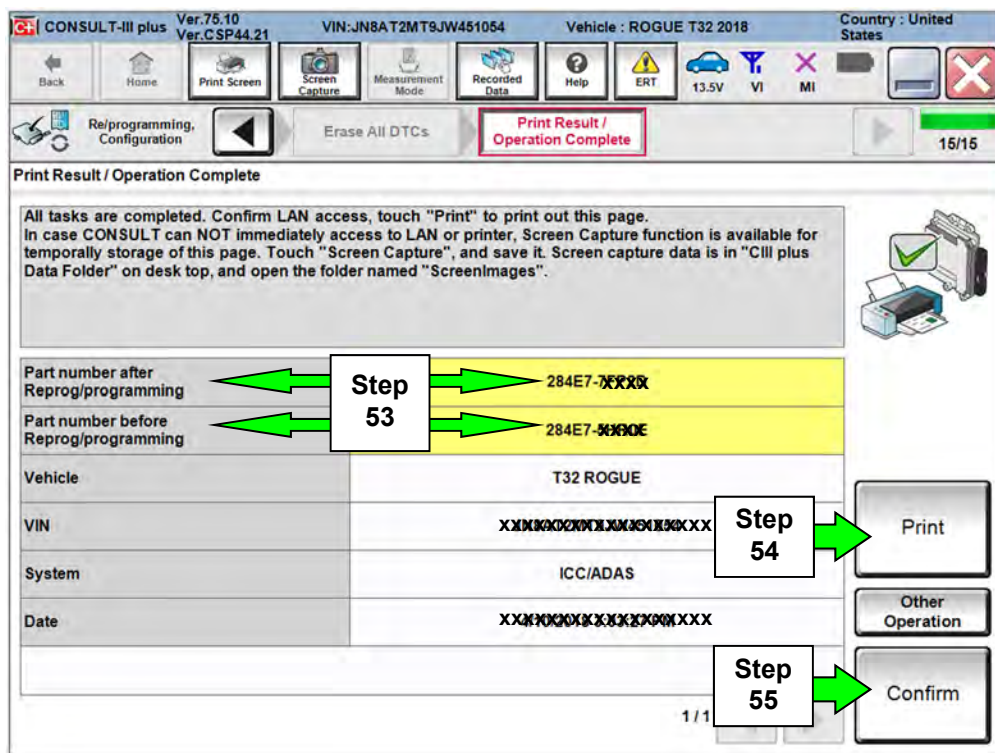
51. Follow the on on-screen instructions to erase DTCs.
 - If needed, refer to step 38 on page 18 for further details.
52. When the entire reprogramming process is complete, the screen in Figure 32 will display.
53. Verify the before and after part numbers are different.
54. Print a copy of this screen (Figure 32) and attach it to the repair order for warranty documentation.
55. Select **Confirm**.
