SERVICE CAMPAIGN BULLETIN

NTB18-049

VOLUNTARY SERVICE CAMPAIGN 2012 – 2017 VERSA SEDAN; ECM REPROGRAM

CAMPAIGN ID #: PM827
APPLIED VEHICLES: 2012 – 2017 Versa Sedan (N17)

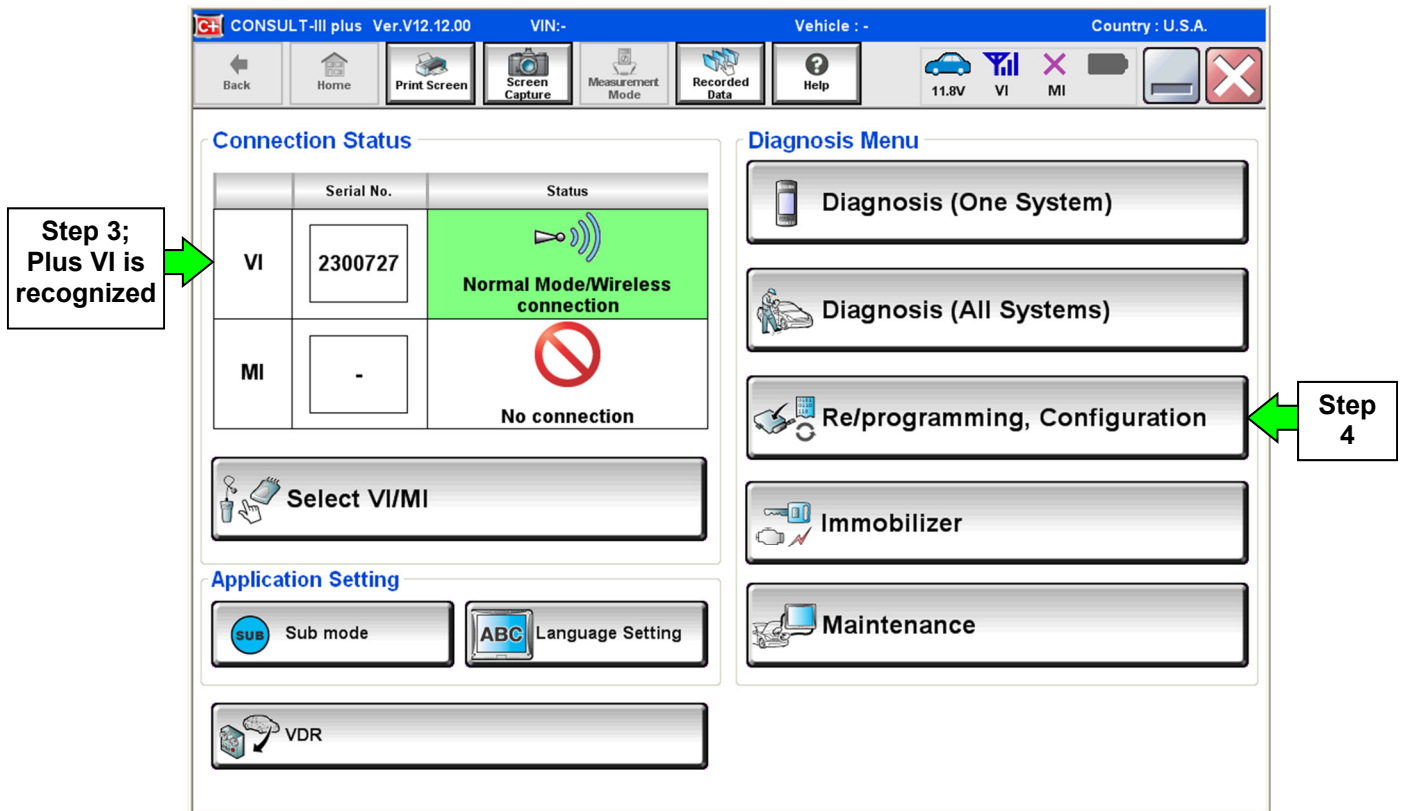
Figure 1

1. Connect the CONSULT PC to the vehicle to begin the reprogramming procedure.
2. Start C-III plus.
3. Wait for the plus VI to be recognized / connected.
 - The serial number will display when the plus VI is recognized / connected.
4. Select **Re/programming, Configuration**.

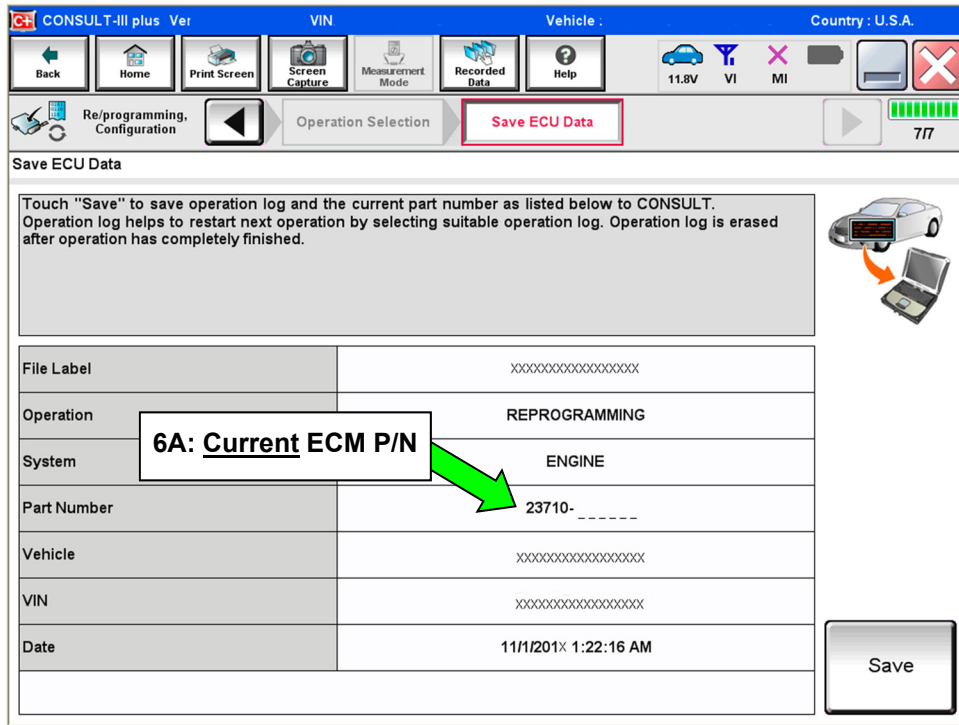
6. When you get to the screen shown in Figure 2, confirm this bulletin applies as follows.

A. Find the ECM **Part Number** and write it on the repair order.

NOTE: This is the current ECM Part Number (P/N).

5. Follow the on-screen instructions and navigate the C-III plus to the screen shown in Figure 2 on the next page.

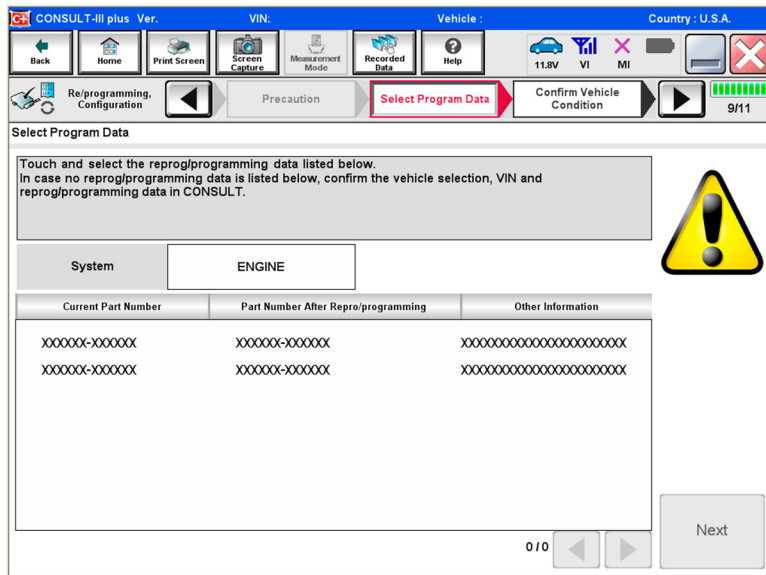
- In some cases, more than one new P/N for reprogramming is available.
 - In this case, the screen in Figure 3 displays.
 - Select and use the reprogramming option that **does not** have the message “Caution! Use ONLY with NTBXX-XXX”.
- If you get this screen and it is blank (no reprogramming listed), it means there is no reprogramming available for this vehicle. Close C-III plus and refer back to ASIST for further diagnosis.

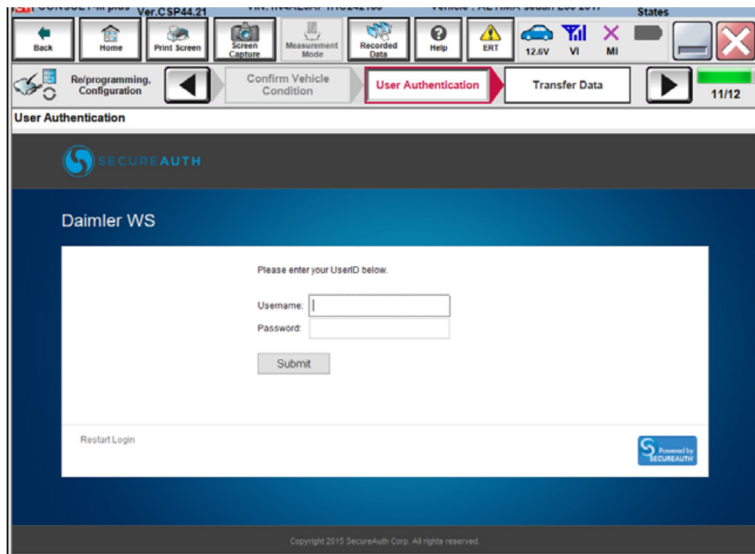
Figure 4

- Before reprogramming will start, you will be required to enter your User Name and Password.
 - The CONSULT PC must be connected to the Internet (Wi-Fi or cable).
 - If you do not know your User Name and Password, contact your Service Manager.

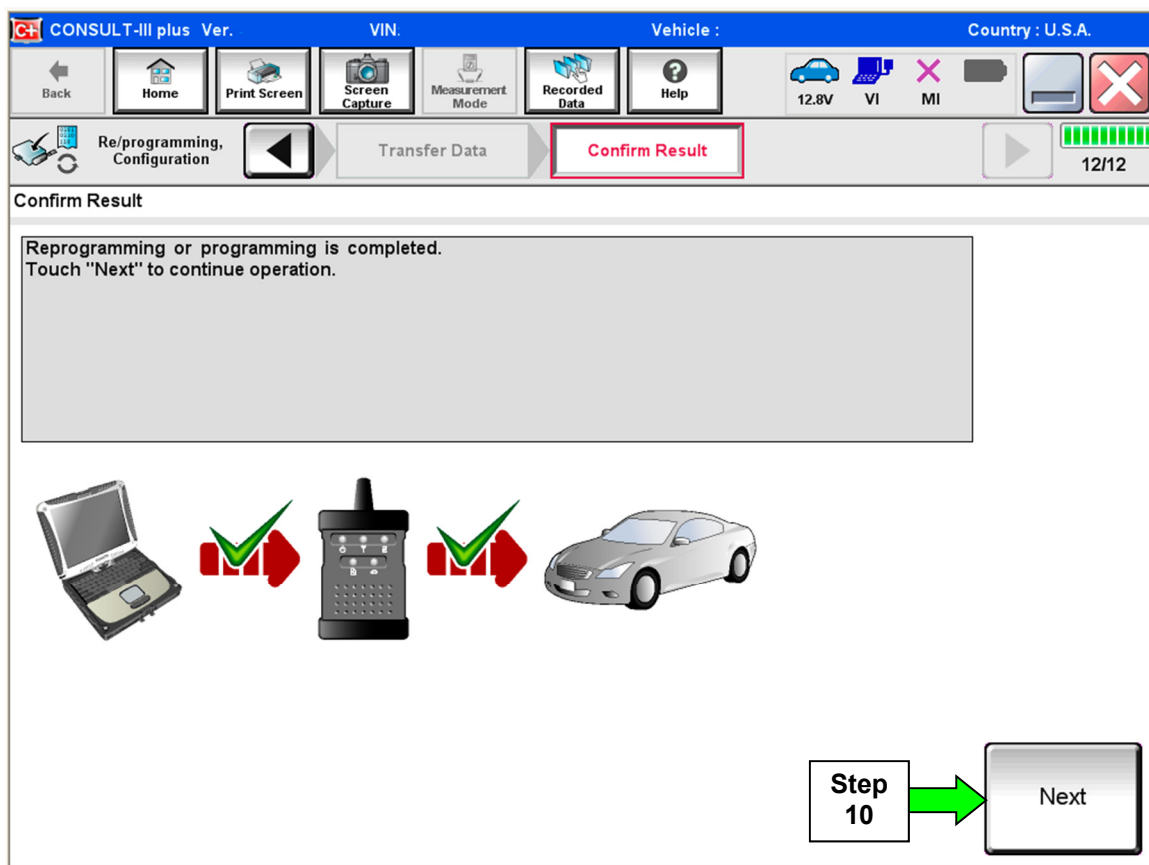
8. When the screen in Figure 5 displays, reprogramming is complete.

NOTE: If the screen in Figure 5 does not display (reprogramming does not complete), refer to the information on page 8.

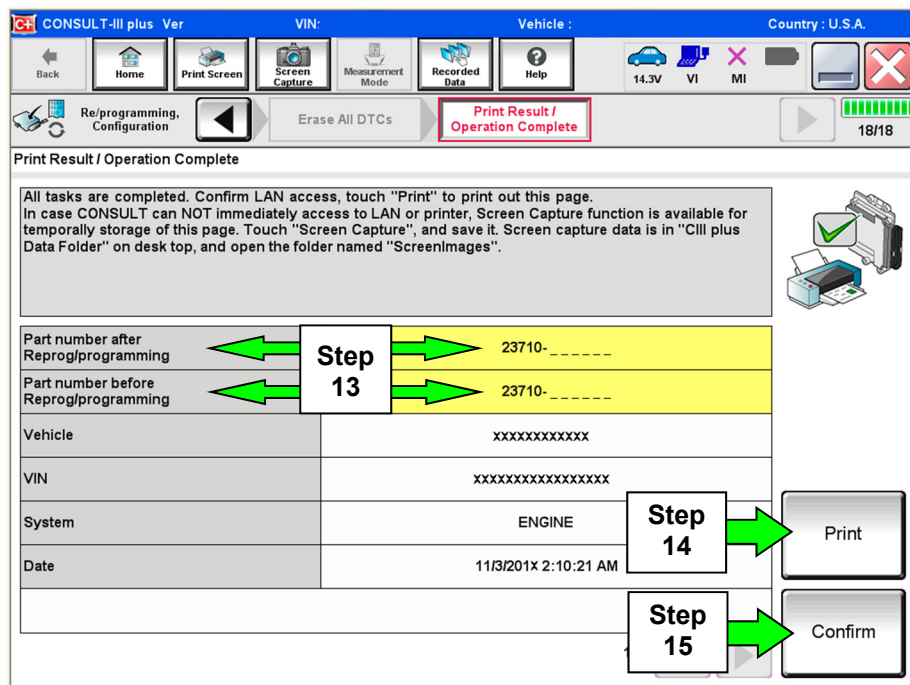
12. When the entire reprogramming process is complete, the screen in Figure 8 will display.
13. Verify the before and after part numbers are different.
14. Print a copy of this screen (Figure 8) and attach it to the repair order for warranty documentation.
15. Select **Confirm**.
