Engine Control Module (ECM) and  
Aftertreatment Control Module (ACM),  
Software Updates  
D13M  
VAH, VHD, VN

## **SP 284-067, Engine Control Module (ECM) and Aftertreatment Control Module (ACM), Software Updates**

(July 2018)

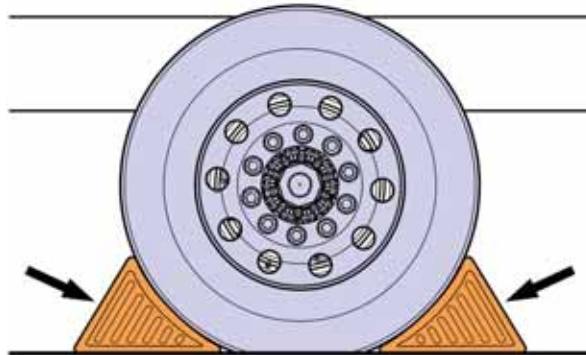
W7086748

- 1 Park the vehicle on a level surface.
- 2 Apply the parking brake.
- 3 Place the transmission in neutral or park.
- 4 Install the wheel chocks.

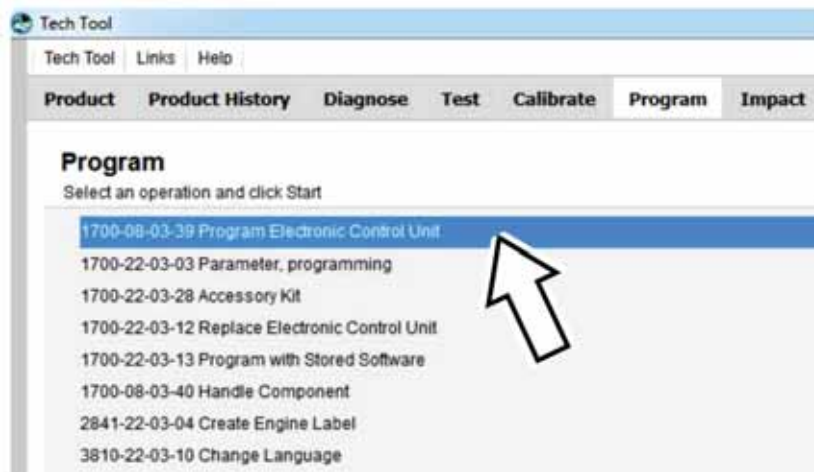
W2115478

- 10 From the Main Menu select Program and **then** Program Electronic Control Unit 1700-08-03-39. Then click Start.

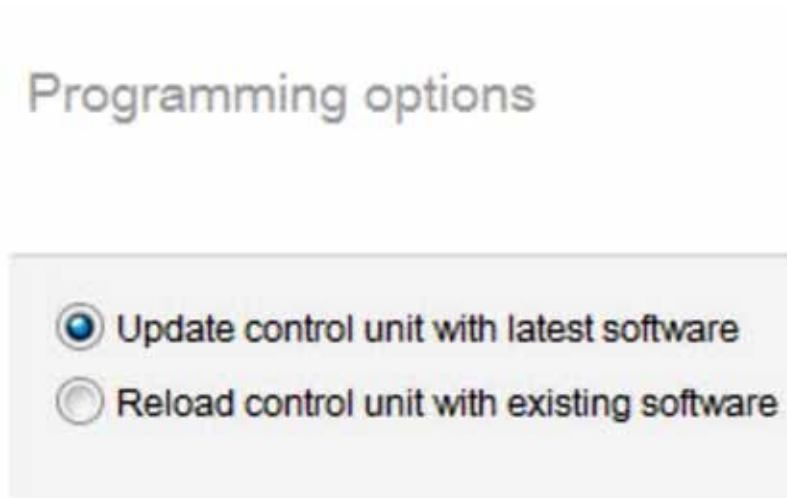
W2115480

12 Select Program to update the **EMS** with the latest software.

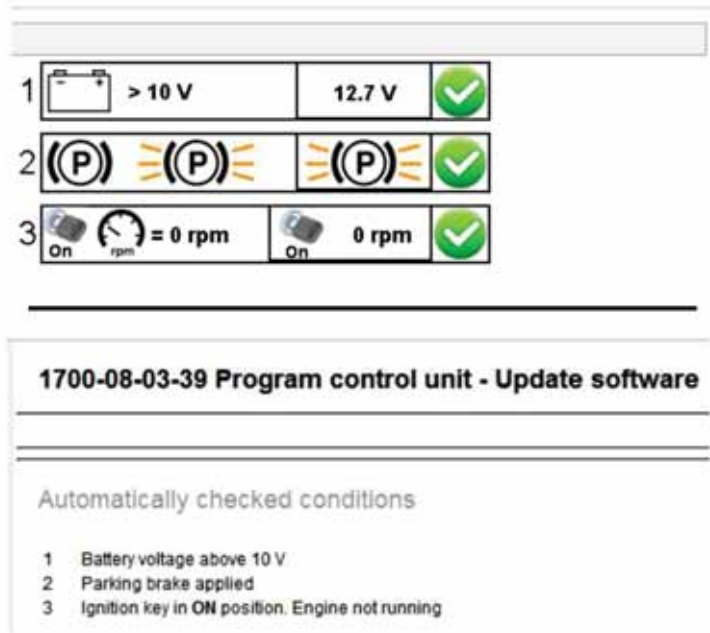
W2115481

13 Certain conditions must be met to continue with programming: battery voltage above 10v, parking brake applied, and ignition key in ON position with engine not running. When all conditions have been met, click Continue to proceed with programming.

1700-08-03-39 Program control unit - Update software

Automatically checked conditions

- 1 Battery voltage above 10 V
- 2 Parking brake applied
- 3 Ignition key in ON position. Engine not running

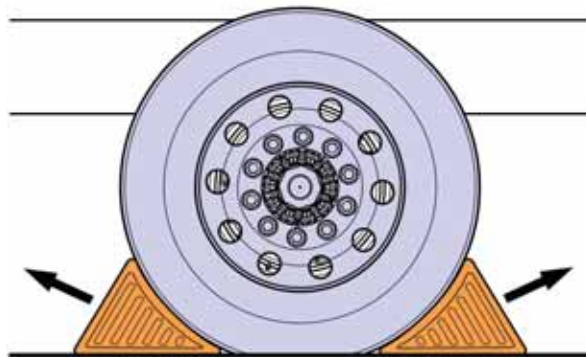
W7086759

- 16 When the programming is complete, clear any diagnostic trouble codes (DTC) and Finish.
- 17 When programming is complete, click Exit to return to Main Menu to program the ACM.
- 18 When all programming is complete, clear any diagnostic trouble codes (DTC) and Finish Work.
- 19 Remove the wheel chocks.
