Technical Service Bulletin

SUBJECT: MIL ILLUMINATION WITH DTC P0AA7/P0AA8		No: TSB-18-54-005
		DATE: July 2018
		MODEL: 2018 Outlander PHEV
CIRCULATE TO:	<input type="checkbox"/> GENERAL MANAGER	<input checked="" type="checkbox"/> PARTS MANAGER
<input checked="" type="checkbox"/> SERVICE ADVISOR	<input checked="" type="checkbox"/> SERVICE MANAGER	<input checked="" type="checkbox"/> TECHNICIAN
	<input checked="" type="checkbox"/> WARRANTY PROCESSOR	<input type="checkbox"/> SALES MANAGER

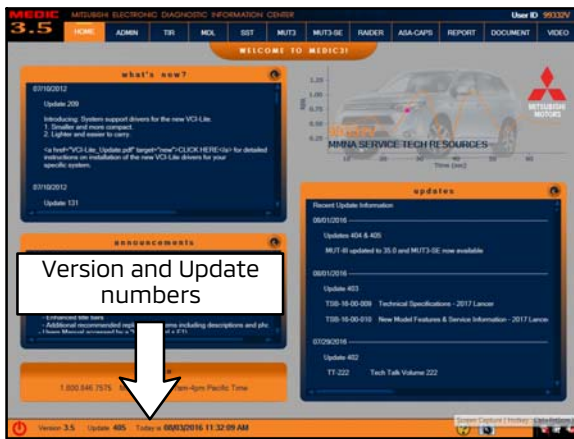
1. Verify that the Sub-BMU has not already been updated to the latest S/W number in the table above.
 If the Sub-BMU is at the latest level, reprogramming is not necessary.

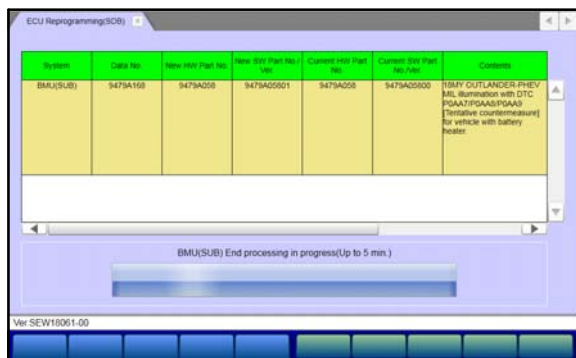
g. Once the reprogramming is initiated, the screen shown will indicate the reprogramming progress.
