GROUP ENG	MODEL 2017-2018MY Forte (YDm) 2.0L MPI
NUMBER 170 (Rev 1, 08/08/2018)	DATE June 2017

TECHNICAL SERVICE BULLETIN

SUBJECT: ADAPTIVE VALUES RESET FOR DTC P0016

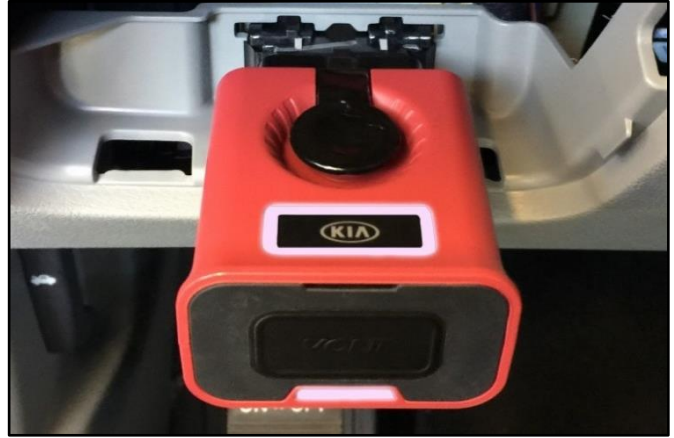
1. Connect the VCI-II to the OBD-II connector, located under the driver's side of the instrument panel.

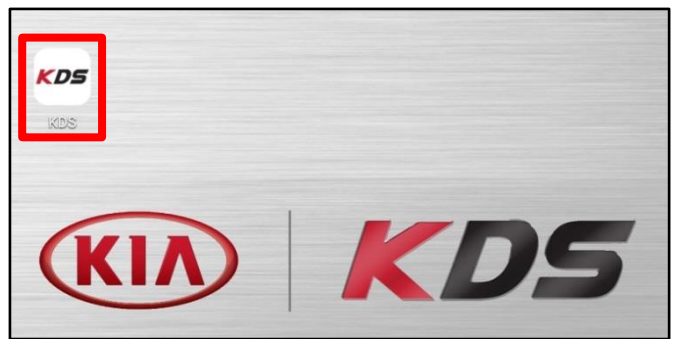
2. With the ignition ON, turn ON the KDS tablet. Select **KDS** from the home screen.

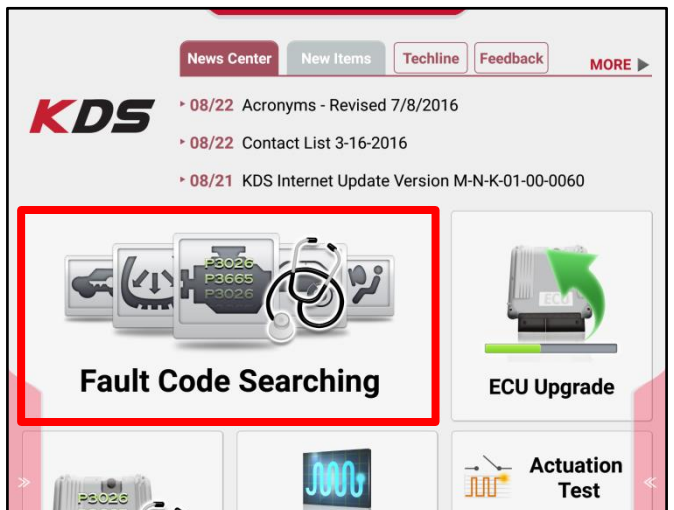
4. From the home page of the KDS app, select "Fault Code Searching".

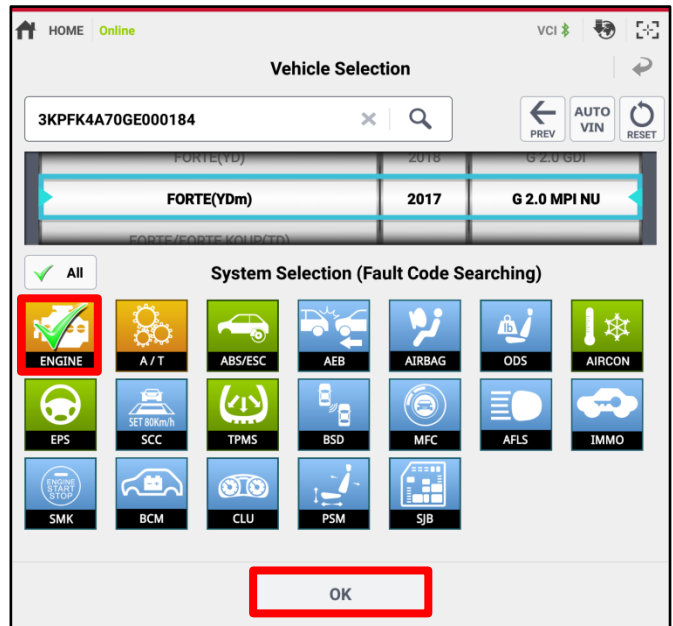
- Select “Engine” and select “OK” to perform the fault code search.

Record and then clear any **Engine** related fault codes.

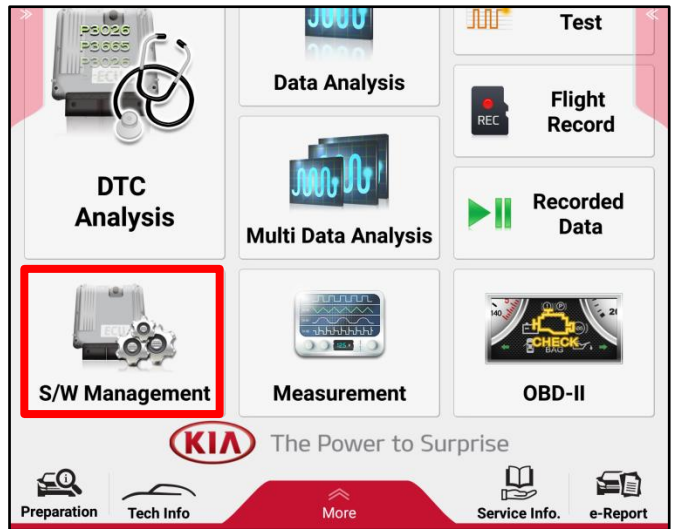
- Return to the KDS app home page and select “S/W Management”.

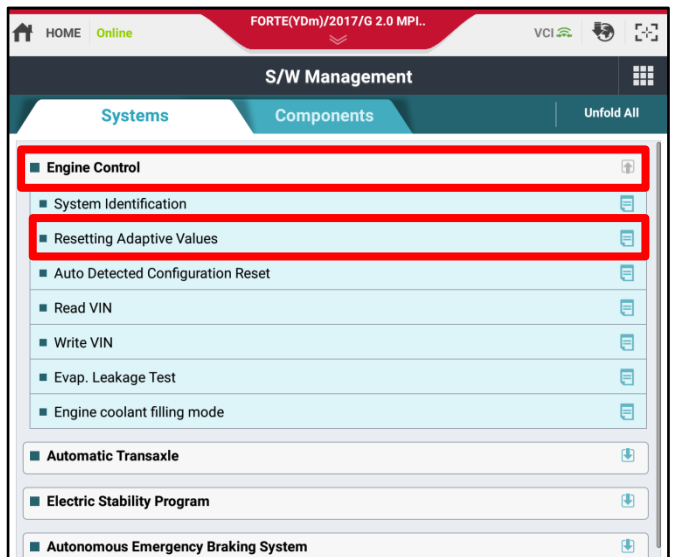
- Select “Engine Control” → “Resetting Adaptive Values” under the “Systems” tab.

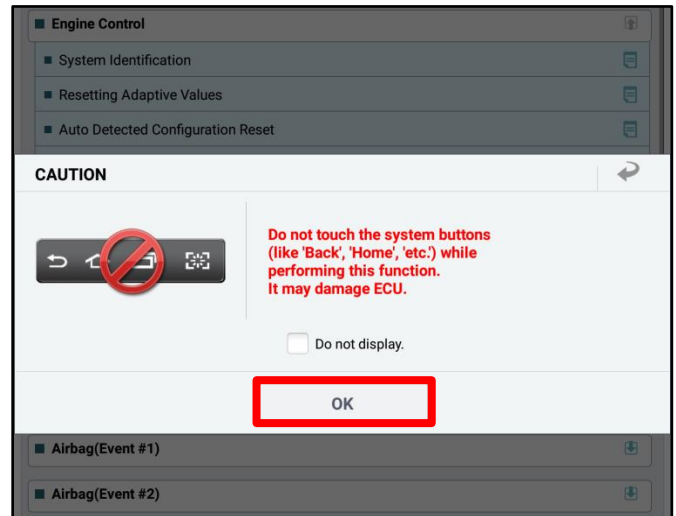
8. Select "OK" to continue.

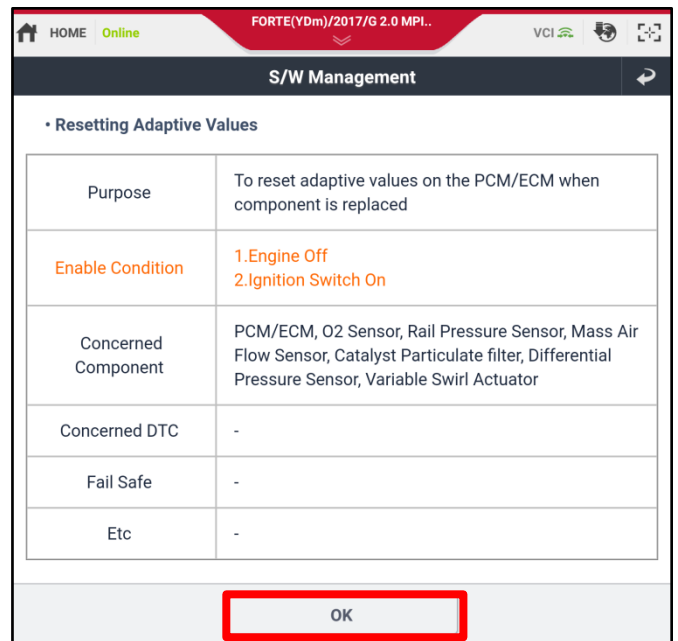
9. Ensure the Enable Conditions are met:

- Ignition ON
- Engine OFF

Select "OK" to continue.

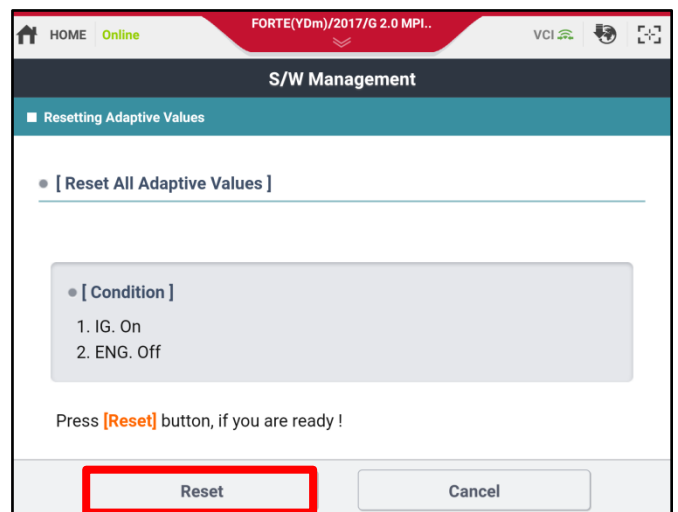
10. Select "Reset" to reset the adaptive values.

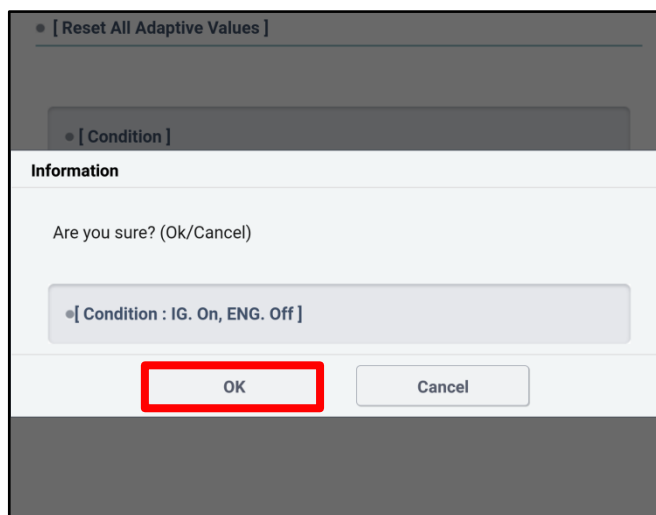
11. Select "OK" when prompted to confirm ("Are you sure?").

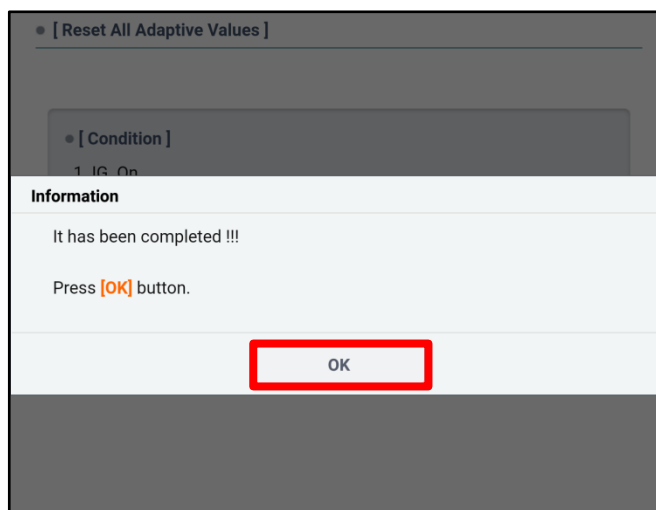
12. Select "OK" to complete the procedure.
