EC18-016

2014 – 2017 Q50 HYBRID; ENGINE STOPS RUNNING IN EXTREMELY HOT AMBIENT TEMPERATURES AND DTC P3182 STORED

APPLIED VEHICLES: 2014 – 2017 Q50 Hybrid (V37)
APPLIED ENGINE: VQ35HR

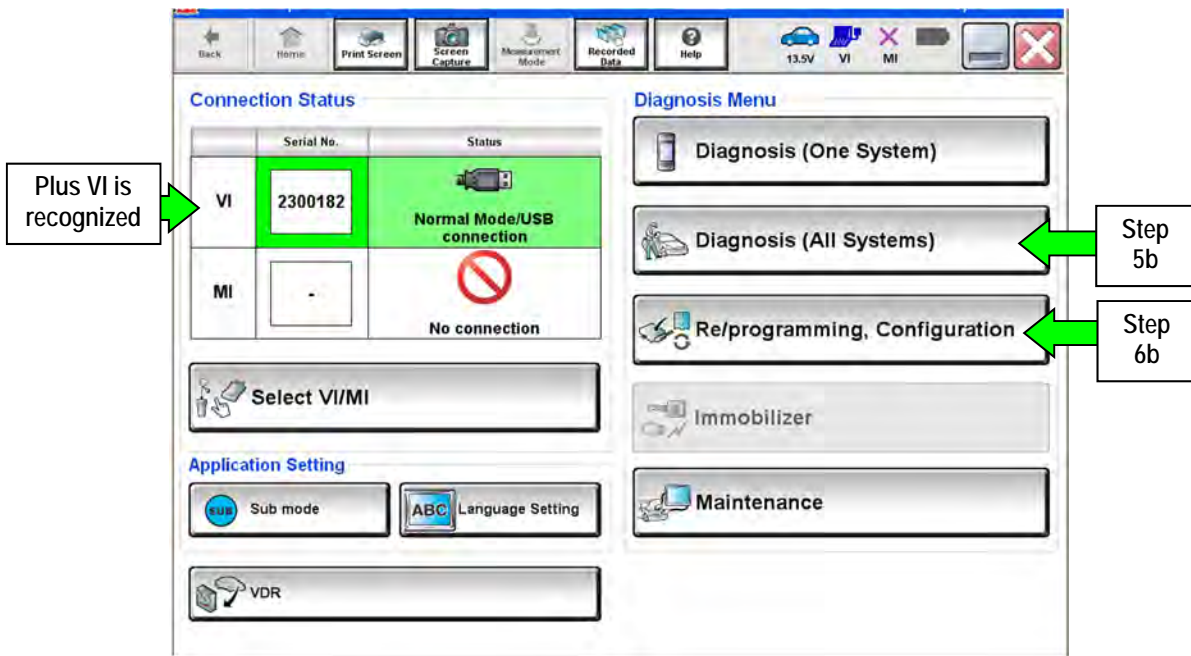
Figure 1

6. Go to **Re/programming, Configuration**.
 - a. Select the **Home** button, and then **YES** to return to the screen shown in Figure 1.
 - b. Select **Re/programming, Configuration**.

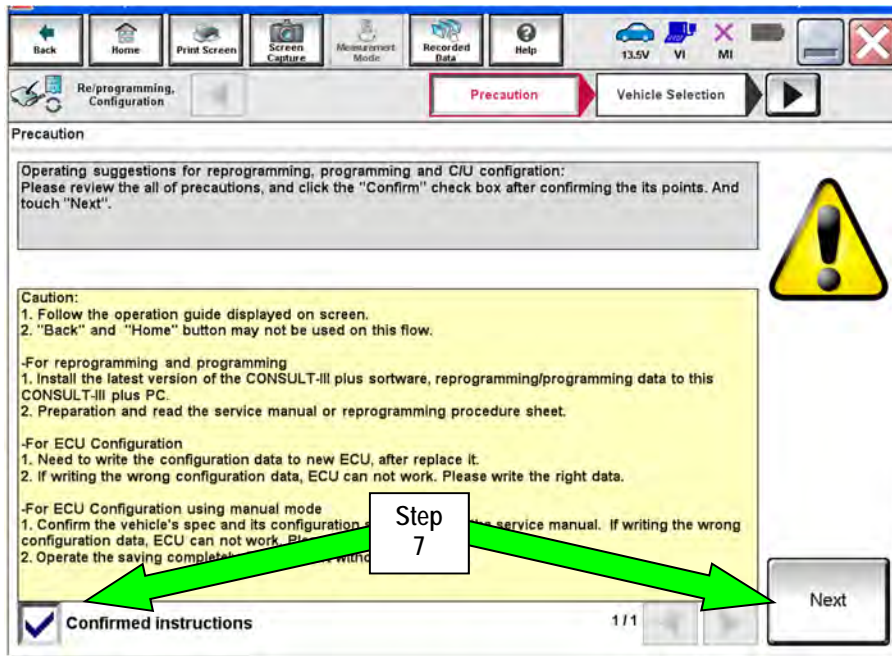
Figure 2

7. Check the box for **Confirmed Instructions**, and then select **Next**.

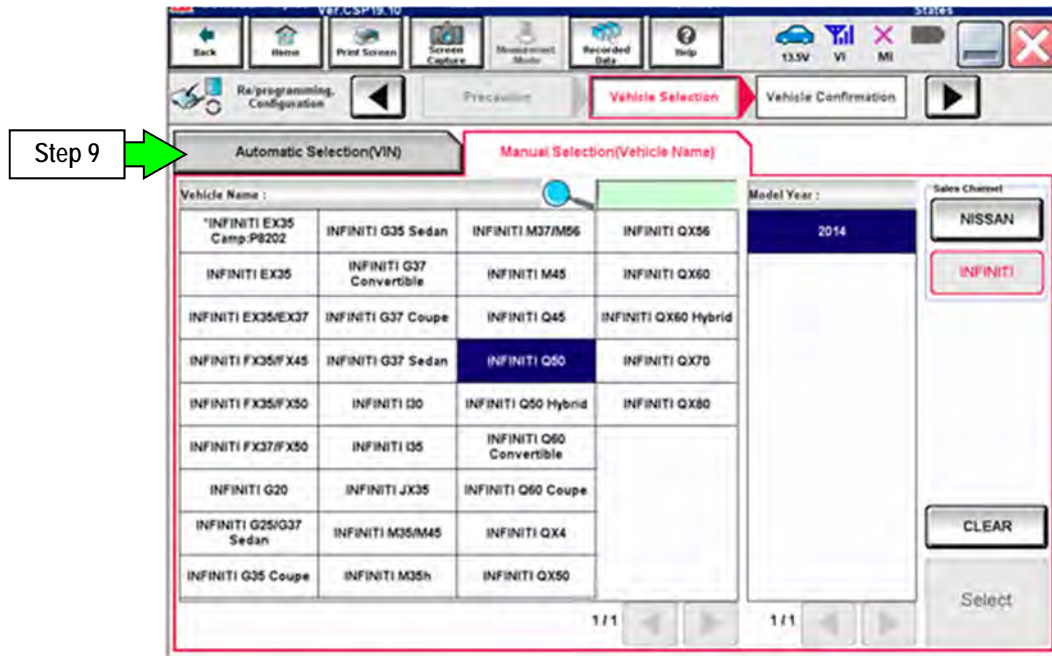
8. If the screen in Figure 3 does not display, skip to step 10.

9. If the screen in Figure 3 displays, select **Automatic Selection(VIN)**.

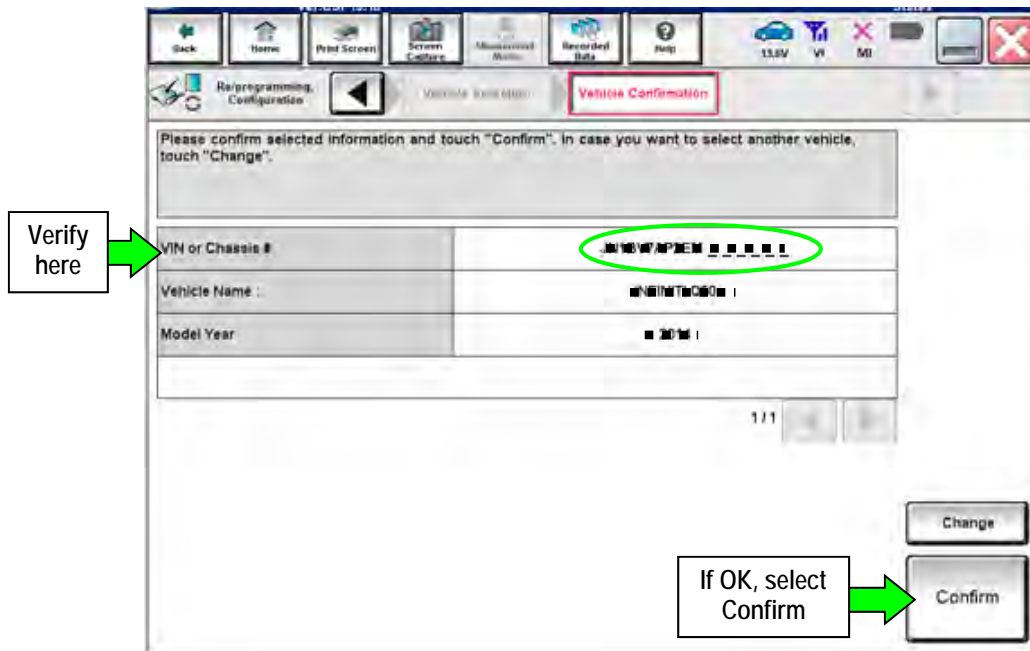
Figure 4

10. Verify the VIN or Chassis # matches that of the vehicle.

- If the correct VIN is displayed, select Confirm.

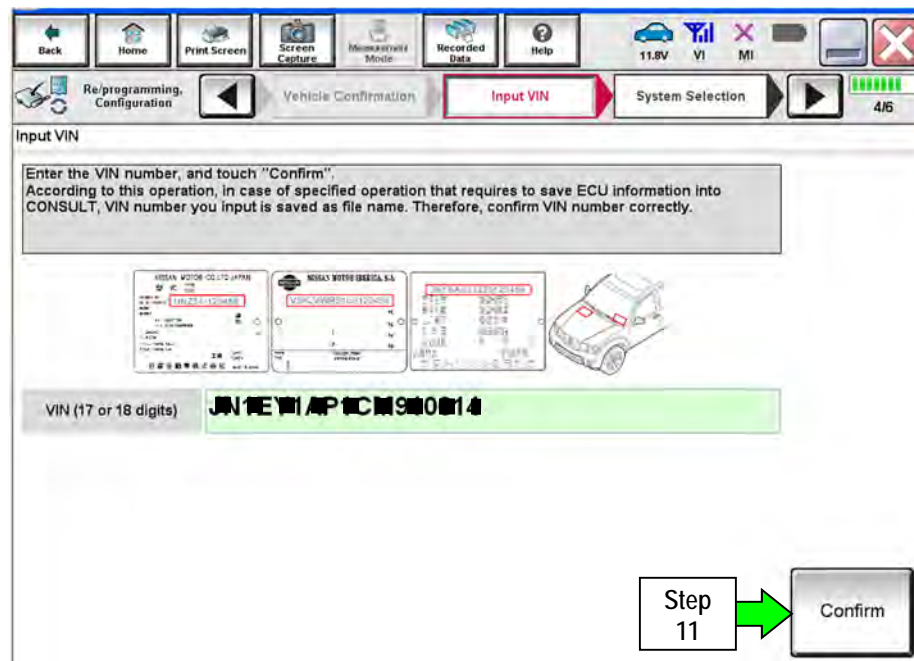
Figure 5

11. Select Confirm again.

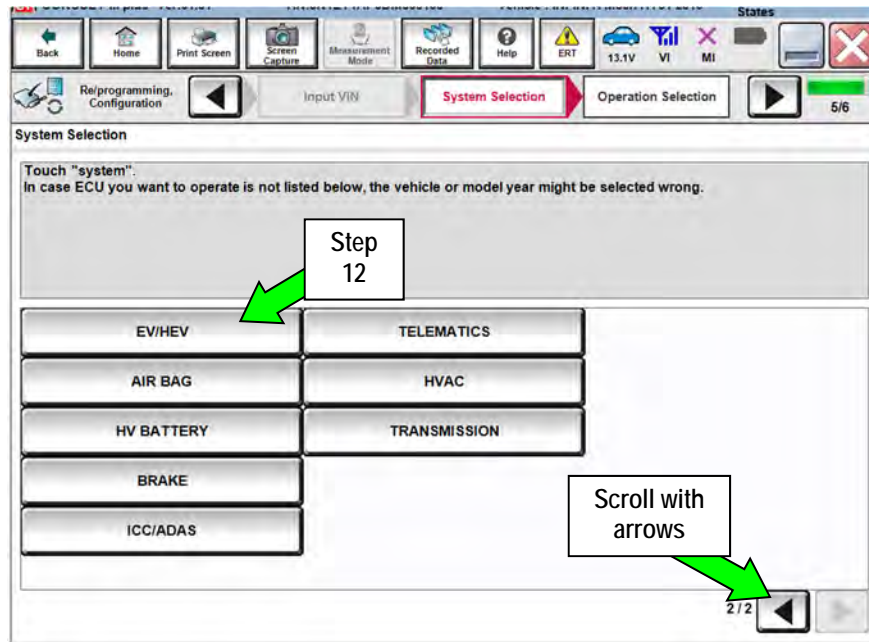
Figure 6

12. Use the page arrows to scroll to EV/HEV.

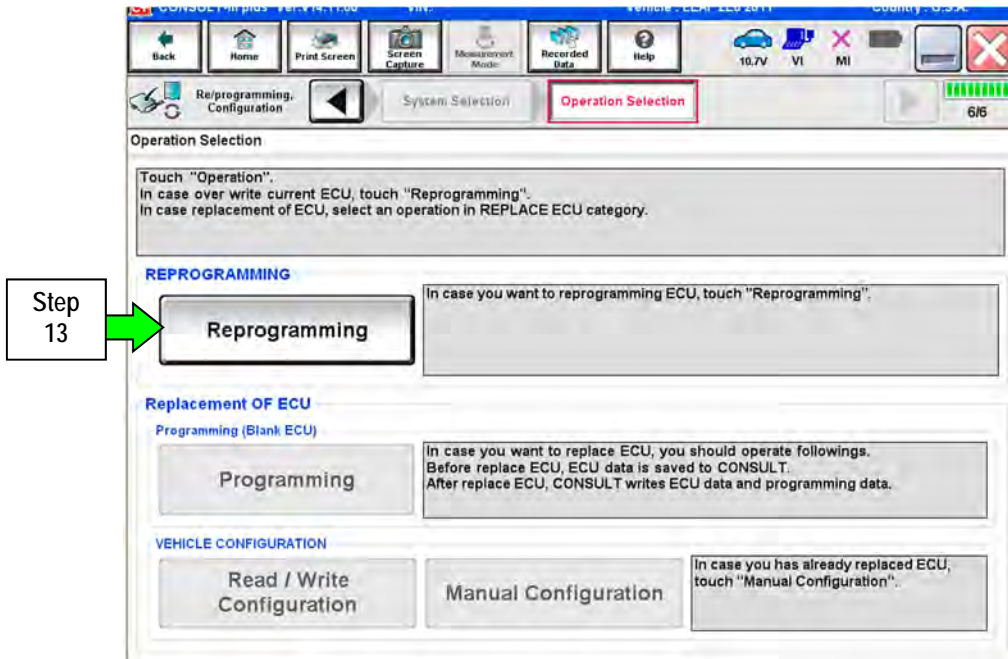
Figure 7

13. Wait for System Call to complete, and then select **Reprogramming**.

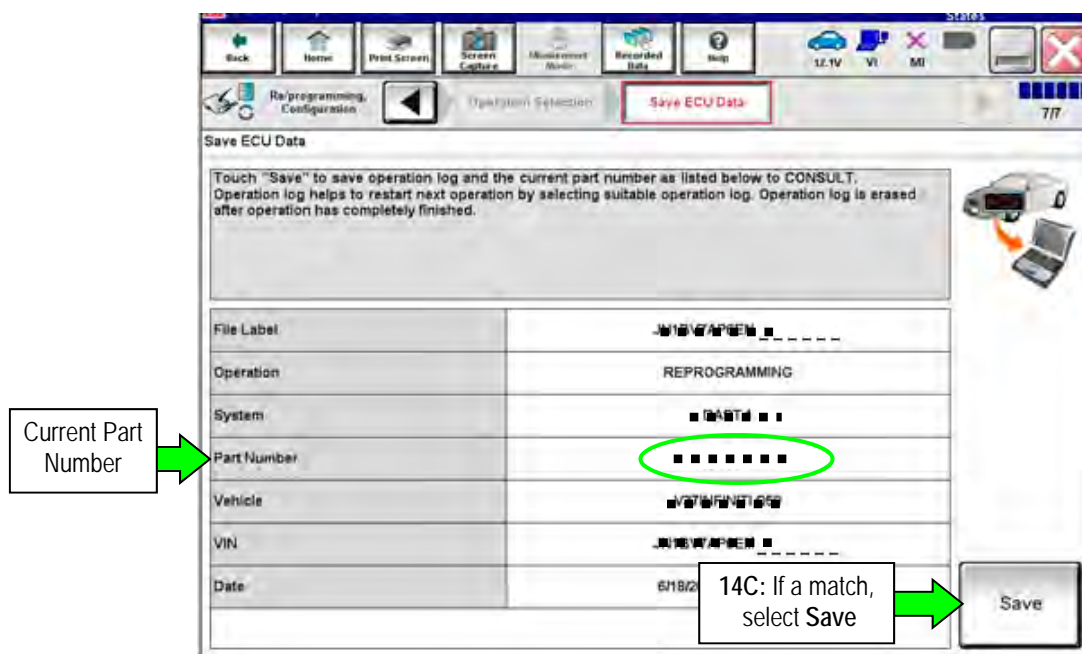
Figure 8

14. When you get to the screen shown in Figure 8, confirm reprogramming applies as follows:

A. Find the current **Part Number** and write it on the repair order.

B. Compare the P/N written down to the P/Ns in the **Current Part Number** column of **Table A** below:

- If there is a match, reprogramming applies. Continue with the reprogramming procedure.
- If there is not a match, this bulletin does not apply. Refer to ASIST for further diagnostic and repair information.

C. If there is a P/N match as specified above, select **Save**, and then continue with the reprogramming procedure.

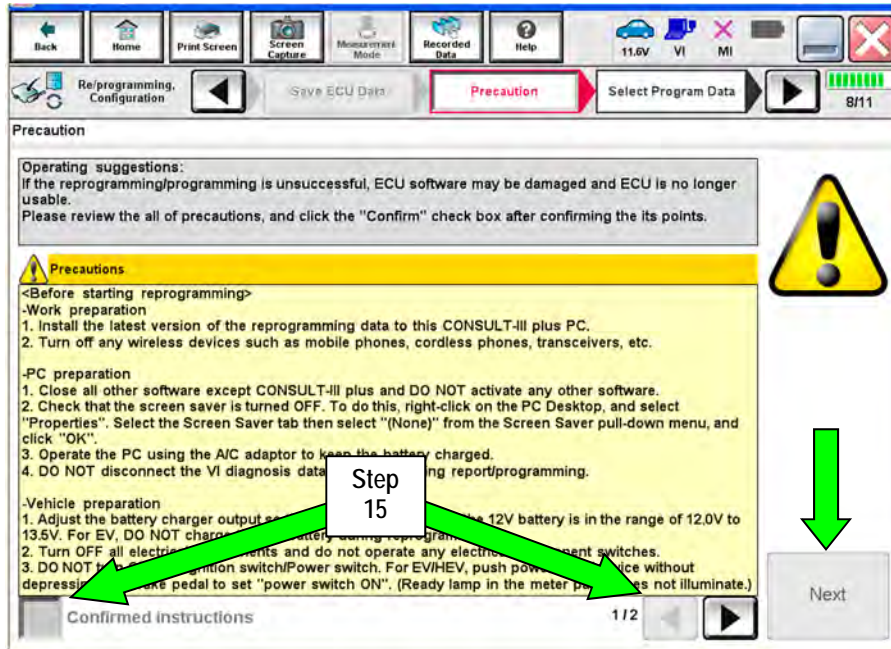
Figure 9

15. Read the precautions on the C-III plus screen (use page arrow as needed). After reading, select **Confirmed instructions**, and then select **Next**.

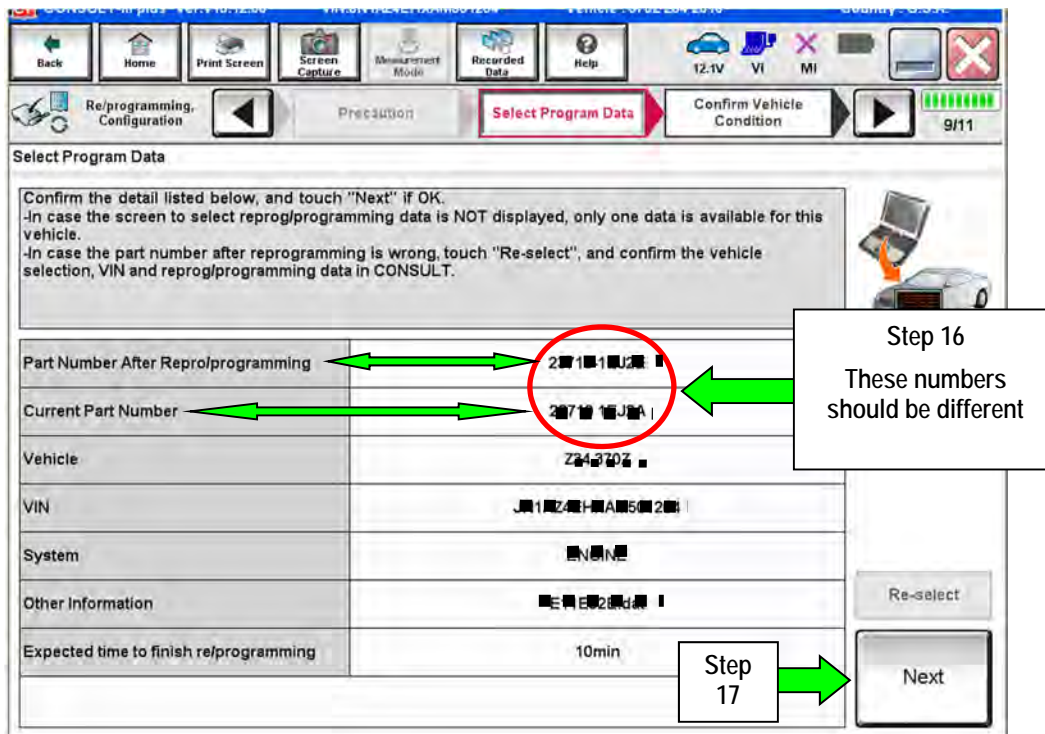
Figure 10

16. Read the **Current Part Number** and **Part Number After Reprogramming**. They should be different.

17. Select **Next**.

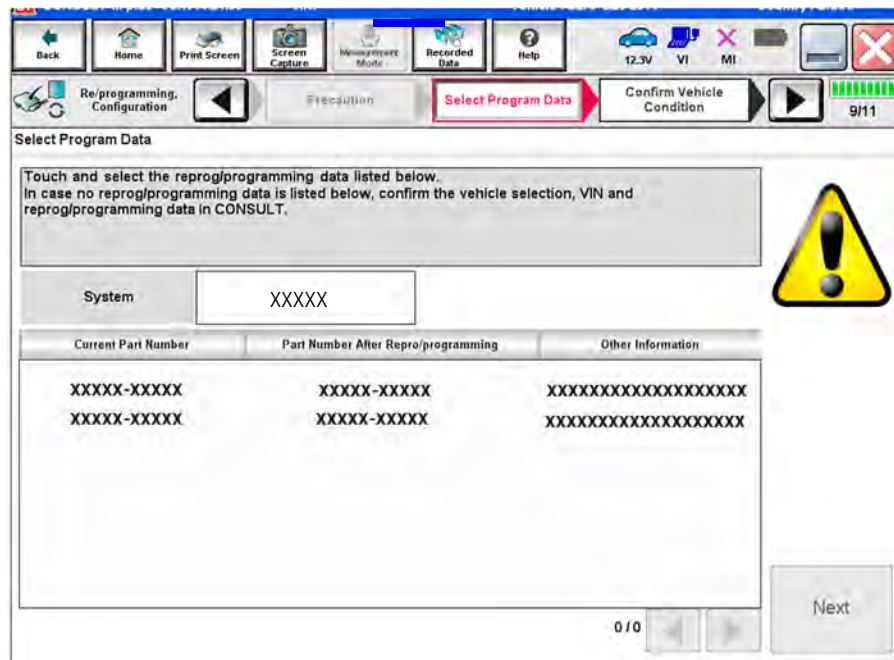
NOTE: In some cases, more than one new P/N for reprogramming is available.

- If more than one new P/N is available, the screen in Figure 11 will display.
- Select and use the reprogramming option that **does not** have the message “Caution! Use ONLY with ITBXX-XXX”.
- If you get this screen and it is blank (no reprogramming listed), it means there is no reprogramming available for that control unit.

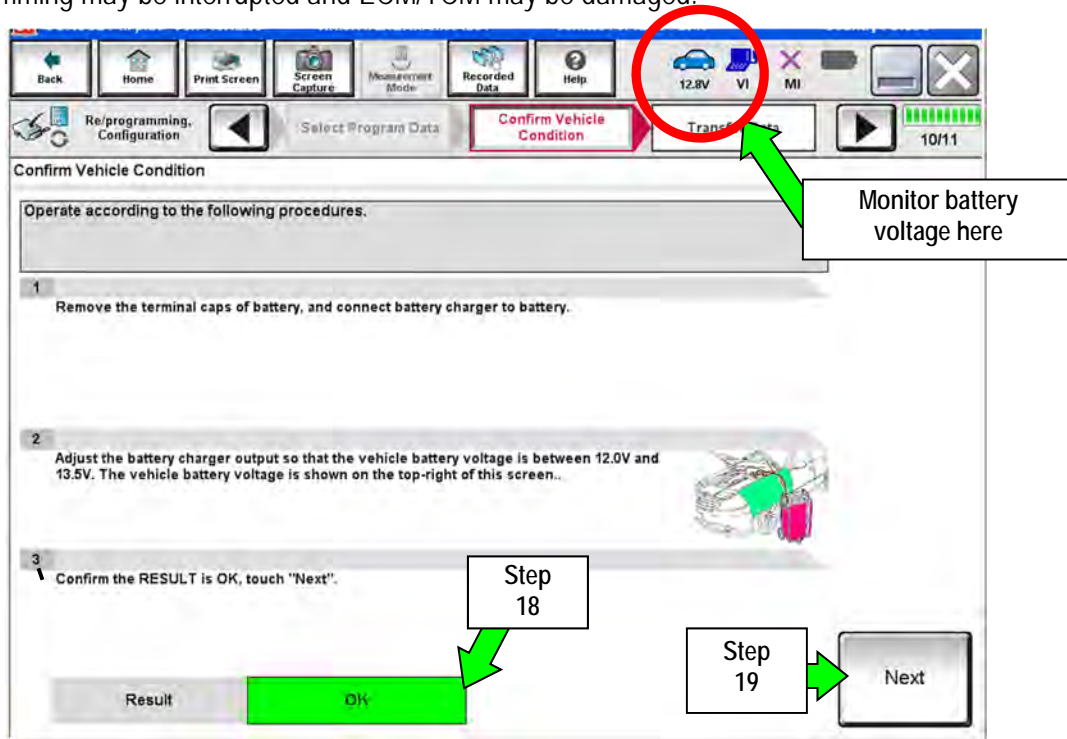
Figure 12

18. Make sure OK is highlighted green (battery voltage must be between 12.0 and 15.5 Volts).

19. Select Next.

IMPORTANT: Battery voltage must stay between 12.0 and 15.5 Volts during reprogramming or ECM reprogramming may be interrupted and ECM/TCM may be damaged.

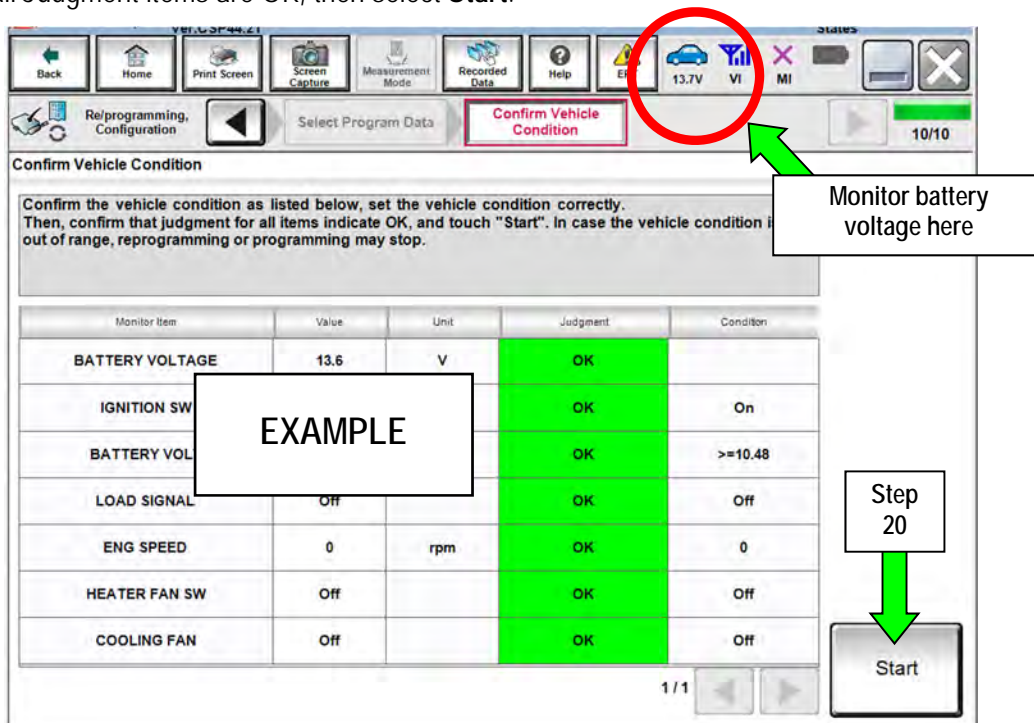
Figure 13

20. Confirm all Judgment items are OK, then select Start.

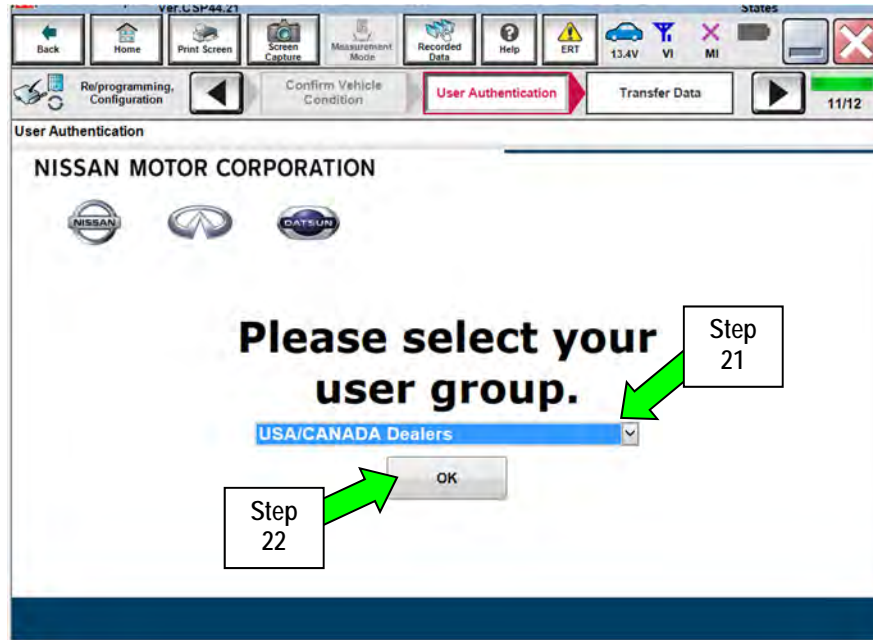
Figure 14

21. Select USA/CANADA Dealers.

22. Select OK.

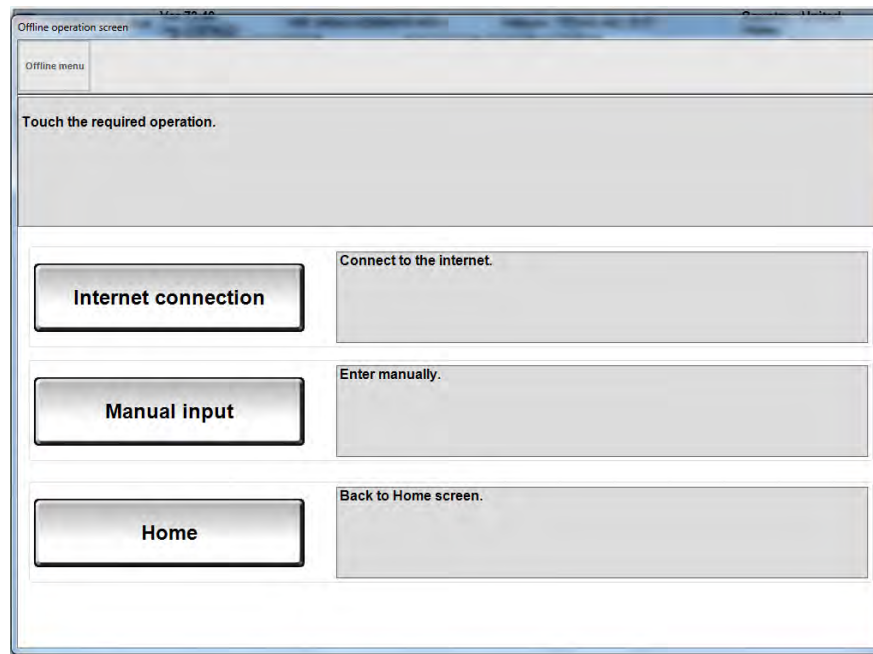
- The above screen may not display if the CONSULT PC has remained ON since the last reprogramming.
- If the CONSULT PC is not connected to the Internet, the screen in Figure 15 will display.

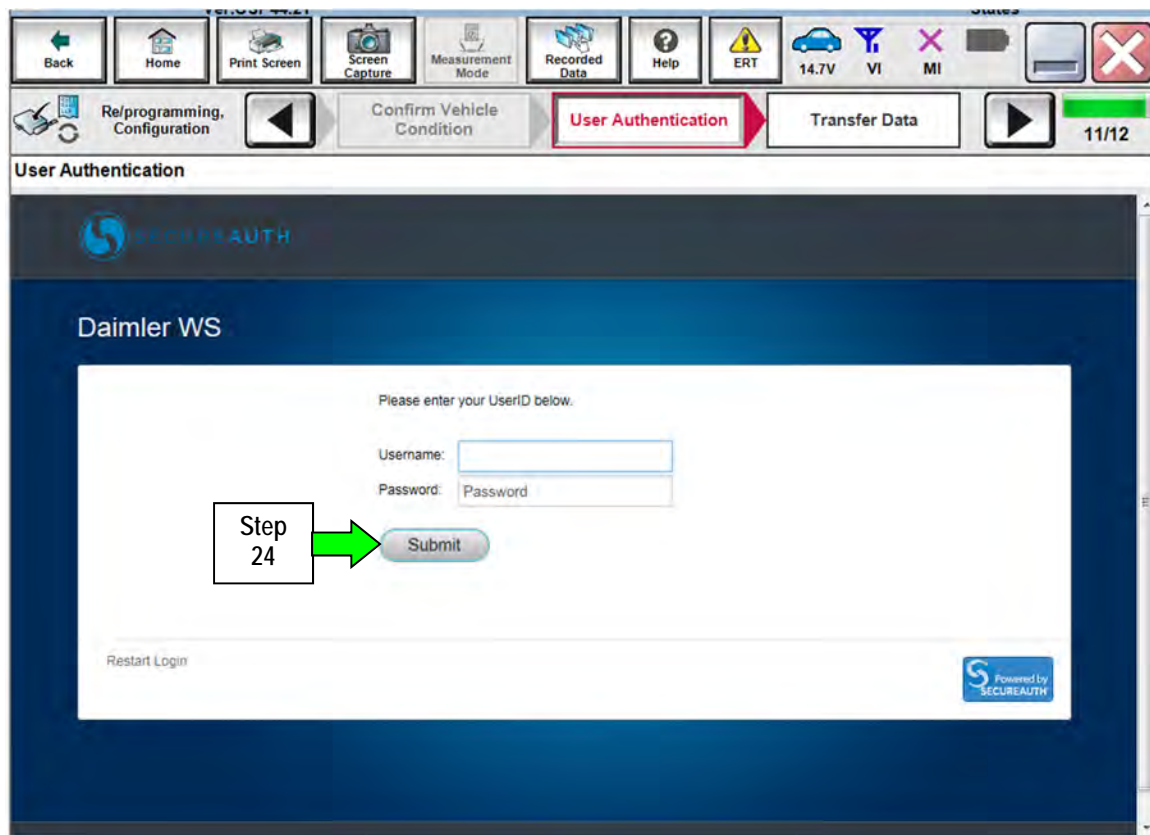
Figure 16

23. Enter your **Username** and **Password**.

- The CONSULT PC must be connected to the Internet via cable or Wi-Fi.
- If you do not know your User Name and Password, contact your Service Manager.

24. Select **Submit**.

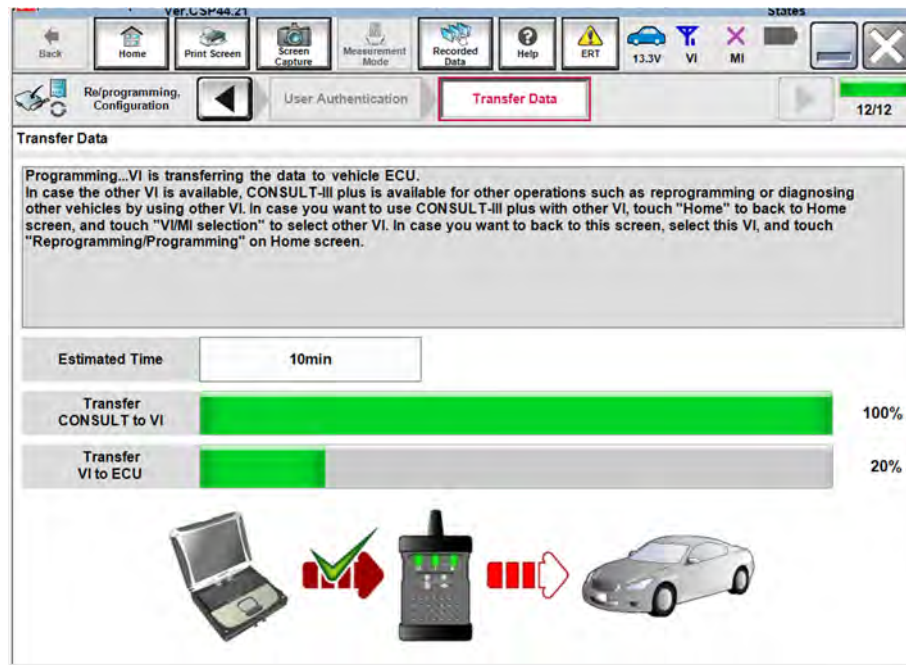
Figure 17

25. Wait for both bar graphs to complete.

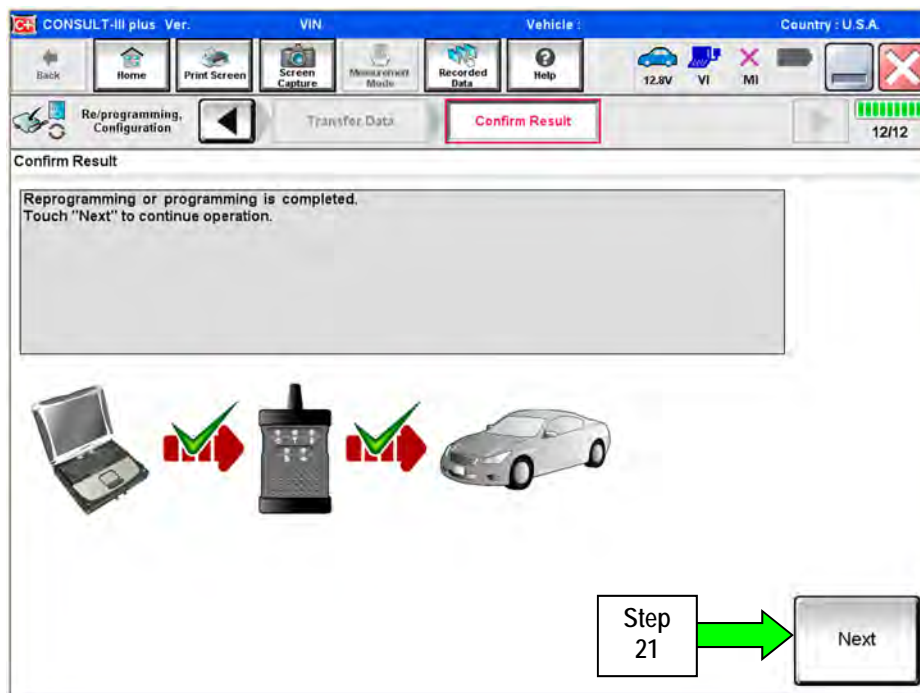
26. When the screen in Figure 18 displays, reprogramming is complete.

NOTE: If the screen in Figure 18 does not display (indicating that reprogramming did not complete), refer to the information on page 14.

27. Select Next.

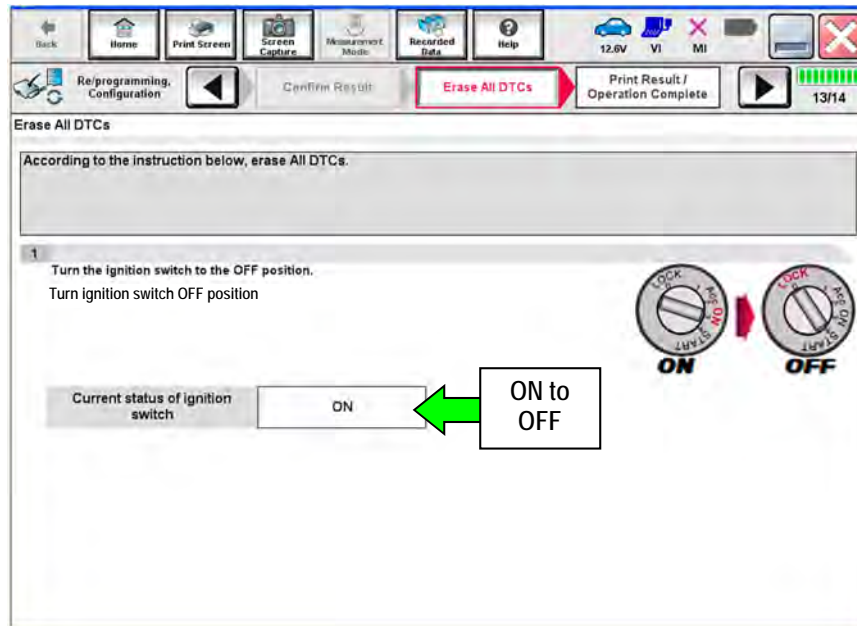
a. Turn the ignition OFF.

- The screen in Figure 21 will read OFF after pressing the power switch once.

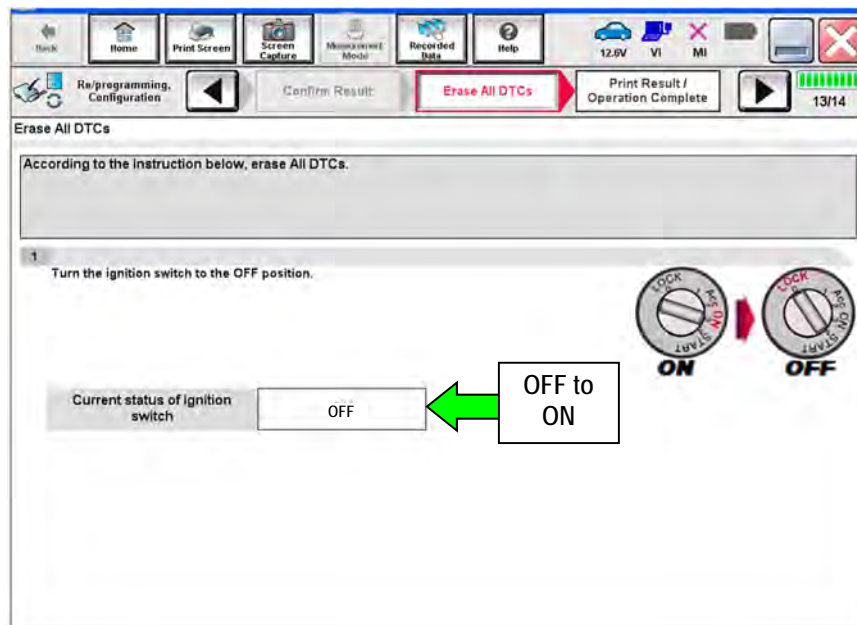
b. Turn the ignition ON, not Ready (press switch twice, no foot on brake).

- The screen in Figure 22 will read ON after pressing the power switch twice.

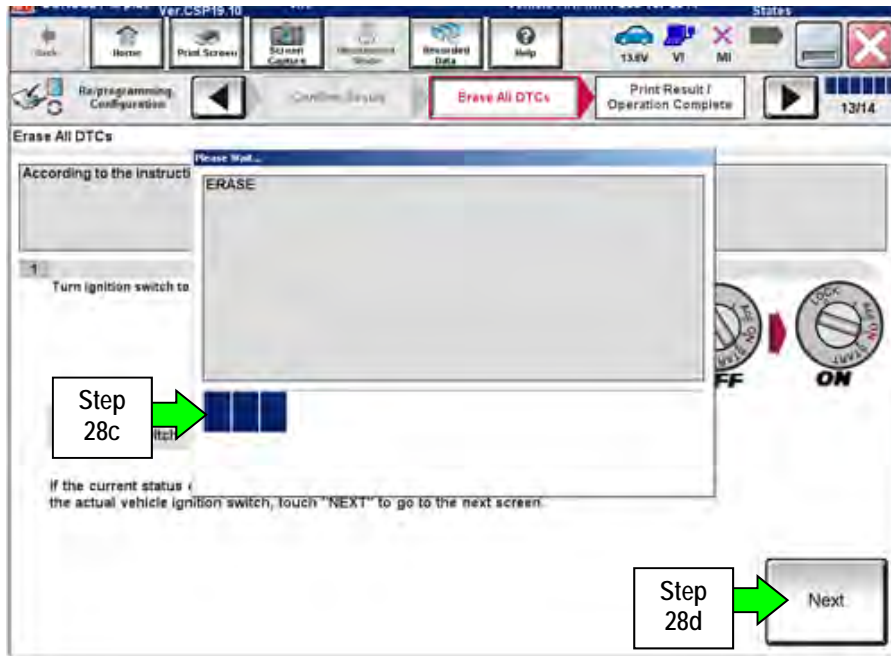
Figure 23

- c. Wait for the bar graph in the ERASE window to complete 100%.
- d. Select Next.

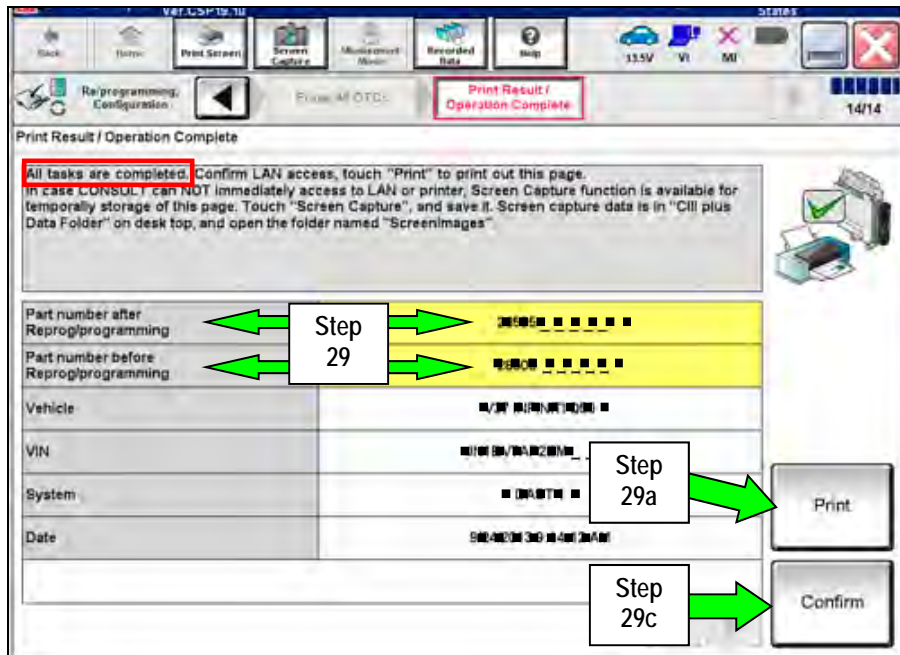
- 29. Verify the P/N has changed (before and after reprogramming P/Ns should be different).
 - a. Print a copy of the screen in Figure 24 by selecting Print.
 - b. Attach the copy to the repair order.
 - c. Once a copy has been printed, select Confirm.

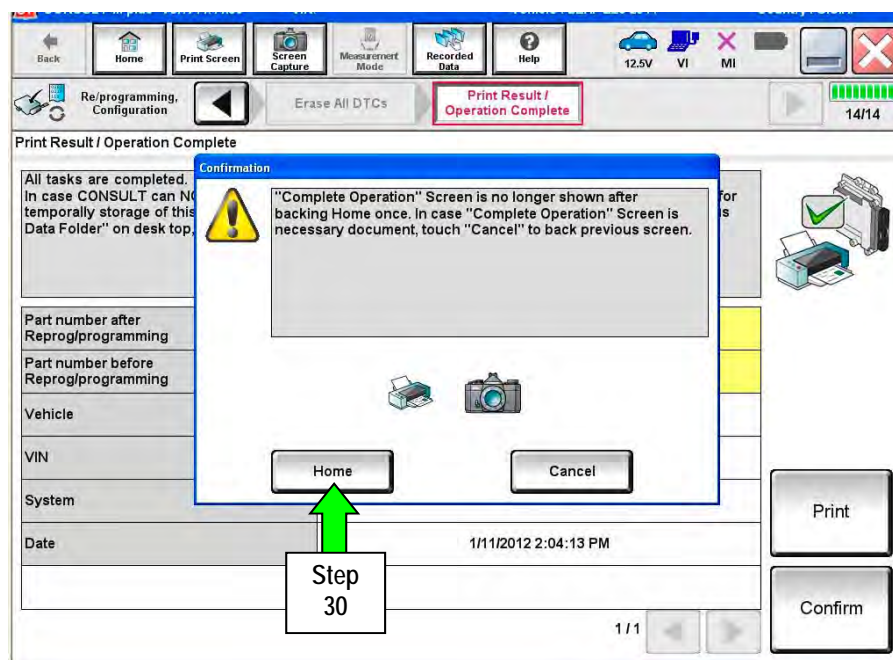
Figure 25

30. After confirmation has completed, select Home
