EC18-025

## 2019 QX50; MIL ON WITH DTC P0606

**APPLIED VEHICLES:** 2019 QX50 (J55)

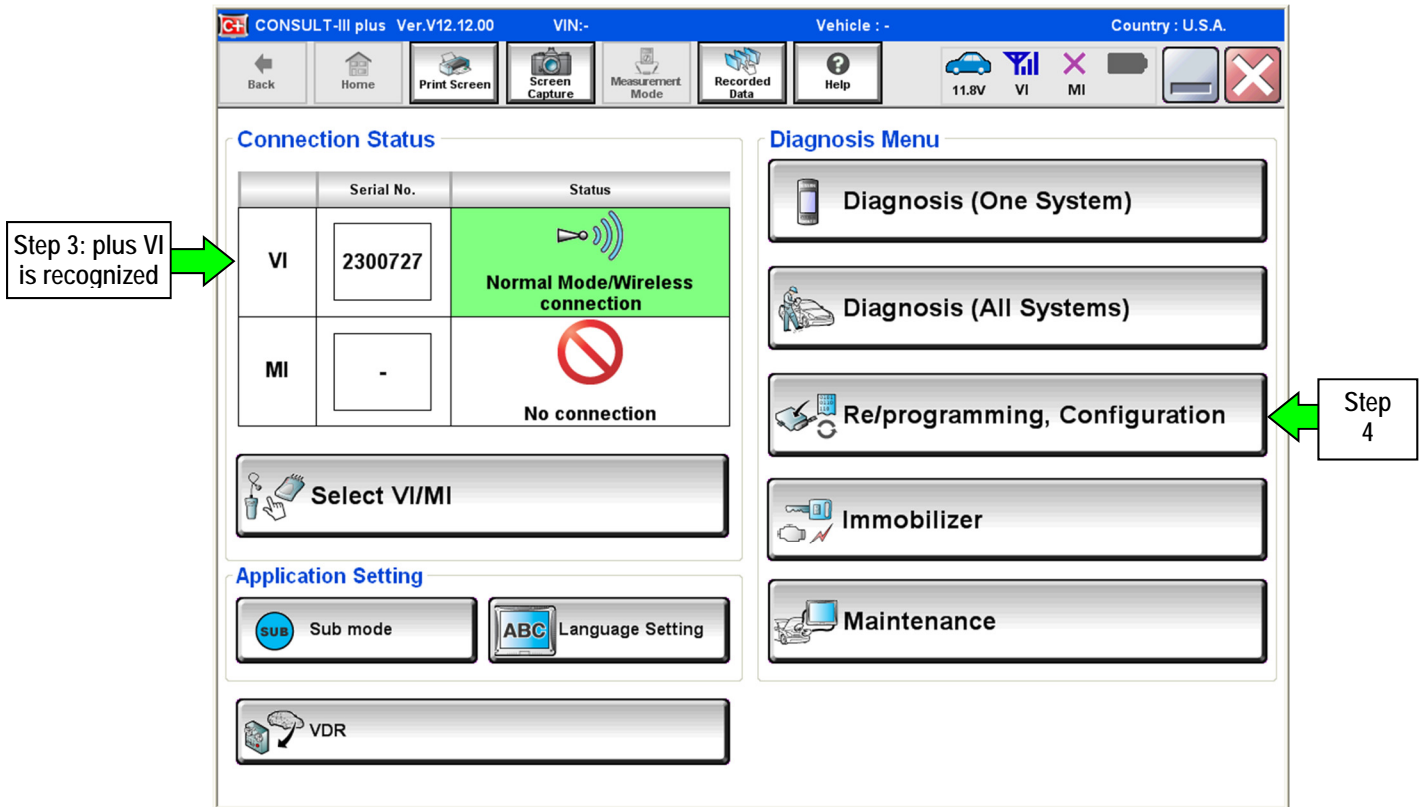
Figure 1

1. Connect the CONSULT PC to the vehicle to begin the reprogramming procedure.
2. Start C-III plus.
3. Wait for the plus VI to be recognized / connected.
  - The serial number will display when the plus VI is recognized / connected.
4. Select **Re/programming, Configuration**.

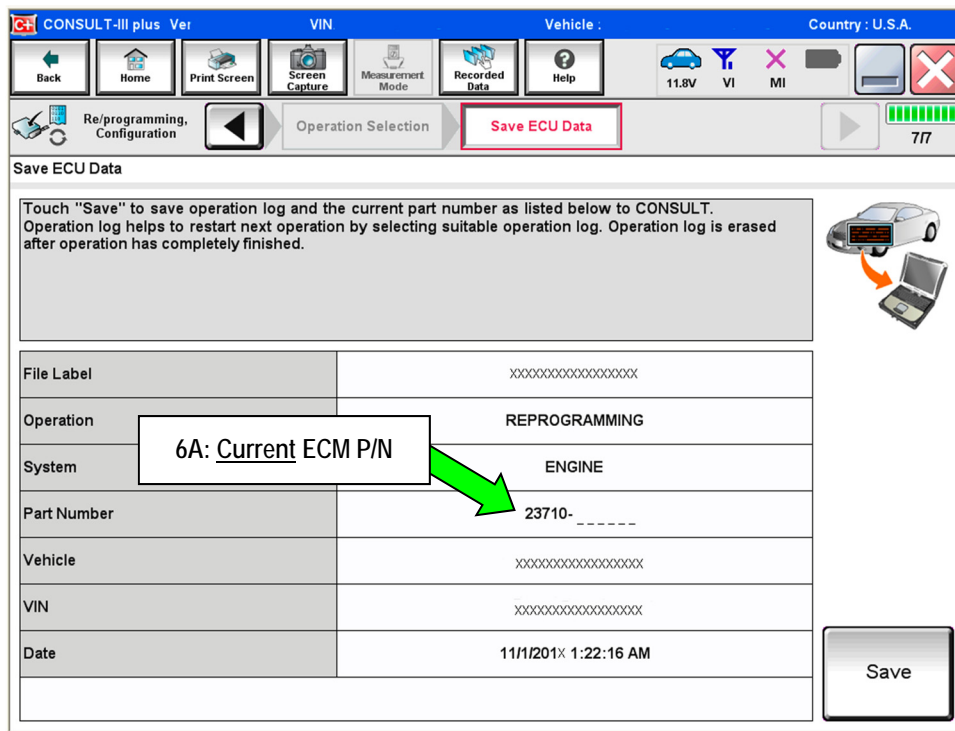
6. When you get to the screen shown in Figure 2, confirm this bulletin applies as follows.

A. Find the ECM **Part Number** and write it on the repair order.

**NOTE:** This is the current ECM Part Number (P/N).

5. Follow the on-screen instructions and navigate the C-III plus to the screen shown in Figure 2 on the next page.

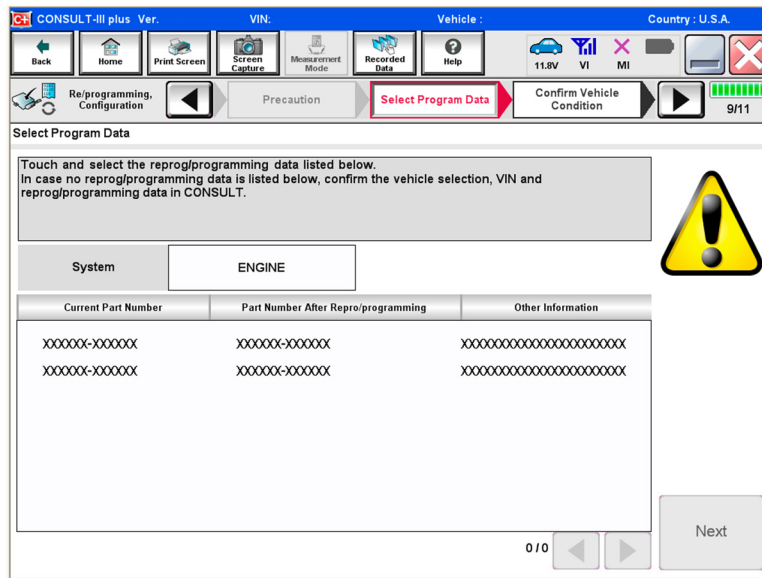
- In some cases, more than one new P/N for reprogramming is available.
  - In this case, the screen in Figure 3 displays.
  - Select and use the reprogramming option that **does not** have the message “Caution! Use ONLY with NTBXX-XXX”.
- If you get this screen and it is **blank** (no reprogramming listed), it means there is no reprogramming available for this vehicle. Close C-III plus and refer back to ASIST for further diagnosis.

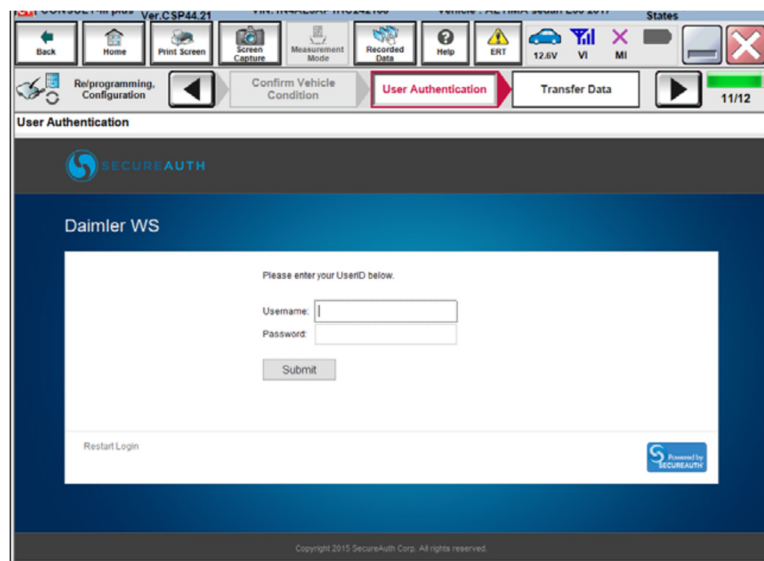
Figure 4

- Before reprogramming will start, you will be required to enter your User Name and Password.
  - The CONSULT PC must be connected to the Internet (Wi-Fi or cable).
  - If you do not know your **Username** and **Password**, contact your service manager.

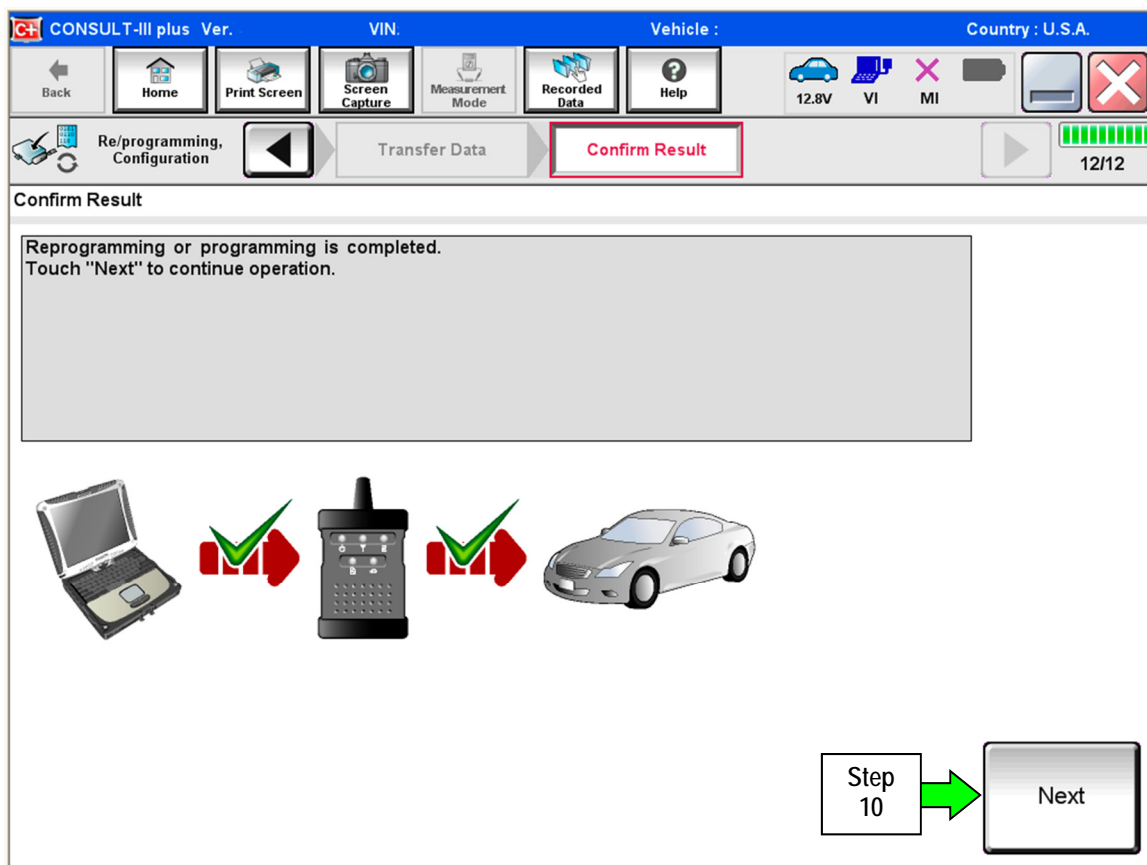
8. When the screen in Figure 5 displays, reprogramming is complete.

**NOTE:** If the screen in Figure 5 does not display (reprogramming does not complete), refer to the information on page 8.

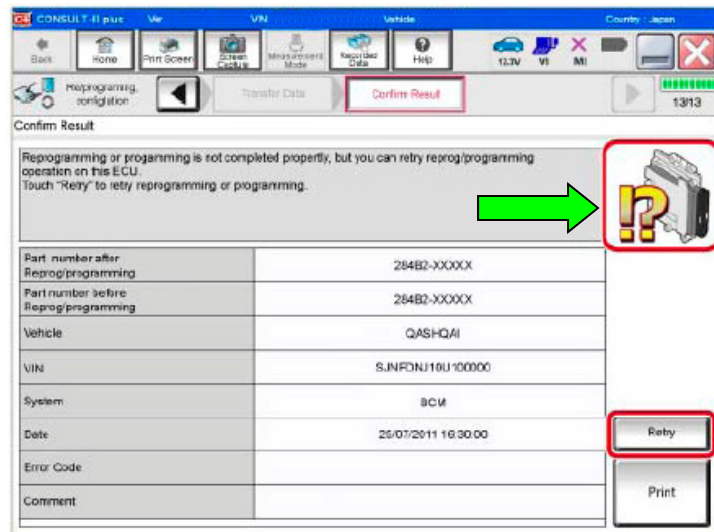
Figure 6

If reprogramming does not complete and the “!” icon displays as shown in Figure 6:

- Check battery voltage (12.0 - 15.5 V).
- Ignition is ON, engine OFF.
- External Bluetooth® devices are OFF.
- All electrical loads are OFF.
- Select retry and follow the on screen instructions.
- “Retry” may not go through on first attempt and can be selected more than once.

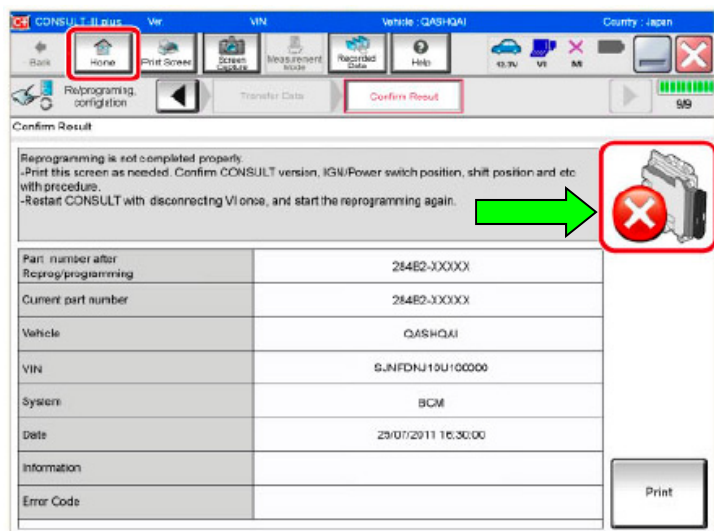
Figure 7

If reprogramming does not complete and the “X” icon displays as shown in Figure 7:

- Check battery voltage (12.0 - 15.5 V).
- CONSULT A/C adapter is plugged in.
- Ignition is ON, engine OFF.
- Transmission is in Park.
- All C-III plus / VI cables are securely connected.
- All C-III plus updates are installed.
- Select Home, and restart the reprogram procedure from the beginning.

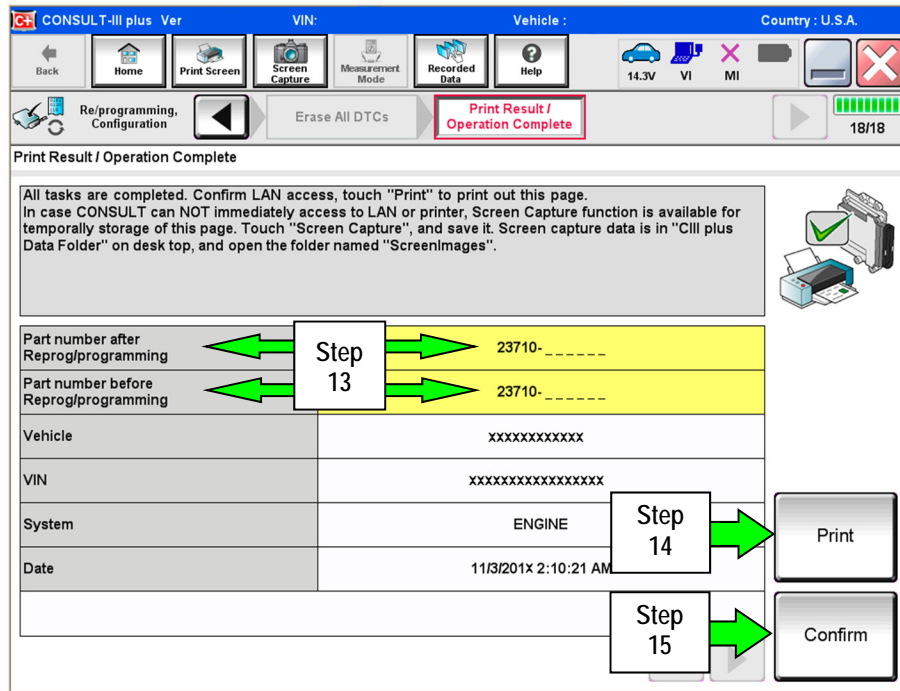
12. When the entire reprogramming process is complete, the screen in Figure 8 will display.
13. Verify the before and after part numbers are different.
14. Print a copy of this screen (Figure 8) and attach it to the repair order for warranty documentation.
15. Select **Confirm**.
