# Technical Service Bulletin

SUBJECT: <b>QUICK CHARGING OR READY MODE NOT POSSIBLE: DTC P101B &amp; P101C</b>			No: <b>TSB-18-54-007</b>
			DATE: <b>August 2018</b>
			MODEL: <b>2016 i-MiEV</b>
<b>CIRCULATE TO:</b>	<input type="checkbox"/> GENERAL MANAGER	<input checked="" type="checkbox"/> PARTS MANAGER	<input checked="" type="checkbox"/> TECHNICIAN
<input checked="" type="checkbox"/> SERVICE ADVISOR	<input checked="" type="checkbox"/> SERVICE MANAGER	<input checked="" type="checkbox"/> WARRANTY PROCESSOR	<input type="checkbox"/> SALES MANAGER

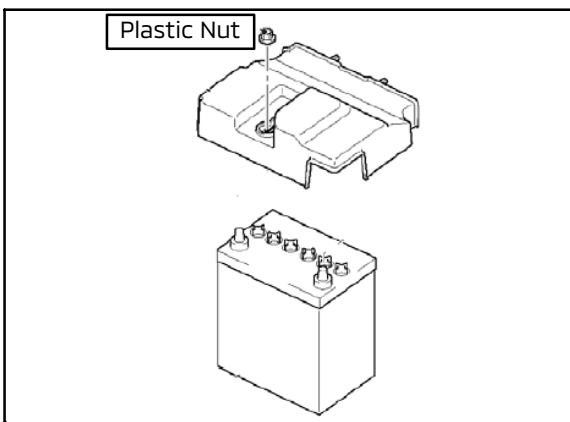
1. With the vehicle parked, set the parking brake and open the hood.
2. Remove the 12V auxiliary battery cover. Unscrew the plastic nut (pull up while turning).

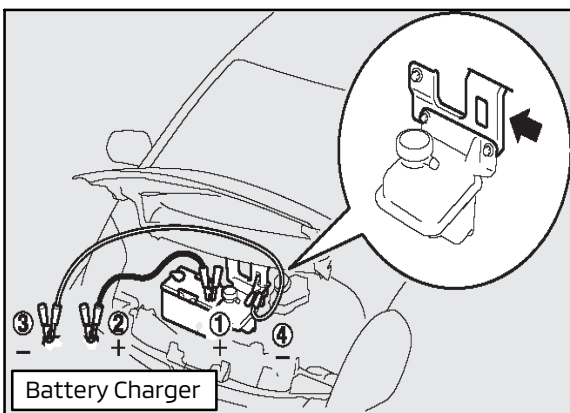
3. Attach the battery charge (with a charging rate not to exceed 10 amps) to the 12V auxiliary battery.  
**NOTE: Ensure battery charger does not time out during this procedure.**

**NOTE: Connect the positive (+) terminal of the 12V auxiliary battery (1) to the positive (+) battery charger cable (2). Connect the negative (-) battery charger cable (3) to the designated ground location (4).**

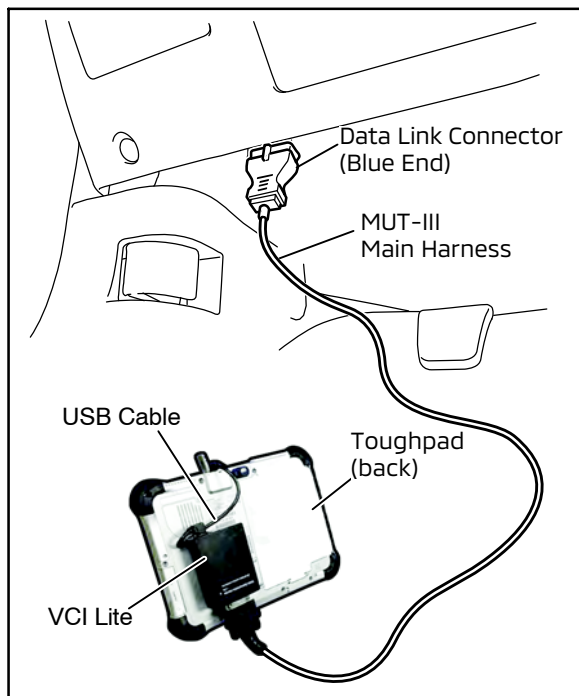
1. Connect the equipment as follows:

**NOTE: VCI Lite and MEDIC 4.0 Toughpad shown for illustration purposes only.**

- Turn the MEDIC PC/tablet on. If the battery indicator in the lower right hand corner of the screen does not show a full charge, it is recommended that either the battery be charged prior to beginning, or be used with the A/C power adaptor connected.
- Connect the USB cable to the VCI/VCI Lite.
- When the laptop/tablet displays the MEDIC main screen, connect the USB cable to the device.
- Connect the MUT-III main harness with the blue DLC connection to the VCI/VCI Lite.
- Connect the blue connection of the MUT-III main harness to the vehicle's data link connector.
- For VCI only (P/N MP991824): Turn the VCI power switch ON. Verify that the indicator lamp in the upper right corner of the screen is green.

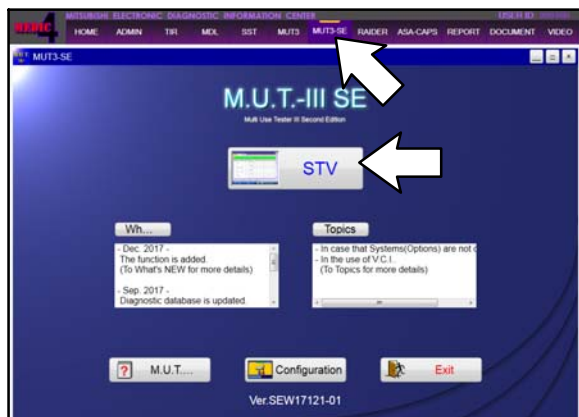
3. Using MEDIC, from the main page, click the "MUT3-SE" icon at the top center of the screen to open MUT-III SE.

Click the "STV" button.

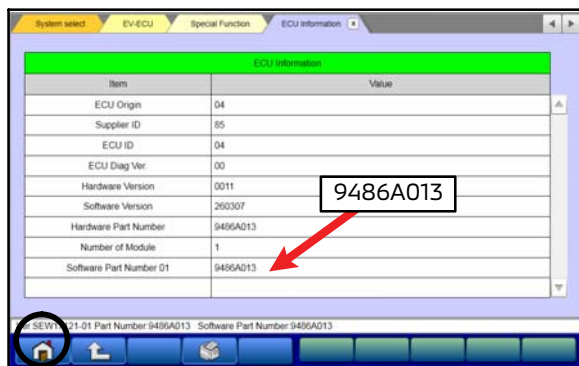
- b. If the Software Part Number listed is **not** at the latest level (shown in the "**EV-ECU Reprogramming Chart**"), proceed with the next steps.

If the Software Part Number is **9486A01303**, then reprogramming is not necessary.

- 12. Verify that the software Part Number is now at the latest number listed in the "EV-ECU Reprogramming Chart" in this TSB. **For instructions, refer to step 5 in this TSB.**

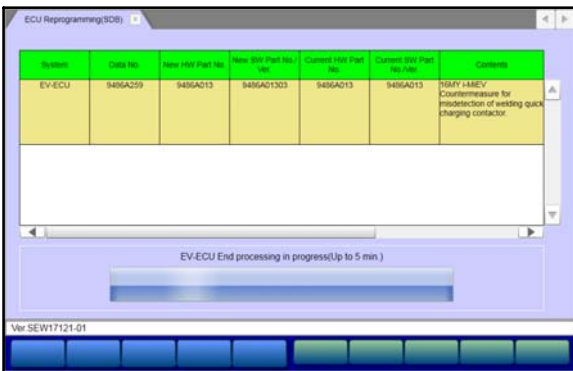
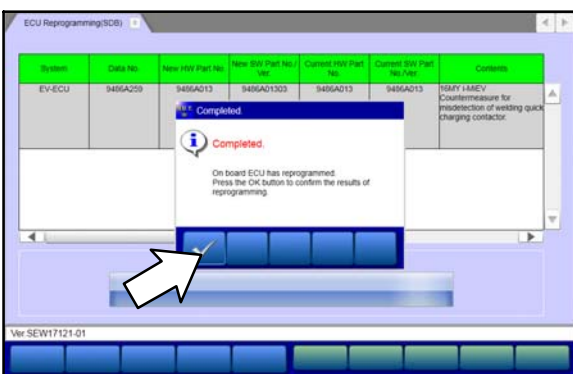
g. Once the reprogramming is initiated, the screen shown will indicate the reprogramming progress.

**NOTE: Do NOT disturb the cables or turn off the ignition during reprogramming.**
