SERVICE BULLETIN

Classification: EC16-032b	Reference: NTB17-060b	Date: September 13, 2018
------------------------------	--------------------------	-----------------------------

2016-2018 TITAN XD; DTC P207F AND DEF SYSTEM ERROR IS DISPLAYED ON THE VEHICLE INFORMATION DISPLAY

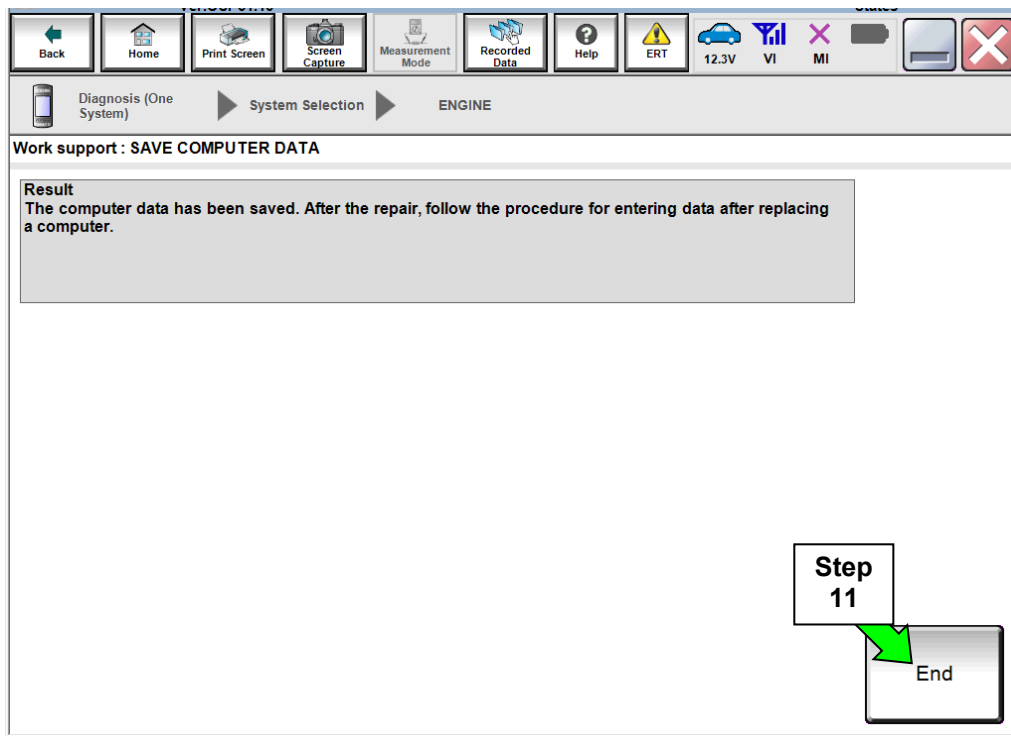
Figure D

11. Select **End**.

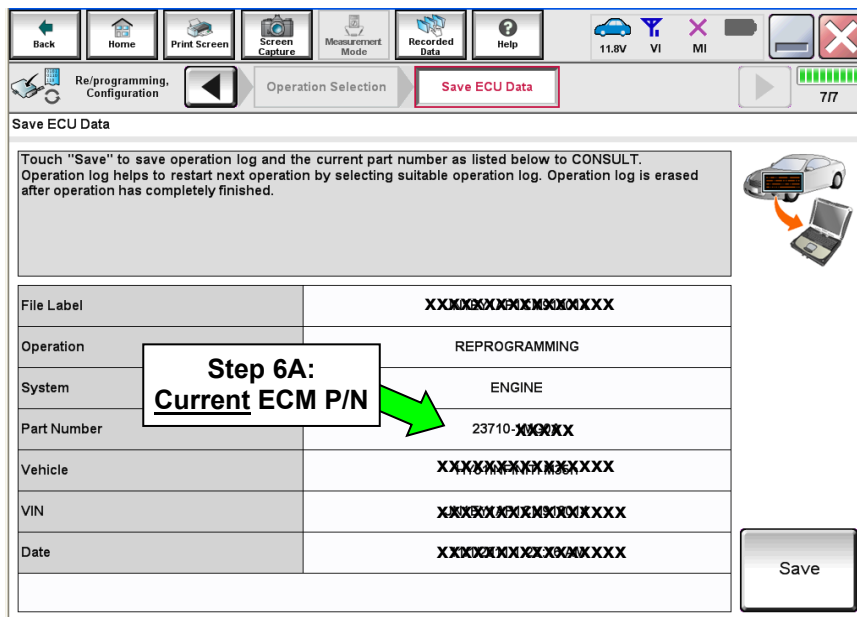
5. Follow the on-screen instructions and navigate C-III plus to the screen shown in Figure 2 on the next page.

6. When you get to the screen shown in Figure 2, confirm this bulletin applies as follows.
- A. Find the ECM **Part Number** and write it on the repair order.

NOTE: This is the current ECM Part Number (P/N).

- B. Compare the P/N you wrote down to the numbers in the **Current ECM Part Number** column in **Table A** below.

- If there is a match, continue with the reprogramming procedure.
- If there is no match, this bulletin does not apply. Close C-III plus and refer to ASIST for further diagnostic information.

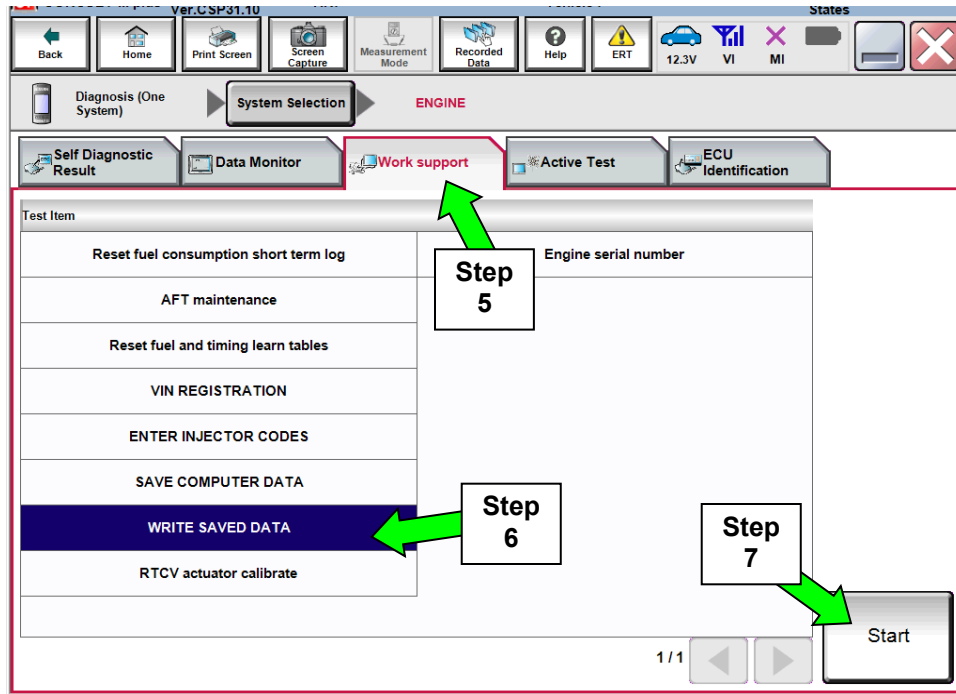
Figure 2A

5. Navigate C-III plus to Engine > Work Support (see Figure 2A).
6. Select **WRITE SAVED DATA**.
7. Select **Start**.

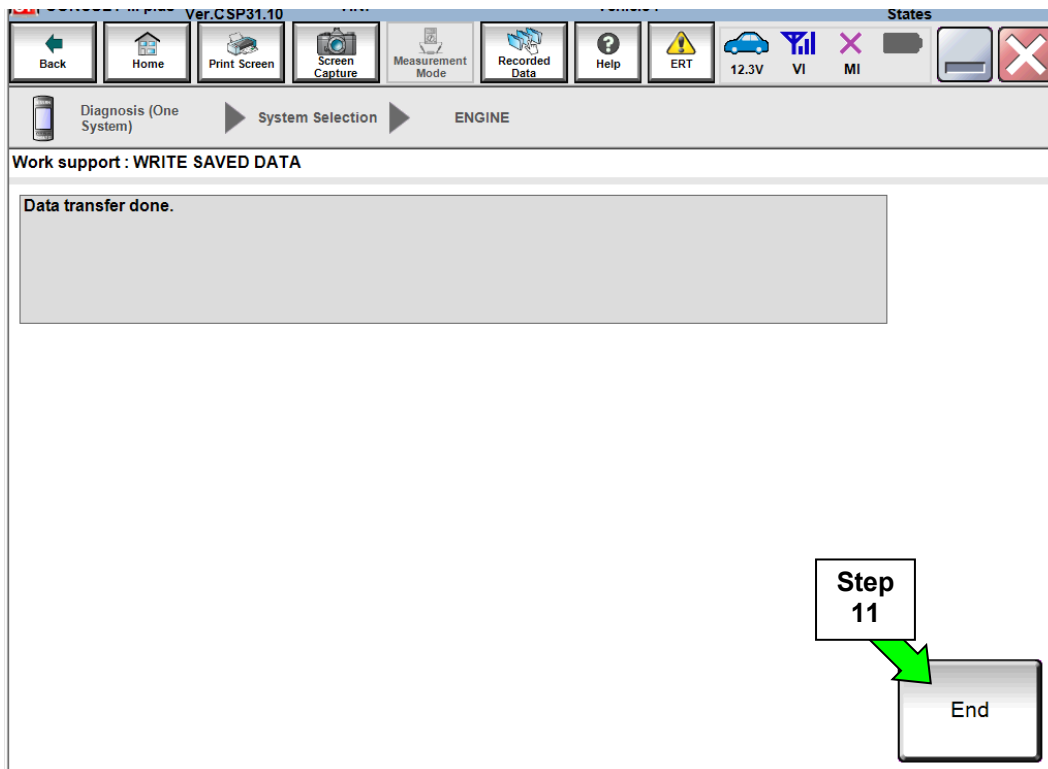
Figure 5A

11. Select **End**.

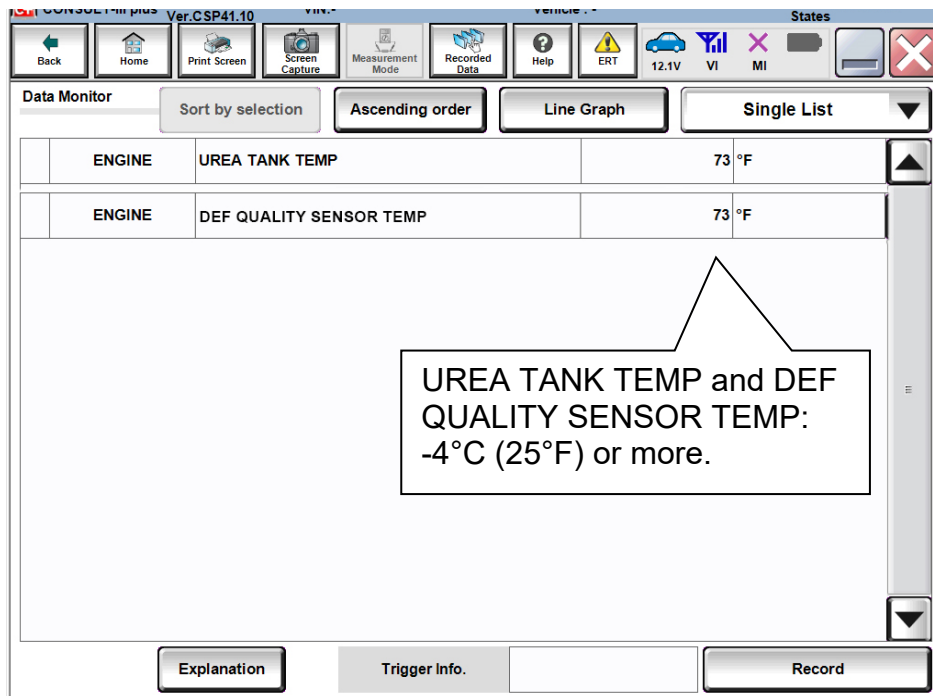
Figure 3B

3. Confirm **UREA TANK TEMP** and **DEF QUALITY SENSOR TEMP** are -4°C (25°F) or more.
 - If needed, start the engine and let it run until the UREA TANK TEMP and DEF QUALITY SENSOR TEMP warms to -4°C (25°F) or more.
