TECHNICAL BULLETIN

303-01A: Engine - INGENIUM I4 2.0L Diesel

Service Action: Balancer Shaft Whine

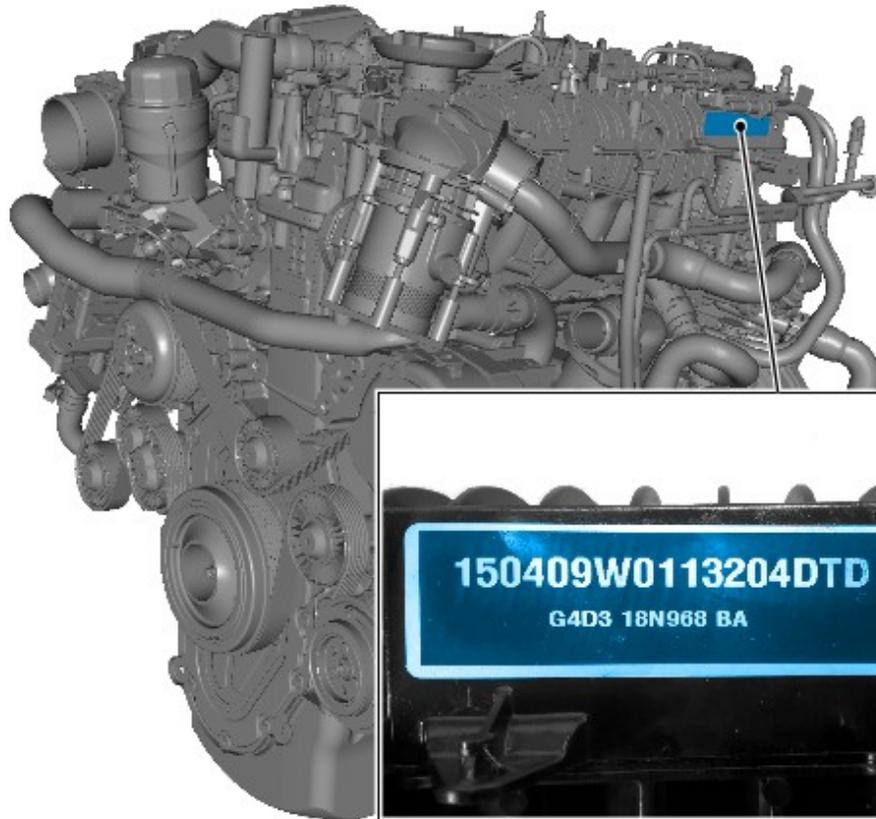
The engine build date is the first 6 characters (YY/MM/DD) of the engine serial number.

Locate and record the engine serial number.

- **2017MY vehicles only:** if the engine build date (first 6 characters of the engine serial number) is before **170817W0976204DTD** (2017 August 17), go to Workshop Procedure 'A'.
- **2018MY vehicles OR** if the engine build date (first 6 characters of the engine serial number) is or after **170817W0976204DTD** (2017 August 17), go to Workshop Procedure 'B'.
