SERVICE CAMPAIGN BULLETIN

SUBJECT:			No: SC-18-001
MIL ILLUMINATION WITH DTC POAA7/POAA8/POAA9 - SERVICE CAMPAIGN			DATE: October 2018
			MODEL: 2018 Outlander PHEV
CIRCULATE TO:	<input checked="" type="checkbox"/> GENERAL MANAGER	<input checked="" type="checkbox"/> PARTS MANAGER	<input checked="" type="checkbox"/> TECHNICIAN
<input checked="" type="checkbox"/> SERVICE ADVISOR	<input checked="" type="checkbox"/> SERVICE MANAGER	<input checked="" type="checkbox"/> WARRANTY PROCESSOR	<input checked="" type="checkbox"/> SALES MANAGER

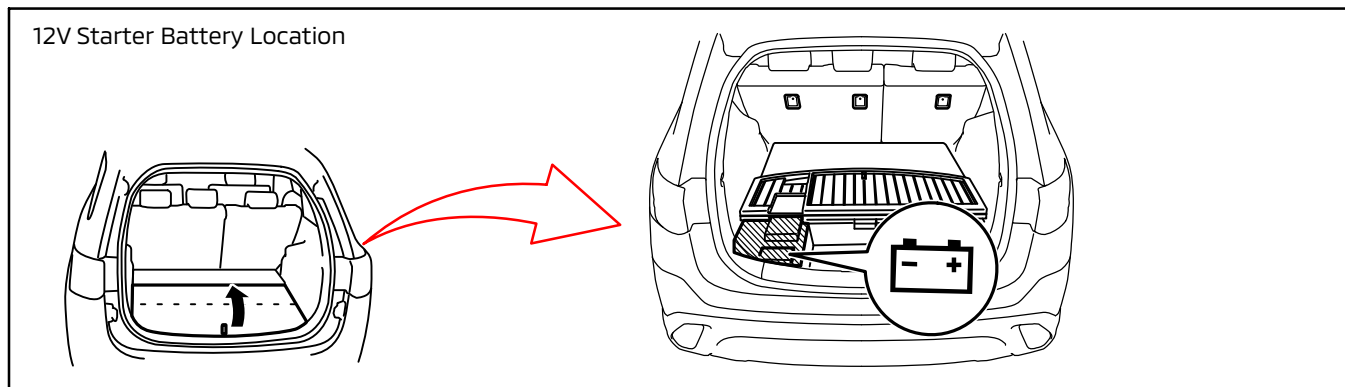
To ensure that the vehicle battery maintains 12V during the procedure, hook-up a battery charger to the 12V starter battery during the procedure. The 12V starter battery can be accessed from the rear of the vehicle under the luggage floorboard, in the location shown below.

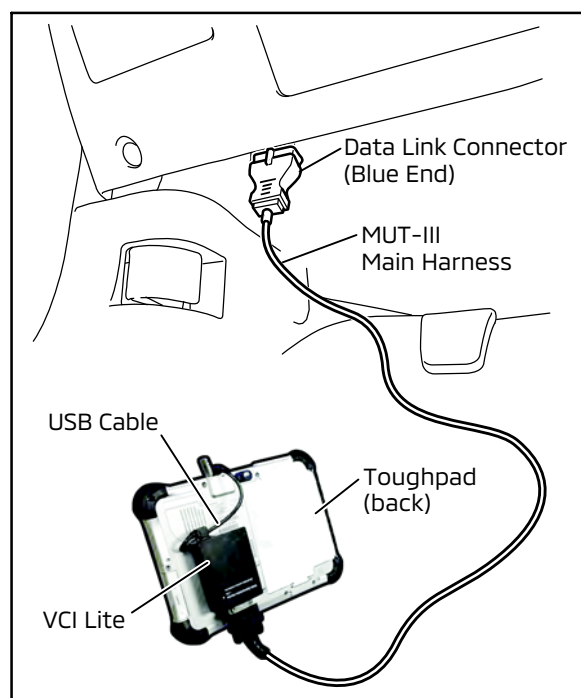
1. Connect the equipment as follows:

NOTE: VCI Lite and MEDIC 4.0 Toughpad shown for illustration purposes only.

- Turn the MEDIC PC/tablet on. If the battery indicator in the lower right hand corner of the screen does not show a full charge, it is recommended that either the battery be charged prior to beginning, or be used with the A/C power adaptor connected.
- Connect the USB cable to the VCI/VCI Lite.
- When the laptop/tablet displays the MUT-III main screen, connect the USB cable to the device.
- Connect the MUT-III main harness with the blue DLC connection to the VCI/VCI Lite.
- Connect the blue connection of the MUT-III main harness to the vehicle's data link connector.
- For VCI only (p/n MB991824): Turn the VCI power switch ON. Verify that the indicator lamp in the upper right corner of the screen is green.

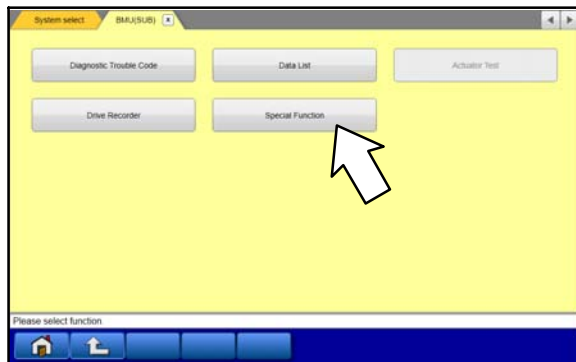
a. Select "BMU(SUB)" from the System List, then click on the check mark at the bottom of the screen.
