**SPECIAL SERVICE CAMPAIGN J0D**

**CONTINUOUSLY VARIABLE TRANSAXLE SOFTWARE UPDATE**

**CERTAIN 2014-2017 TOYOTA Corolla**  
**CERTAIN 2017 TOYOTA Corolla iM**  
**CERTAIN 2016 SCION iM**

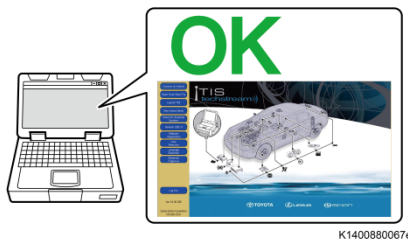
**Exit all applications.**

- b) Exit all applications except Techstream 2.0 (TIS Techstream / Techstream Lite).

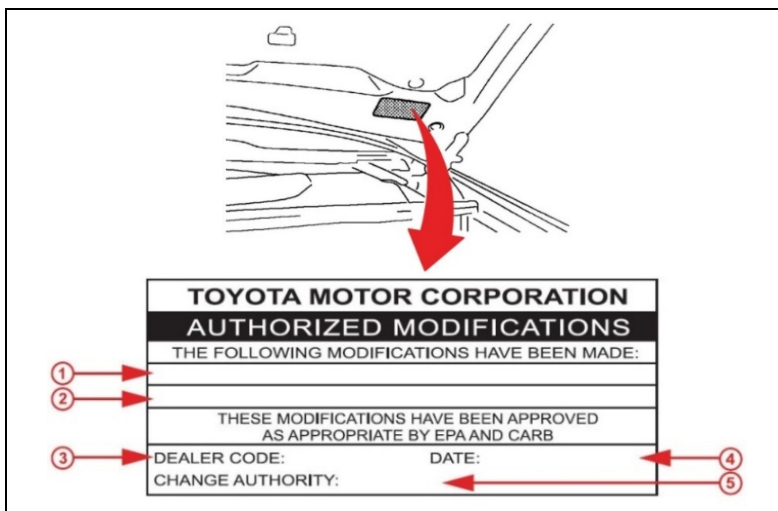
- a. Fill out the label.
- b. Affix the label to the under-side of the hood.

1	ECM P/N
2	New Calibration ID
3	Dealer Code
4	Date Completed
5	Campaign Code (XXX)
