TECHNICAL INSTRUCTIONS

SPECIAL SERVICE CAMPAIGN JOR

INTELLIGENT CLEARANCE SONAR (ICS) SYSTEM REPROGRAM

CERTAIN: 2018 CAMRY & CAMRY HYBRID 2016 – 2018 PRIUS 2017 - 2018 PRIUS PRIME

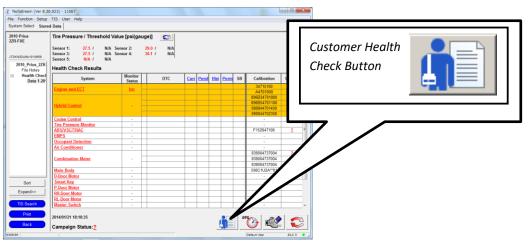
a. From the Stored Data tab, select the Customer Health Check Report button (TIS will launch when button is pressed).
