GROUP ELE	MODEL 2019MY Sorento (UMa)
	NUMBER 154	DATE December 2018
TECHNICAL SERVICE BULLETIN		
SUBJECT: BCW LOGIC IMPROVEMENT FOR DTC C270254

This bulletin provides the procedure to improve the logic of the Blind Spot Collision Warning (BCW) system on some 2019MY Sorento (UMa) vehicles, produced from January 22, 2018 through September 22, 2018, which may experience a Malfunction Indicator Lamp (MIL) illumination with DTC C270254, even though there is no issue or defective part. To correct this concern, apply the improved logic to the BCW using the KDS ECU Upgrade function as described in this bulletin. For confirmation that the latest reflash has been applied to a vehicle you are working on, verify the ROM ID using the table on page 2 of this bulletin.

Upgrade Event Name
378. UMA PE BCW MIL ON DTC (C270254) LOGIC IMPROVEMENT

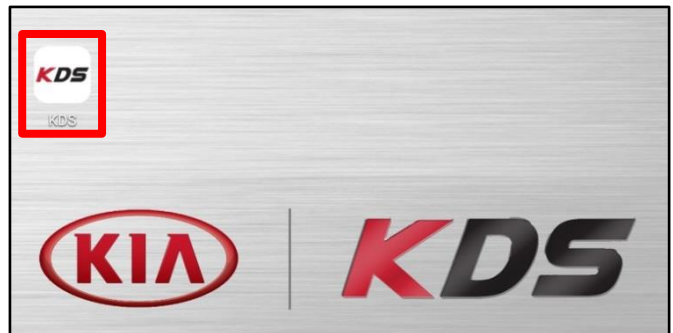
2. With the ignition ON, turn ON the KDS tablet. Select **KDS** from the home screen.

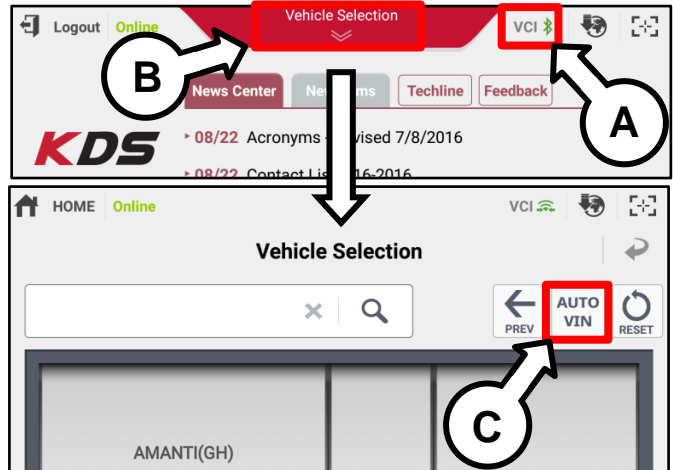
3. Confirm communication with VCI (A) and then configure the vehicle (B) using the **AUTO VIN** (C) feature.

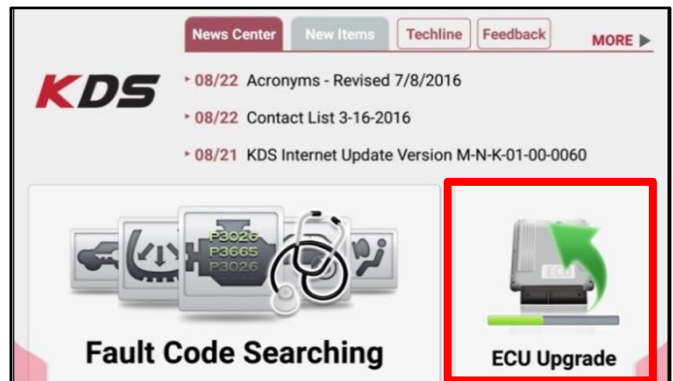
4. Select **ECU Upgrade**.

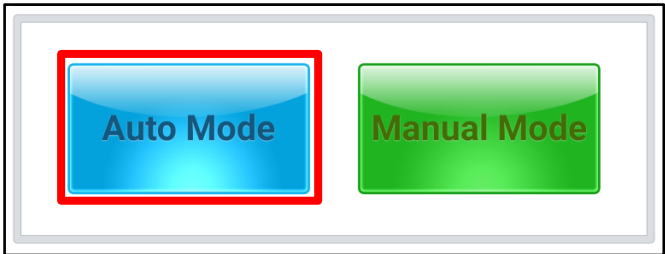
- Select **Auto Mode**.

CAUTION
 Do NOT attempt to perform a Manual Mode upgrade UNLESS Auto Mode fails. Always follow the instructions given on the KDS in either Auto or Manual mode.

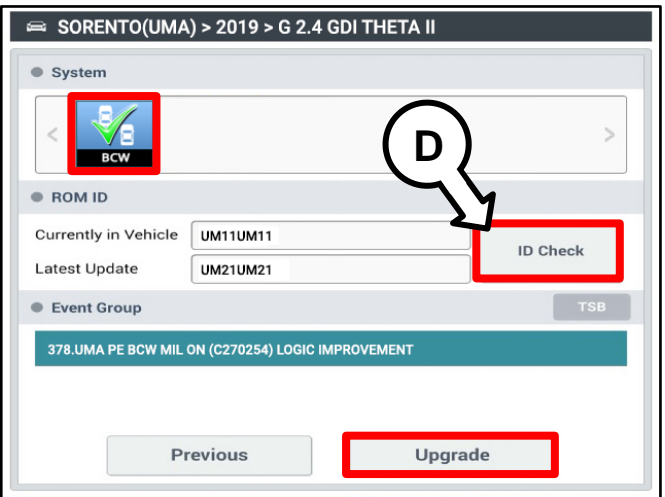
- Select the **BCW** system under the System selection menu.

Touch **ID Check** (D) and confirm that the latest update is available.

Select **Upgrade Event #378** and select **Upgrade** to continue.

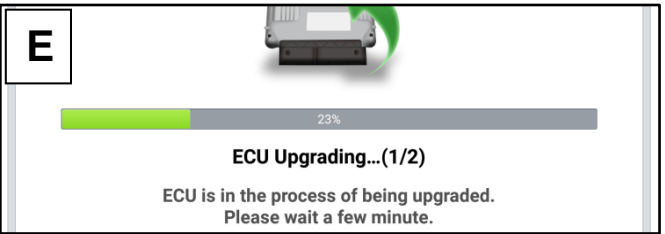
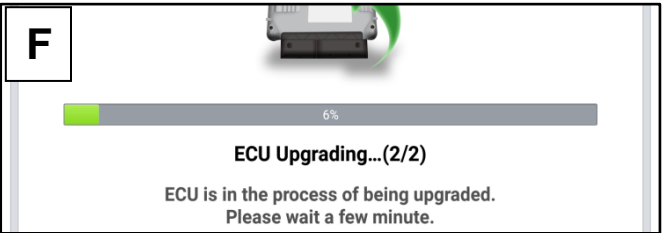
- The ECU upgrade will begin and the progress of the upgrade will appear on the bar graph. Upgrade part (1/2) (E) will download the upgrade event to the VCI-II. Upgrade part (2/2) (F) will upgrade the ECU.

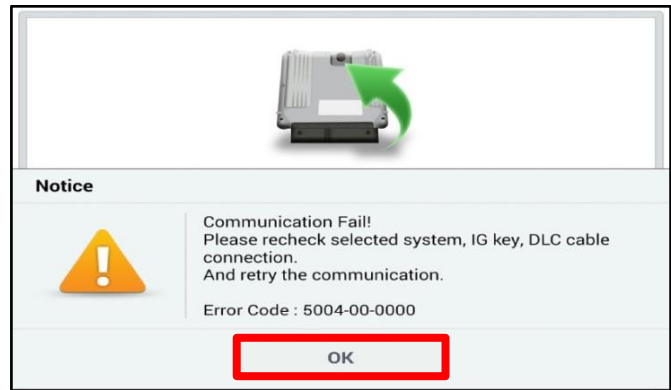
9. If a “Communication Fail” screen appears, verify that the VCI-II and KDS are communicating properly. Touch **OK** and restart the procedure from step 4.

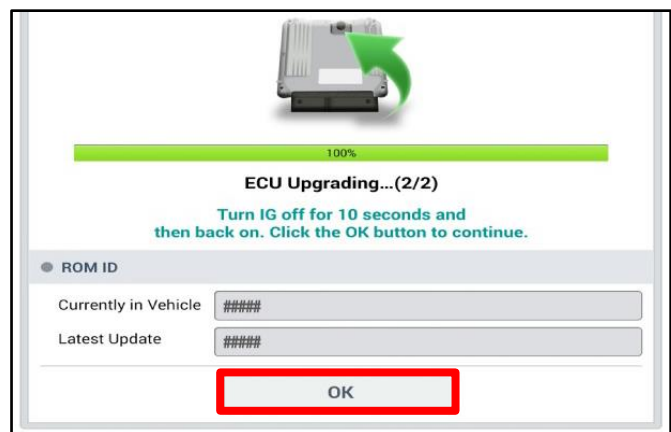
10. When instructed on the KDS, turn the ignition **OFF** for ten (10) seconds then back on. Touch **OK** to continue.

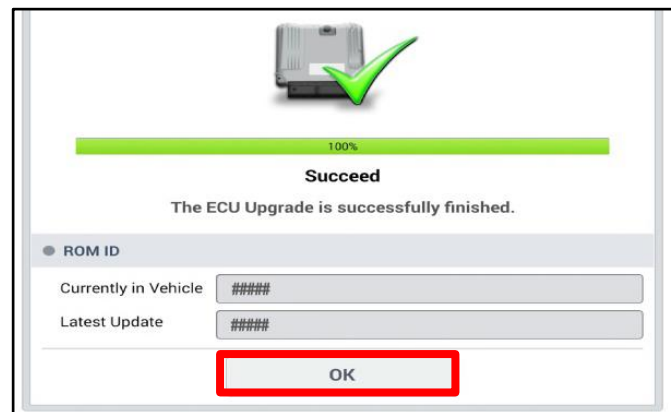
11. Once the upgrade is complete, touch **OK** to finalize the procedure.

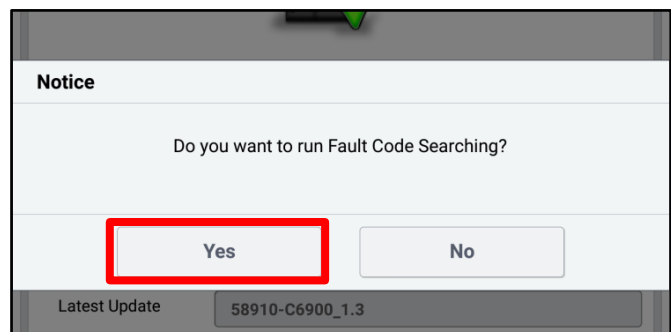
12. When prompted, select **YES** to check for Diagnostic Trouble Codes (DTC) and erase any DTCs stored such as EPS, ESC, and TPMS that may have been set during the upgrade.

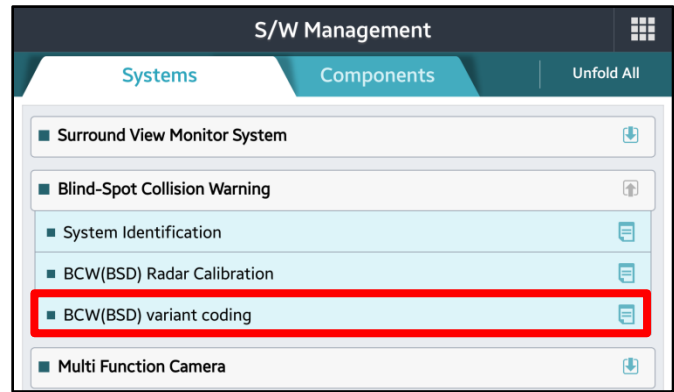
13. At the KDS Home Screen, select S/W Management → Blind-Spot Collision Warning → BCW(BSD) Variant Coding and perform the BCW(BSD) Variant Coding.

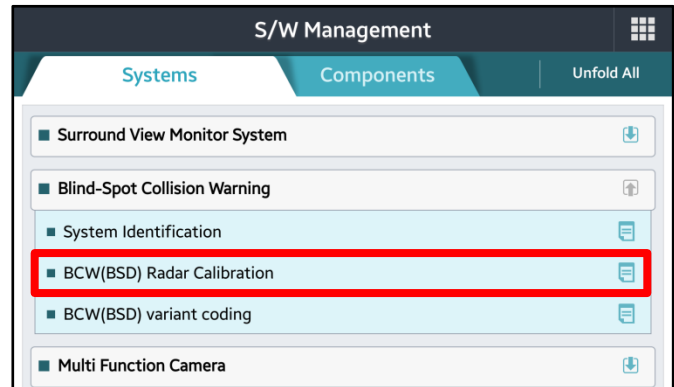
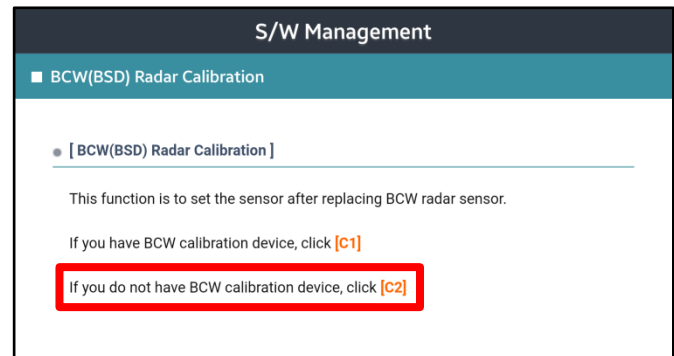
14. After performing BCW(BSD) Variant Coding, perform BCW(BSD) Radar Calibration (without calibration device).
