<b>GROUP</b> <b>Product Improvement</b>	<b>MODEL</b> <b>2011-2014MY Optima (QF/TF)</b> <b>2012-2014MY Sorento (XMa)</b> <b>2011-2013MY Sportage (SL)</b>
	<b>NUMBER</b> <b>1803 (Rev 1, 01/02/2018)</b>	<b>DATE</b> <b>November 2018</b>
<b>PRODUCT IMPROVEMENT CAMPAIGN</b>		
<b>SUBJECT: KNOCK SENSOR DETECTION SYSTEM - ECU LOGIC IMPROVEMENT (PI1803)</b>

This bulletin provides information related to a software update to the Engine Control Unit (ECU) to install the Knock Sensor Detection System (KSDS) in order to protect the engine from excessive connecting rod bearing damage. This update is for:

## KNOCK SENSOR DETECTION SYSTEM – ECU LOGIC IMPROVEMENT (PI1803)

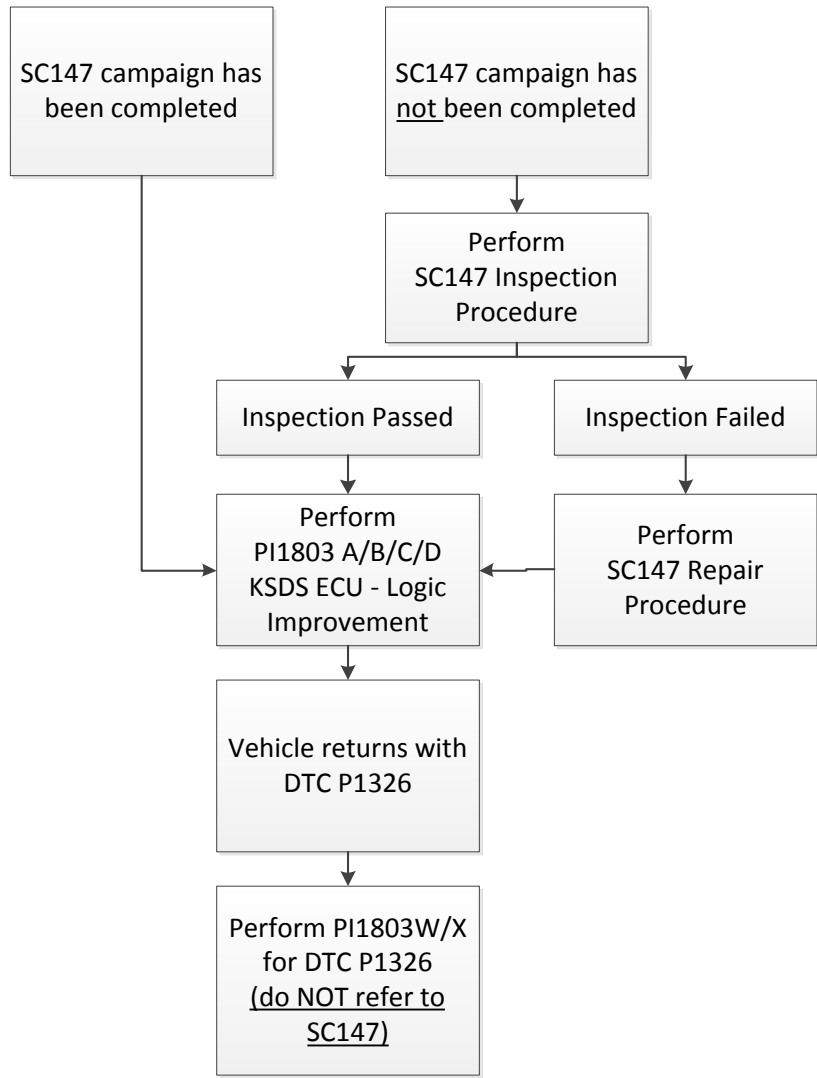
**SC147 → PI1803 Flow Chart**

Prior to conducting the procedure described in this bulletin, please make certain the SC147 inspection/repair procedure has been completed on the affected vehicles. If the SC147 inspection/repair procedure has not been completed, please complete the SC147 inspection/repair procedure **BEFORE** you perform the software update requested in this bulletin.

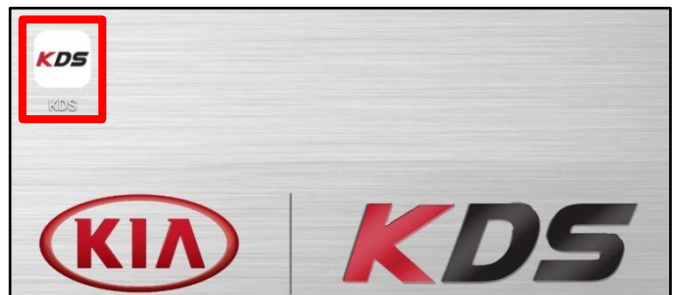
2. With the ignition ON, turn ON the KDS tablet. Select **KDS** from the home screen.
