SERVICE BULLETIN

Classification: EL18-022a	Reference: NTB18-081a	Date: December 19, 2018
------------------------------	--------------------------	----------------------------

2017-2018 PATHFINDER AND 2018 ARMADA; SOFTWARE UPDATES FOR INFOTAINMENT ISSUES

APPLIED VEHICLES: 2017-2018 Pathfinder (R52)
2018 Armada (Y62)

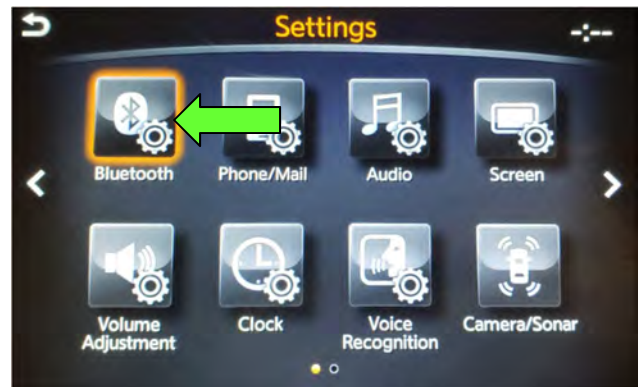
Figure 10

20. Open the Settings Menu and then select **Bluetooth**.

- The settings menu is accessed with the hard button located under the display.

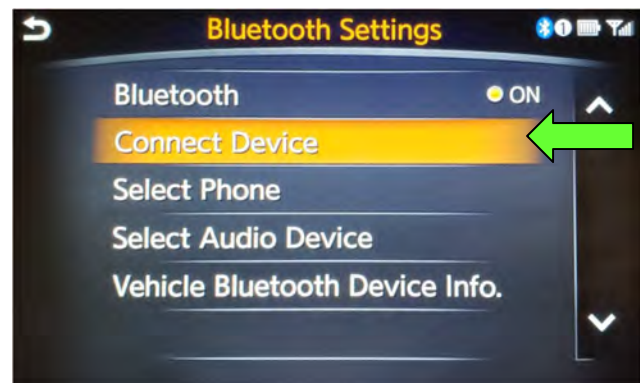
Figure 11

21. Select **Connect Device** from the Bluetooth Settings menu.

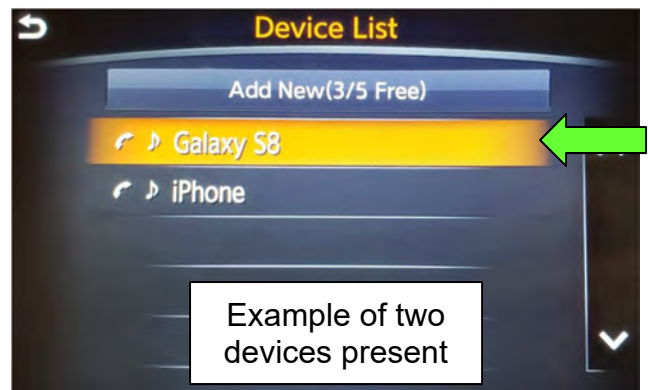
Figure 12

22. Is a device present in the Device List?

- **YES:** Select a device and then proceed to step 23.
- **NO:** Proceed to step 25.

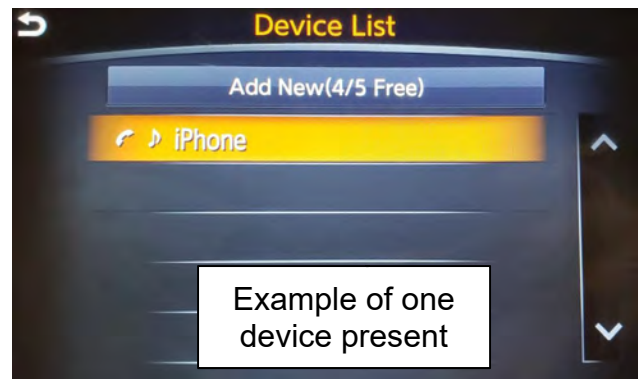
Figure 16

24. Are any devices still present in the Device List?

- **YES:** Select a device and then perform step 23 and 24 again.
- **NO:** Proceed to step 25.
