CAMPAIGN BULLETIN

Display Control Unit (DCU) Software Update Retailer Inventory

Reference: PC677

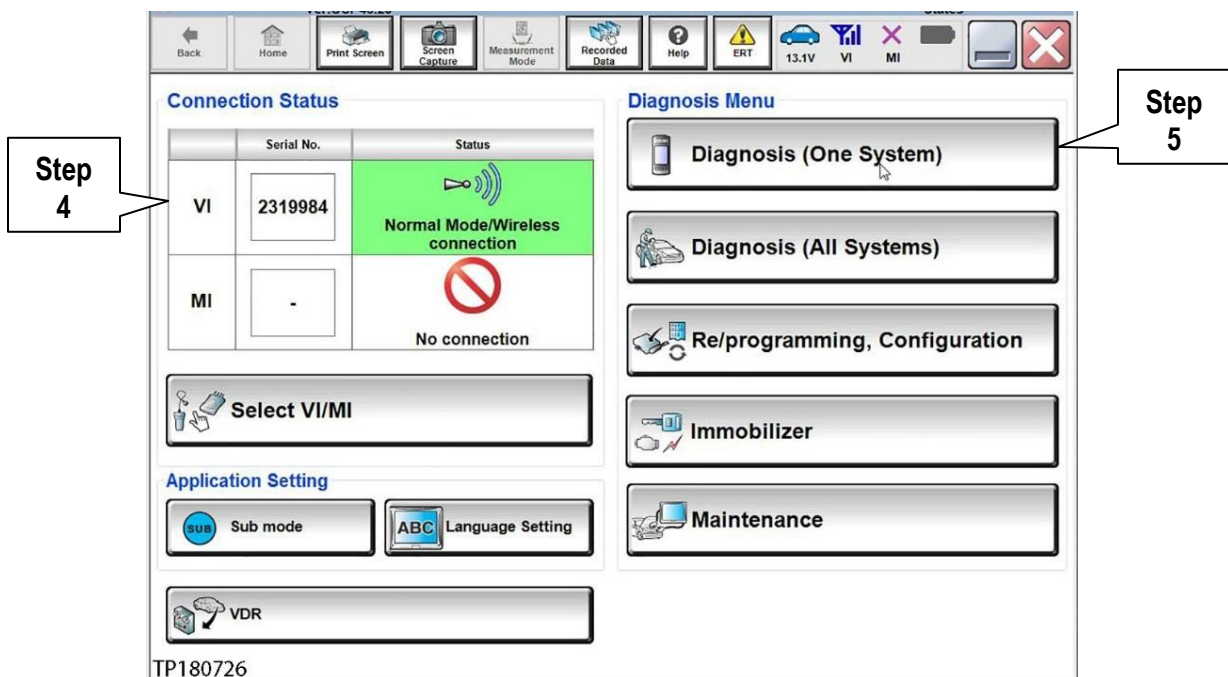
Figure 2

1. Connect the CONSULT PC and plus VI to the vehicle.
2. Start C-III plus.
3. Turn ON the ignition.
4. Wait for the plus VI to be recognized / connected.
 - The serial number will display when the plus VI is recognized / connected.
5. Select **Diagnosis (One System)**.

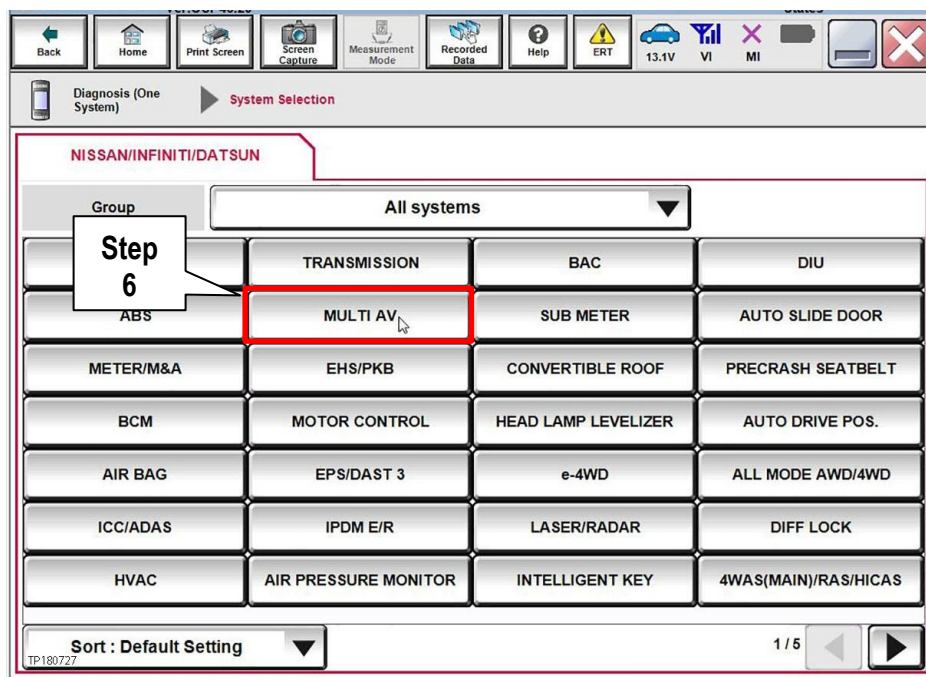
Figure 3

6. Select MULTI AV.

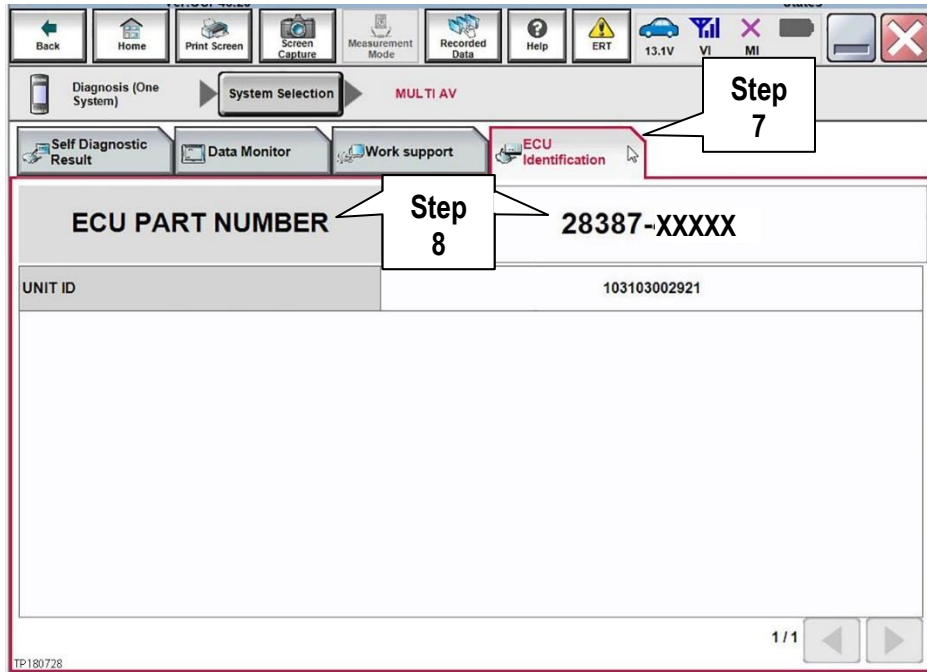
7. Select the **ECU Identification** tab.
8. When the screen in Figure 4 displays, confirm this bulletin applies as follows:
 - a. Write down the **ECU PART NUMBER** on the repair order.

NOTE: This is the current DCU part number (P/N).

- b. Compare the P/N you wrote down to the P/Ns in the **CURRENT DCU PART NUMBER** column in **Table A** below.
 - If there is a match, this bulletin applies. Go to the next page, **Update Display Control Unit**.
 - If there is not a match, this bulletin does not apply. Refer to ASIST for further diagnosis.

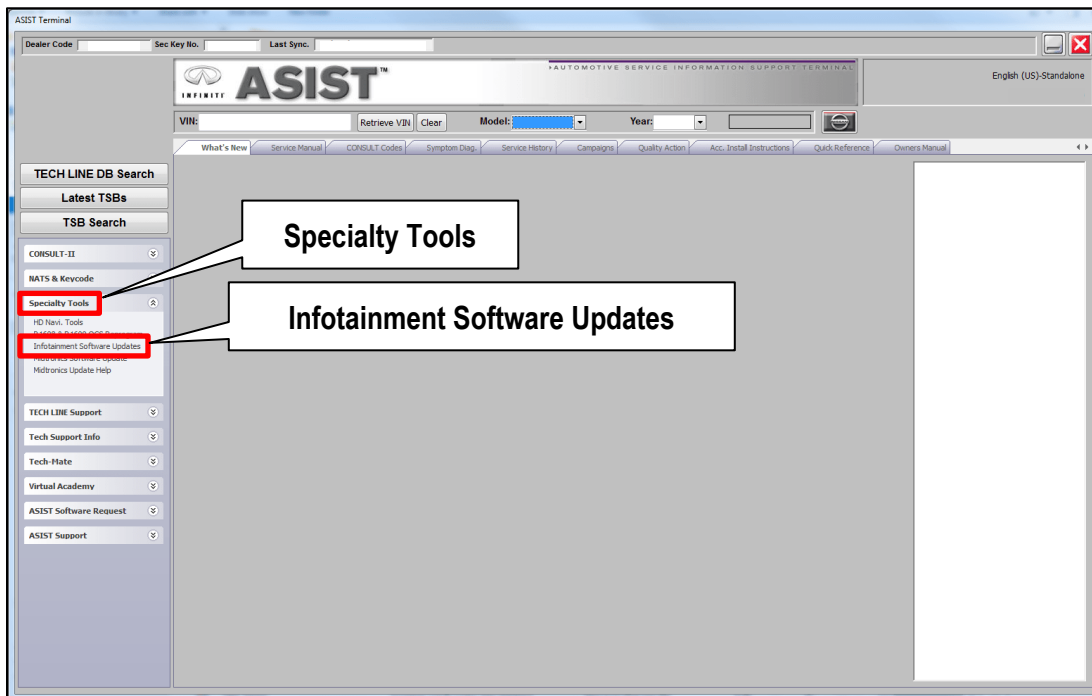
Figure 5

11. Select **Specialty Tools**, and then select **Infotainment Software Updates**.

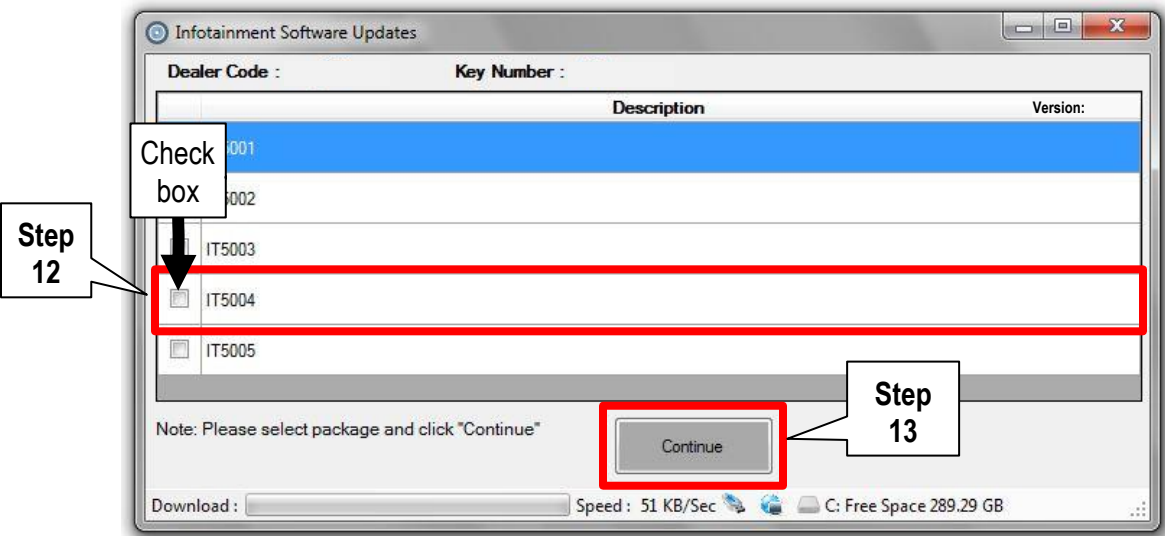
12. Select the check box next to the correct update software package below (also refer to Figure 6 below).

13. Select **Continue**, and then wait for the download to complete.

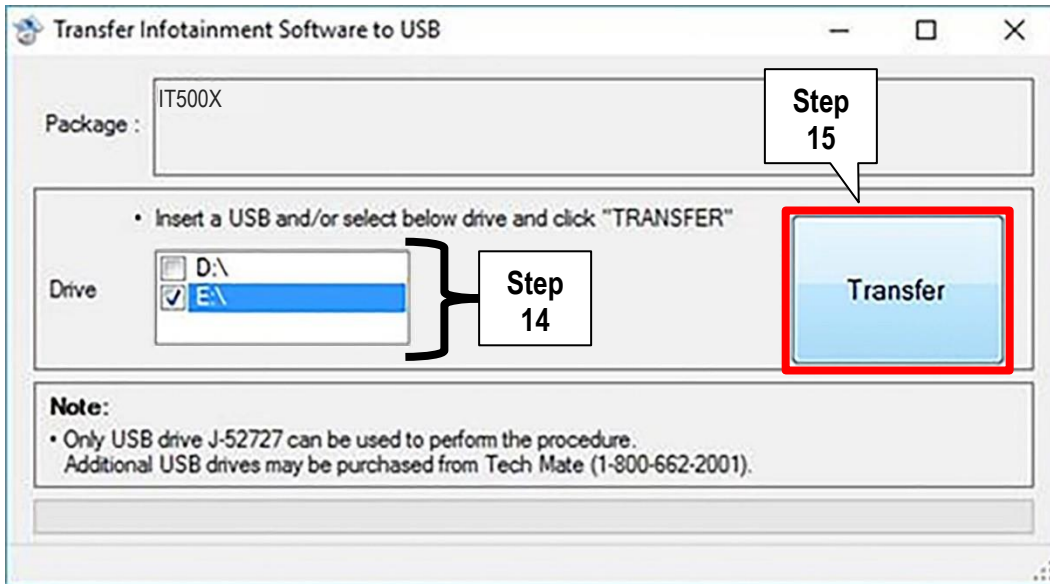
Figure 7

14. Once the download is complete, select the USB drive for update software package transfer.

- See example in Figure 7. The drive selection on your PC may be different.

15. Select **Transfer**, and then wait for the transfer to complete (see Figures 7 and 8).

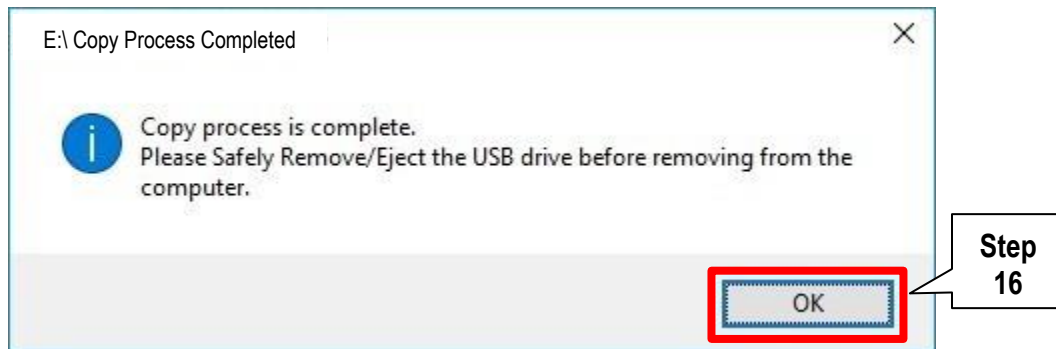
Figure 8

16. Select **OK**.

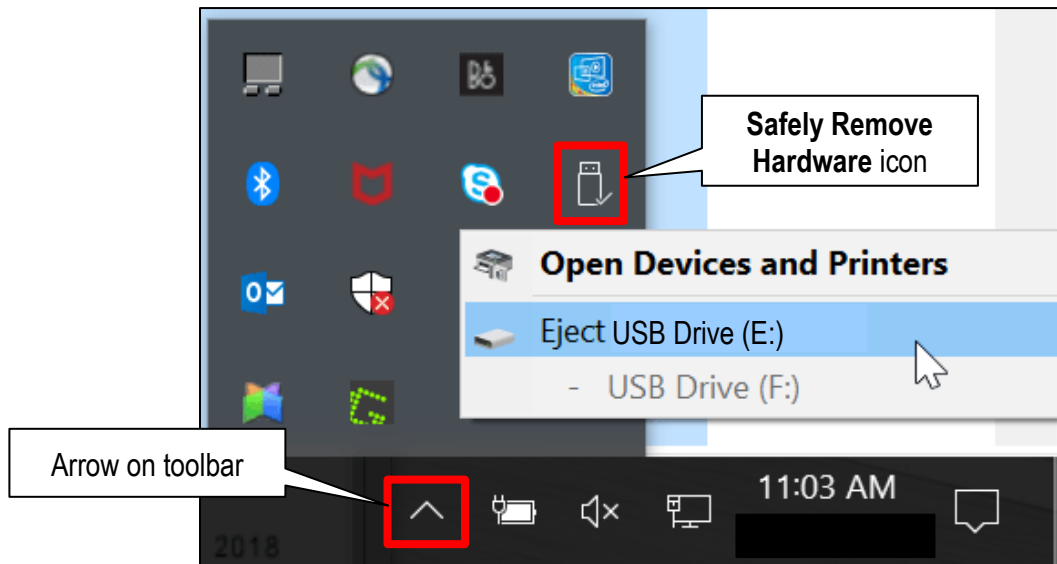
Figure 9

17. Once the transfer is complete, safely remove the USB drive from the ASIST Station.
 - a. From the PC toolbar, select the **Safely Remove Hardware** icon.
 - The icon is on the toolbar, or to be found after selecting the arrow.
 - b. Select the USB drive to be removed, and then remove the USB drive from the ASIST Station.

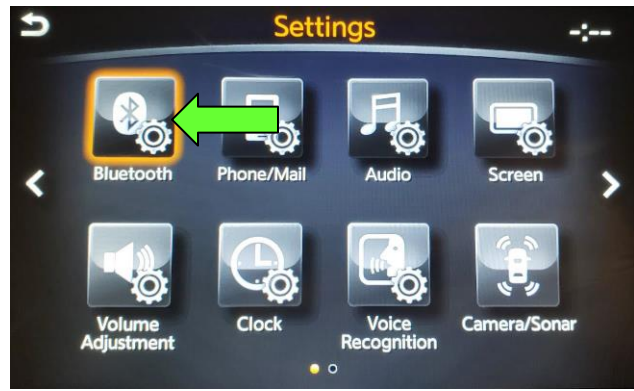
Figure 10

20. Open the Settings Menu and then select **Bluetooth**.
- The settings menu is accessed by selecting the settings app icon on the lower display.

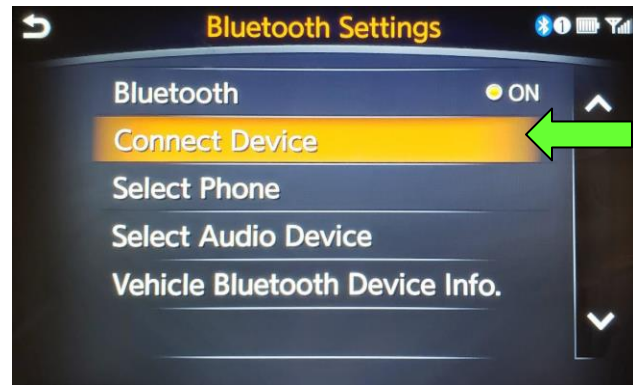
Figure 11

21. Select **Connect Device** from the Bluetooth Settings menu.
- NOTE:** If no connected devices are present, Figure 17 will be displayed.

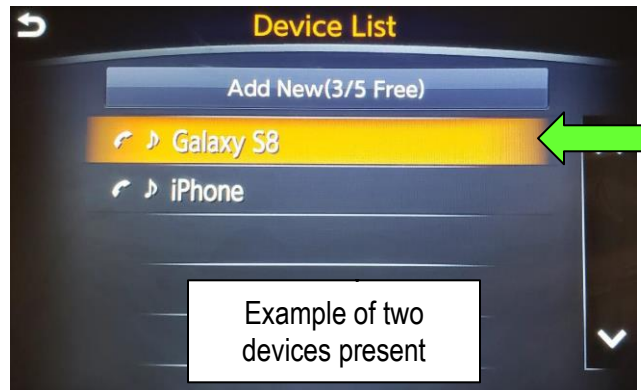
Figure 12

22. Is a device present in the Device List?
- YES:** Select a device and then proceed to step 23.
 - NO:** Proceed to step 25.
- IMPORTANT:** All paired devices must be deleted before proceeding to step 25.

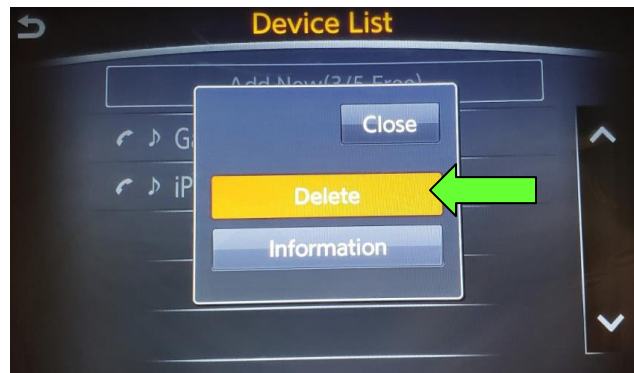
Figure 13

23. Select **Delete** and confirm the screens in Figure 14 and then Figure 15 are displayed.

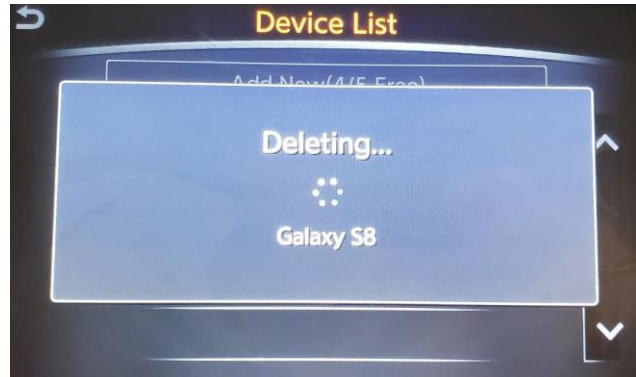
Figure 14

- The first screen will show “Deleting...” followed by the device name.

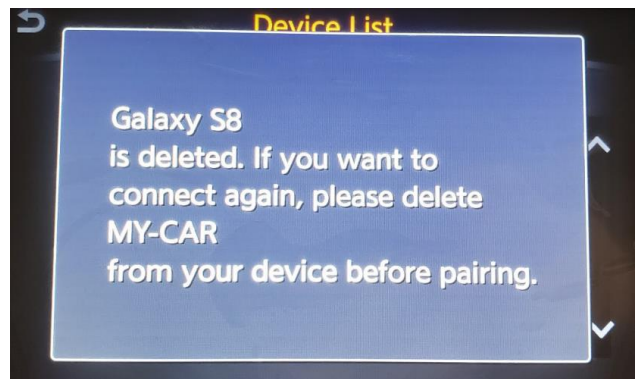
Figure 15

- The second screen will show information regarding repairing the BT device.

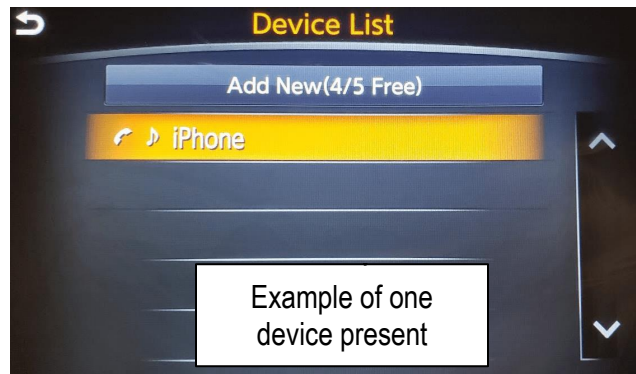
Figure 16

24. Are any devices still present in the Device List?

- **YES:** Select a device and then perform step 23 and 24 again.
- **NO:** Proceed to step 25.

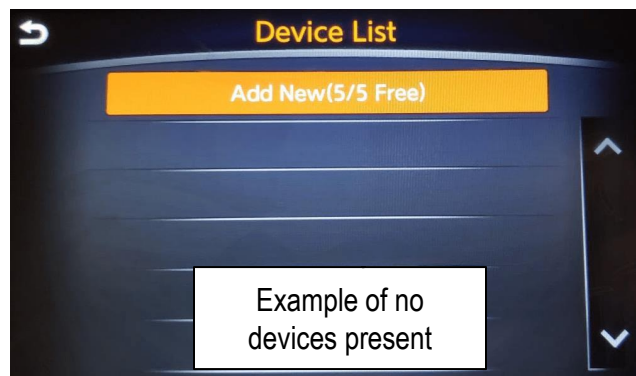
- Figure 17 will be displayed when all devices have been deleted.

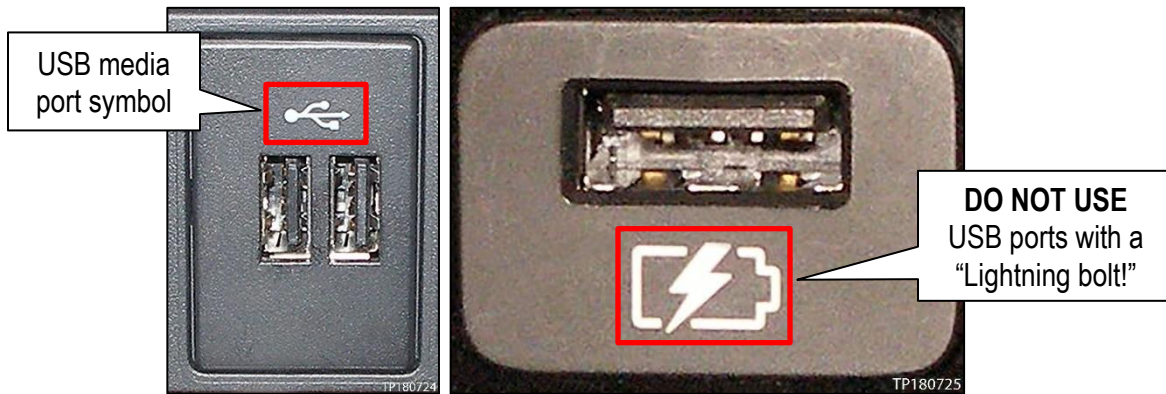
Figure 18

25. Connect the USB drive with update software package into the vehicle's USB media port.

CAUTION: Charging ports are marked in the vehicle with a "lightning bolt" symbol. Do not insert the USB drive into a charging port. If used, the update software and/or USB drive may become damaged. Only insert the USB drive in a USB media port.

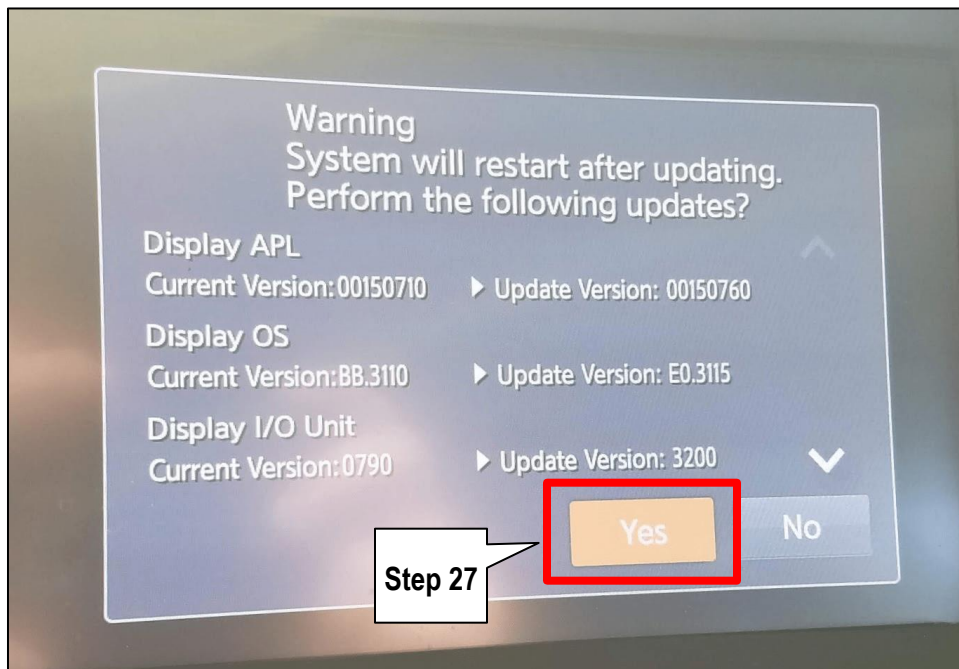
26. Wait approximately 10-30 seconds for the screen in Figure 19 to appear.

27. Select **Yes** to begin the software update.

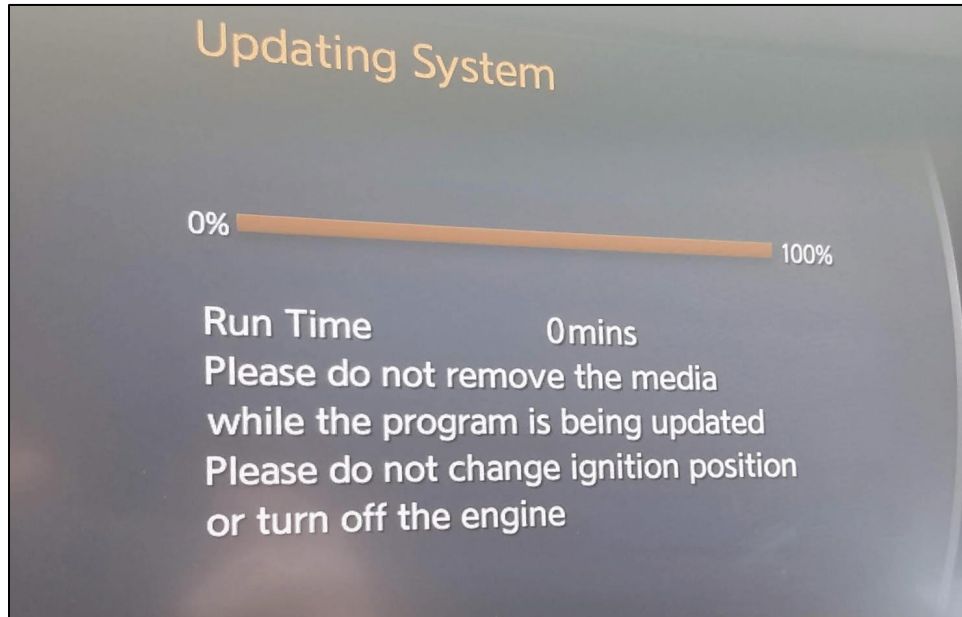
Figure 20

28. Wait for the update to complete.

- Follow the on-screen instructions while waiting.

NOTE: The update lasts 10-70 minutes.

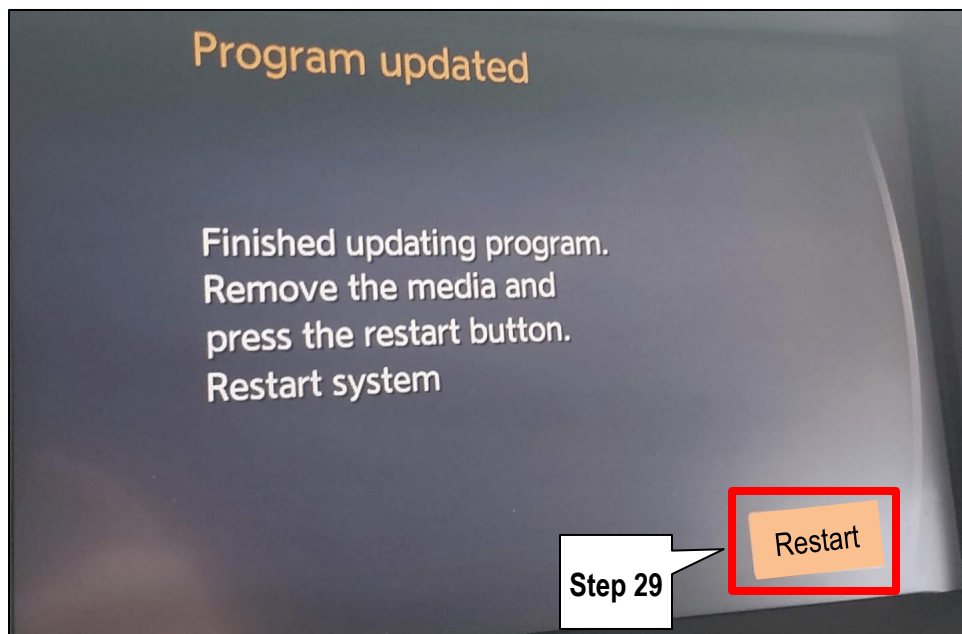
Figure 21

29. Once the update is complete, remove the USB drive, and then select **Restart**.
