Emissions Recall

Code: 23U7

Subject	2.0L TDI Engine (GEN 1) Emissions Modification – Customer Only (Retail Sold) <u>USA ONLY</u>
Release Date	September 12, 2017
Revision Summary	Updated work instructions.
Important Repair Information!	CAMPAIGN 23W1 MUST BE COMPLETED BEFORE BEGINNING THE 23U7 CAMPAIGN! Over the next few weeks there will be updates made to ODIS and the campaign circular. Do not retain any hard copies of campaign circulars – only refer to the electronic copies posted to Elsa and ServiceNet.
Affected Vehicles	U.S.A.: 2010-2013 MY Audi A3 2.0L TDI (Generation 1) <i>Check Campaigns/Actions screen in Elsa on the day of repair to verify that a VIN qualifies for repair under this action. Elsa is the <u>only</u> valid campaign inquiry & verification source.</i> <ul style="list-style-type: none"> ✓ Campaign status must show “open.” ✓ If Elsa shows other open action(s), inform your customer so that the work can also be completed at the same time the vehicle is in the workshop for this campaign.

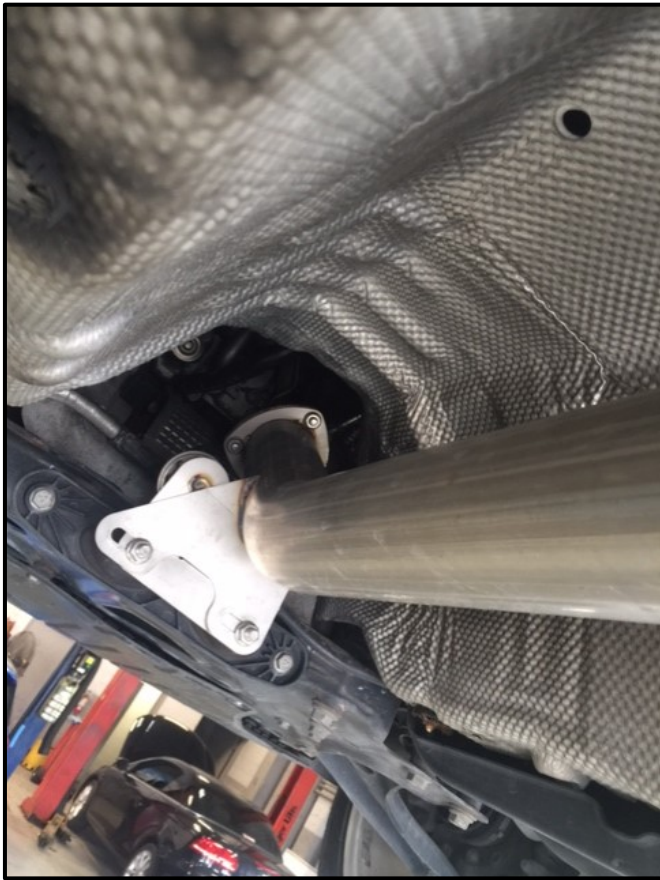
- Check for vehicle modifications from original equipment.
 - If vehicle modifications from original equipment related to emissions components are found, **STOP**, create an ATA ticket and contact the Audi Technicians Helpline.
 - If vehicle modifications from original equipment related to emissions components are not found, continue the work procedure.

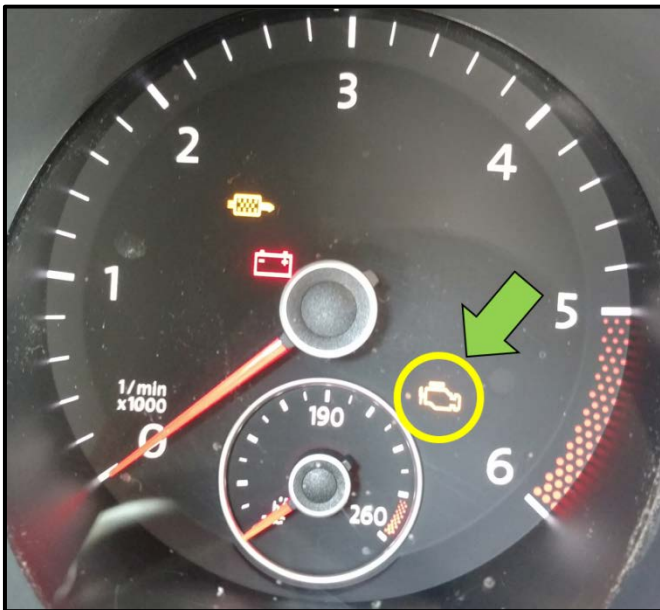
- Check for illumination of the MIL <arrow>.
 - If MIL is illuminated, **STOP**, create an ATA ticket and contact the Audi Technicians Helpline.
 - If MIL is not illuminated, continue the work procedure.

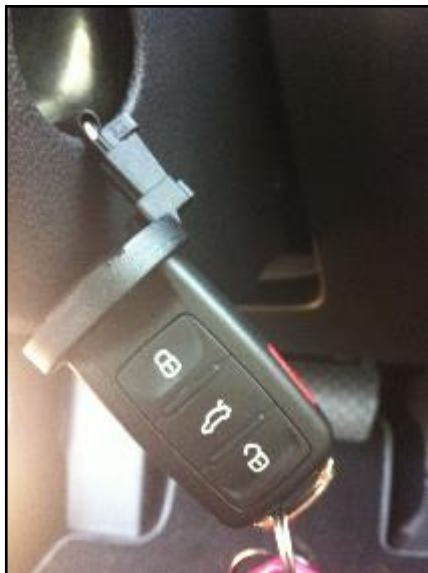
- If loss of communication between the reader coil and the key occurs during the flash, it may damage a control module.
- If equipped with a removable reader coil cap, it is **REQUIRED** to remove the reader coil cap and insert the key into the reader coil, or secure the key in close proximity to the reader coil throughout the flash process.
- If the reader coil cap is not removable, it is **REQUIRED** to secure the key to the steering column in close proximity to the reader coil using a residue-free adhesive or tape, an elastic cloth or stretch bandage, or other improvised retaining device.

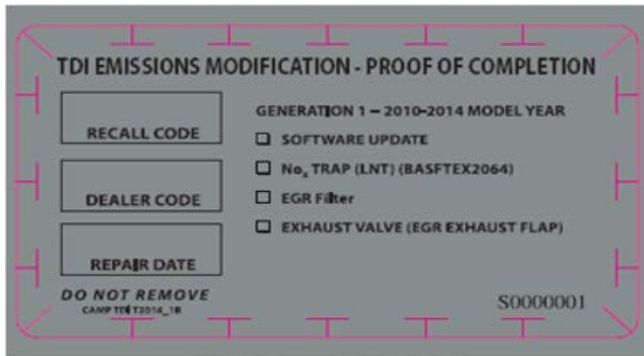
MY 2010-2014 – CAMP TDI 2016_1B

The image shows a rectangular label form with a pink border. At the top, it reads "TDI EMISSIONS MODIFICATION - PROOF OF COMPLETION". Below this, there are three input fields: "RECALL CODE", "DEALER CODE", and "REPAIR DATE". To the right of these fields, it says "GENERATION 1 – 2010-2014 MODEL YEAR" followed by three checkboxes: "SOFTWARE UPDATE", "No_x TRAP (LNT) (BASFTX2064)", and "EGR Filter". Below the checkboxes, it says "EXHAUST VALVE (EGR EXHAUST FLAP)". At the bottom left, it says "DO NOT REMOVE" and "CAMP TDI 2016_1B". At the bottom right, it says "S0000001".
