EL18-023

INFINITI; SOFTWARE UPDATES FOR INFOTAINMENT ISSUES

APPLIED VEHICLES: 2016-2018 Q50 (V37) 2017-2018 QX30 (H15)
2016-2018 Q50 Hybrid (V37) 2017-2018 QX60 (L50)
2017-2018 Q60 (V37) 2017-2018 QX60 Hybrid (L50)
2018 Q70 (Y51) 2018 QX80 (Z62)
2018 Q70 Hybrid (Y51)

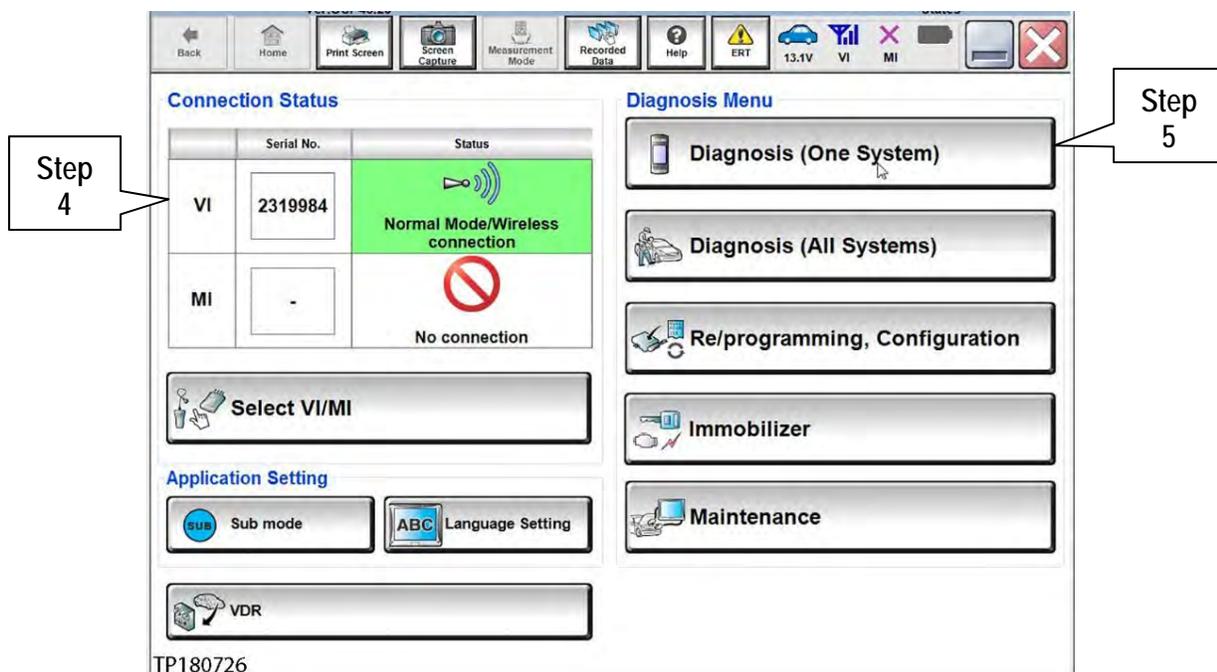
Figure 2

1. Connect the CONSULT PC and plus VI to the vehicle.
2. Start C-III plus.
3. Turn ON the ignition.
4. Wait for the plus VI to be recognized / connected.
 - The serial number will display when the plus VI is recognized / connected.
5. Select **Diagnosis (One System)**.

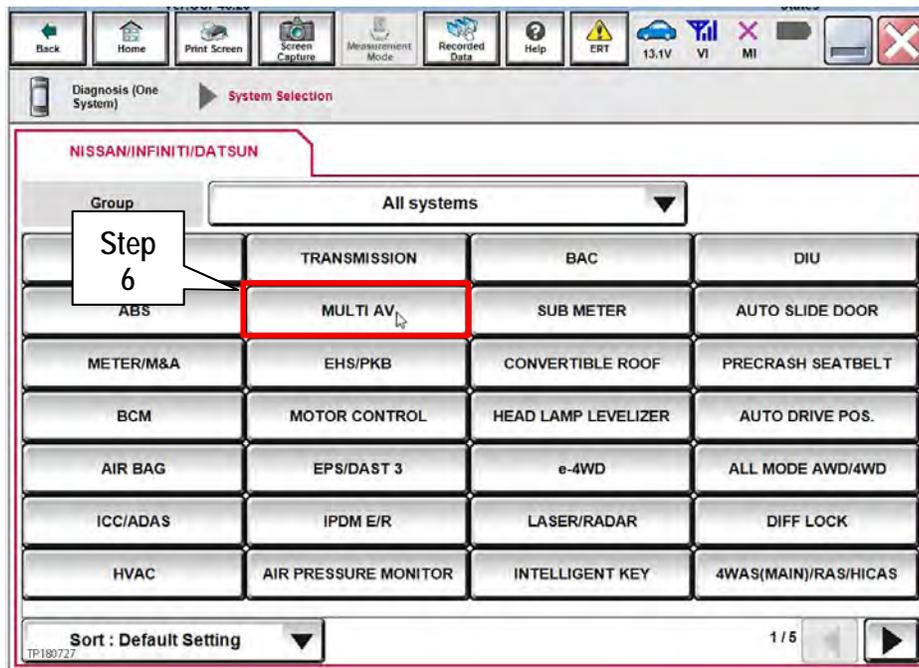
Figure 3

6. Select MULTI AV.

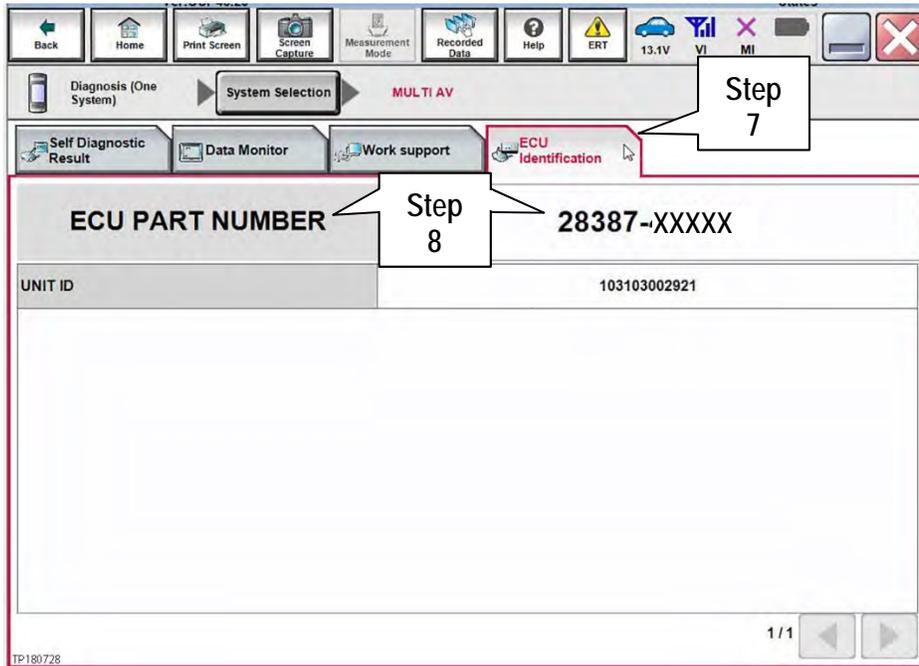
7. Select the **ECU Identification** tab.
8. When the screen in Figure 4 displays, confirm this bulletin applies as follows:
 - a. Write down the **ECU PART NUMBER** on the repair order.

NOTE: This is the current DCU part number (P/N).

- b. Compare the P/N you wrote down to the P/Ns in the **CURRENT DCU PART NUMBER** column in **Table A** on the next page.
 - If there is a match, this bulletin applies. Go to page 6, **Update Display Control Unit**.
 - If there is not a match, DCU updating does not apply. Refer to ASIST for further diagnosis.

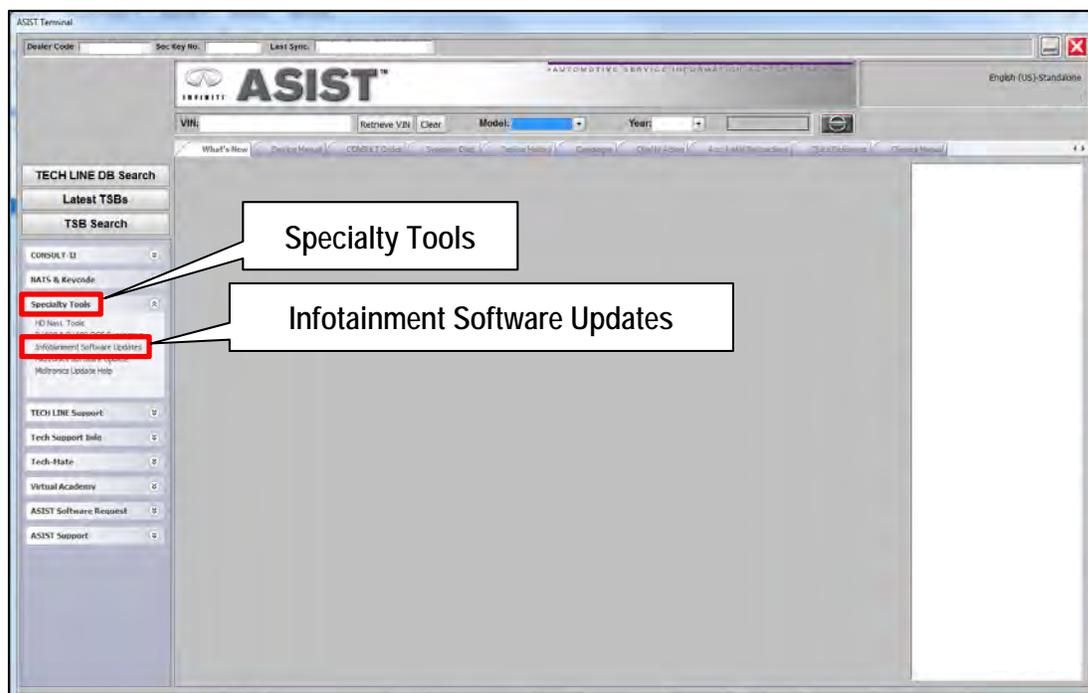
Figure 5

11. Select **Specialty Tools**, and then select **Infotainment Software Updates**.

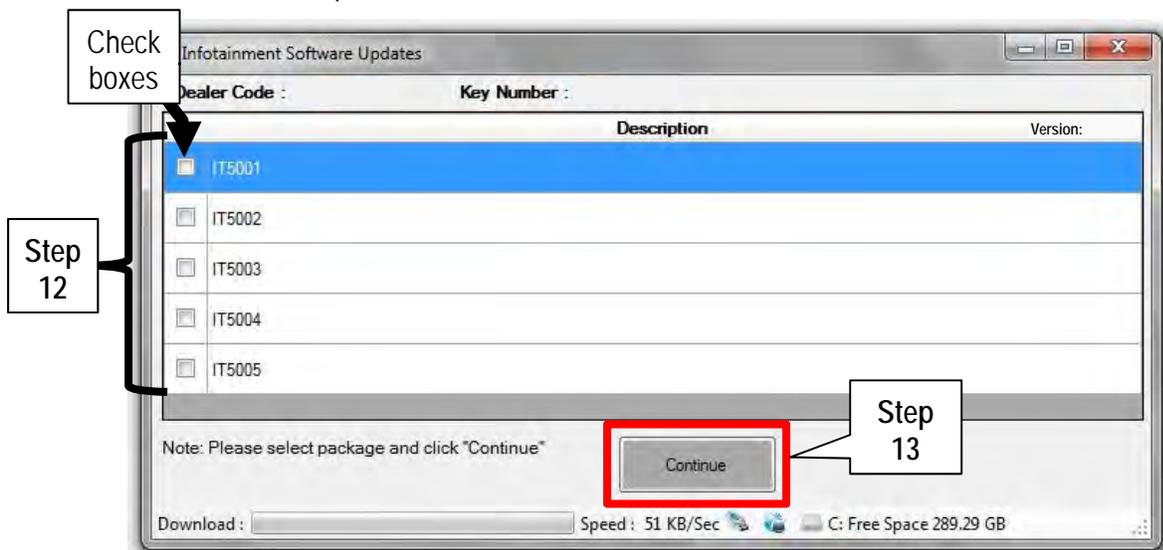
13. After selecting the check box of the correct update software package, select **Continue**, and then wait for the download to complete.

12. Select the check box next to the correct update software package based on **Table B** below (also refer to Figure 6 further below).

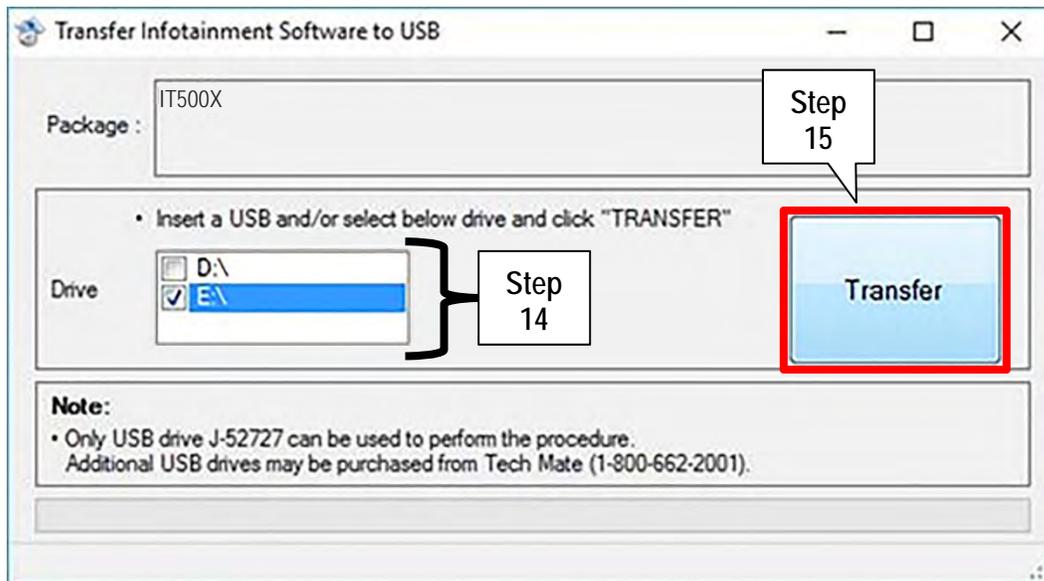
Figure 7

14. Once the download is complete, select the USB drive for update software package transfer.

- See example in Figure 7. The drive selection on your PC may be different.

15. Select **Transfer**, and then wait for the transfer to complete (see Figures 7 and 8).

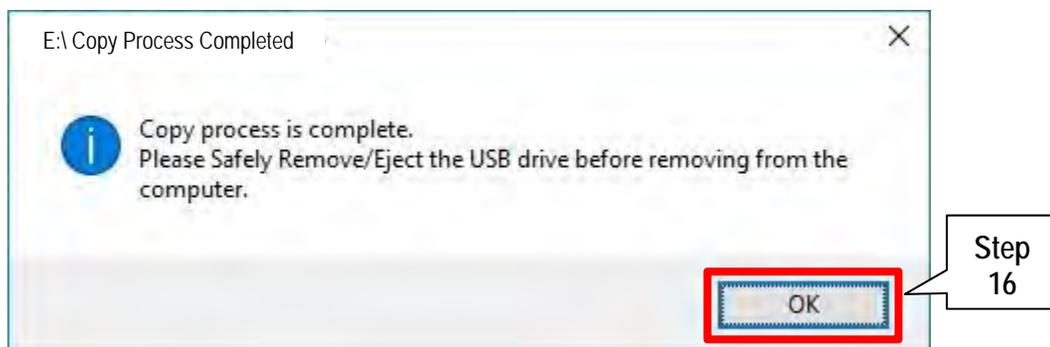
Figure 8

16. Select **OK**.

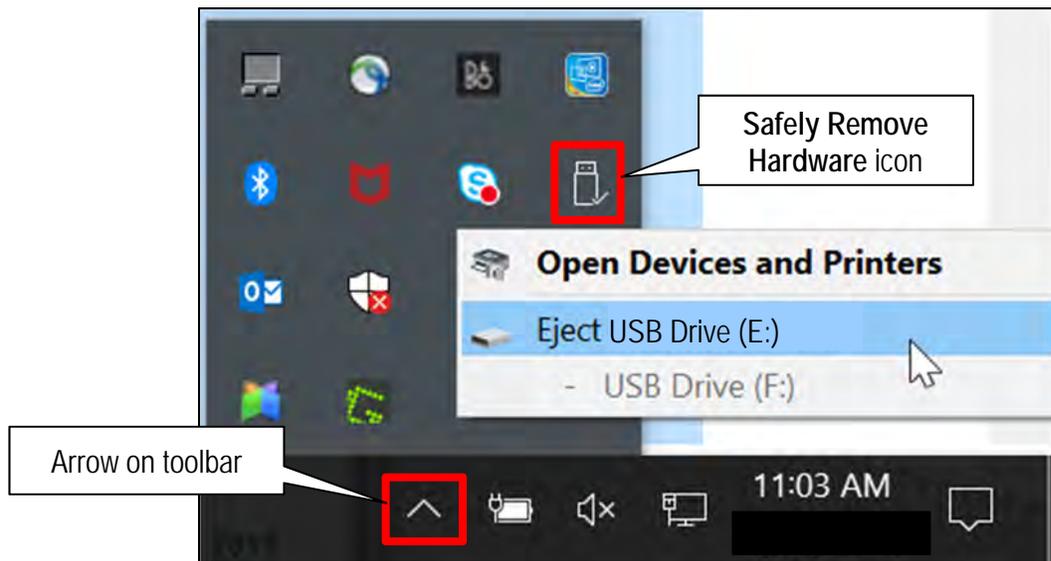
Figure 9

a. From the PC toolbar, select the **Safely Remove Hardware** icon.

- The icon is on the toolbar, or to be found after selecting the arrow.

b. Select the USB drive to be removed, and then remove the USB drive from the ASIST Station.

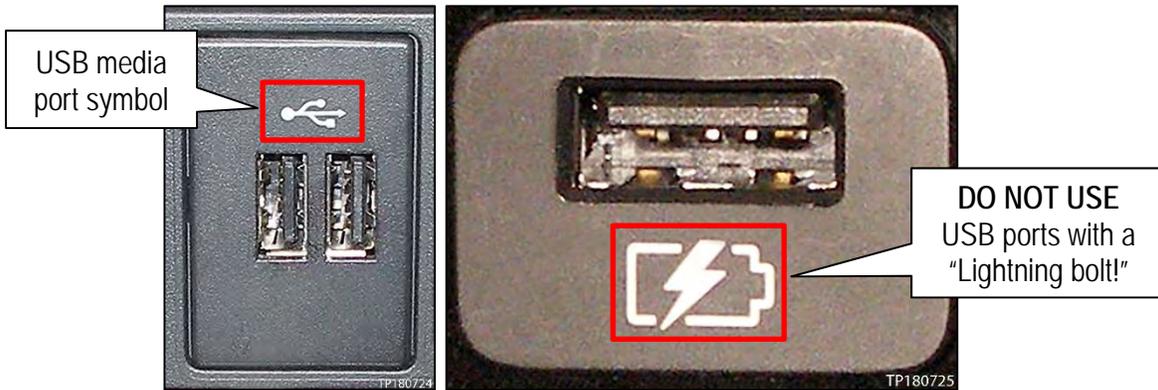
Figure 10

20. Connect the USB drive with update software package into the vehicle's USB media port.

CAUTION: Charging ports are marked in the vehicle with a "lightning bolt" symbol. Do not insert the USB drive into a charging port. If used, the update software and/or USB drive may become damaged. Only insert the USB drive in a USB media port.

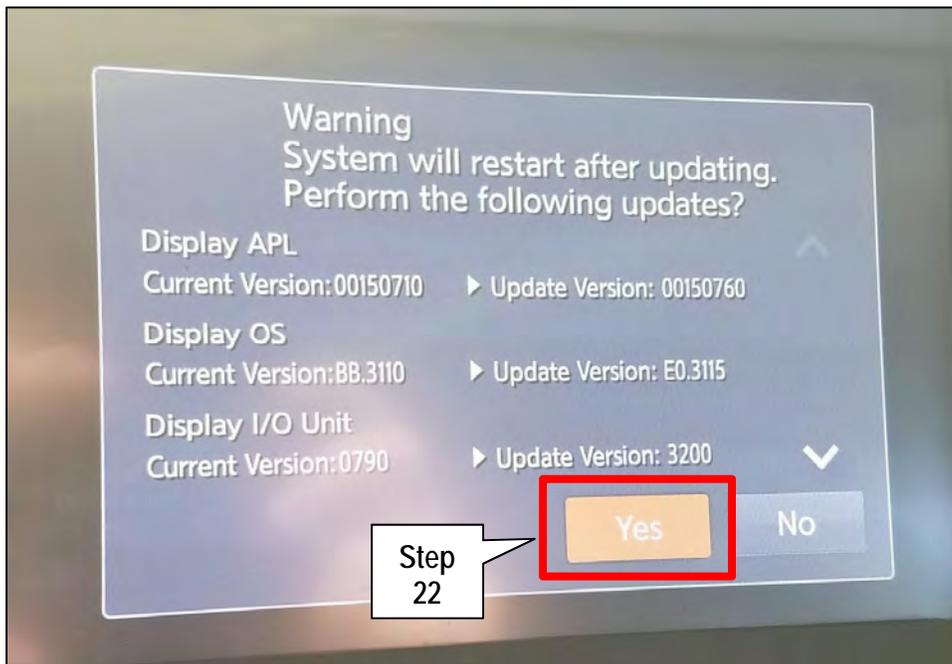
21. Wait approximately 10-30 seconds for the screen in Figure 11 to appear.
22. Select **Yes** to begin the software update.

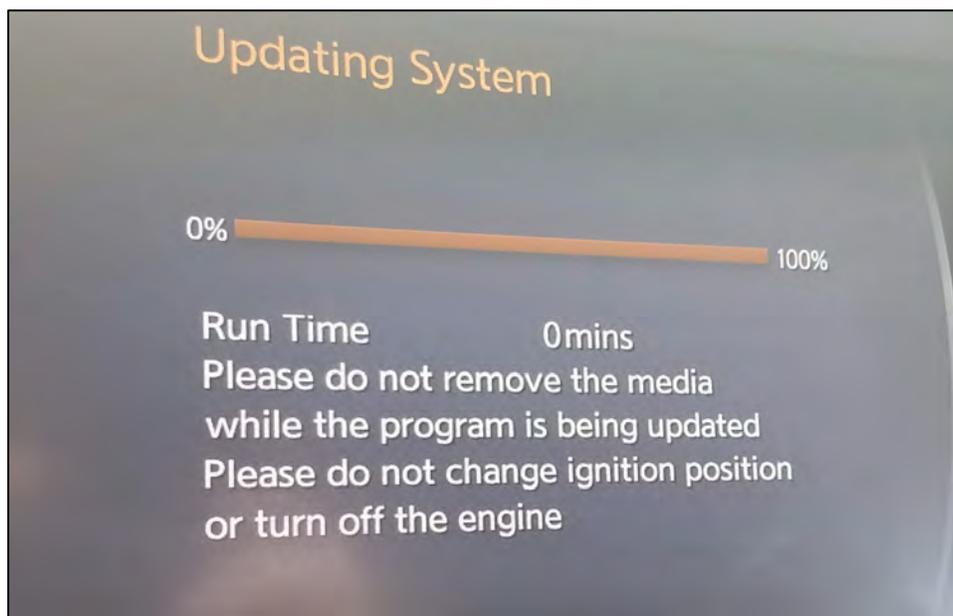
Figure 12

23. Wait for the update to complete.

- Follow the on-screen instructions while waiting.

NOTE: The update lasts 10-70 minutes.

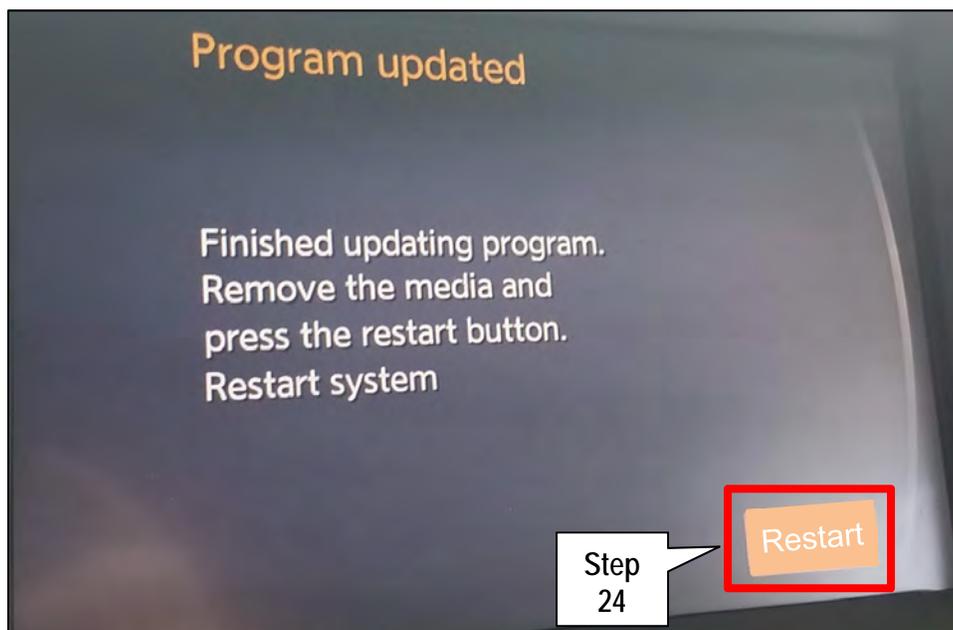
Figure 13

24. Once the update is complete, remove the USB drive, and then select **Restart**.
