EL18-023a

## INFINITI; SOFTWARE UPDATES FOR INFOTAINMENT ISSUES

<b>APPLIED VEHICLES:</b>	2016-2018 Q50 (V37)	2017-2018 QX30 (H15)
	2016-2018 Q50 Hybrid (V37)	2017-2018 QX60 (L50)
	2017-2018 Q60 (V37)	2017-2018 QX60 Hybrid (L50)
	2018 Q70 (Y51)	2018 QX80 (Z62)
	2018 Q70 Hybrid (Y51)

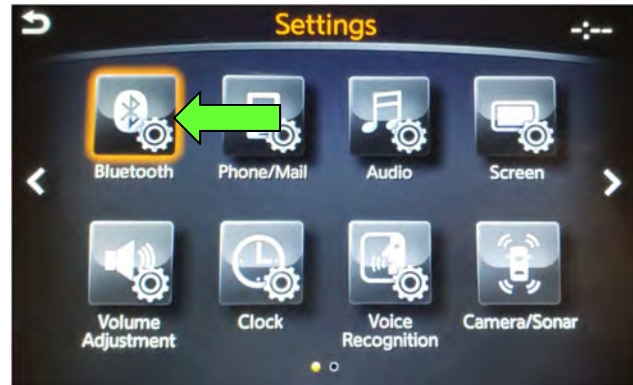
Figure 10

20. Open the Settings Menu and then select **Bluetooth**.

On a system with one (1) screen:

- The settings menu is accessed with the hard button located under the display.

On a system with two (2) screens:

- The settings menu is accessed by selecting the settings app icon on the lower display.

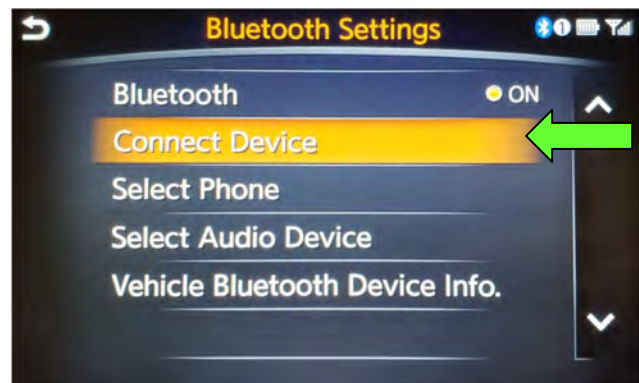
Figure 11

21. Select **Connect Device** from the Bluetooth Settings menu.

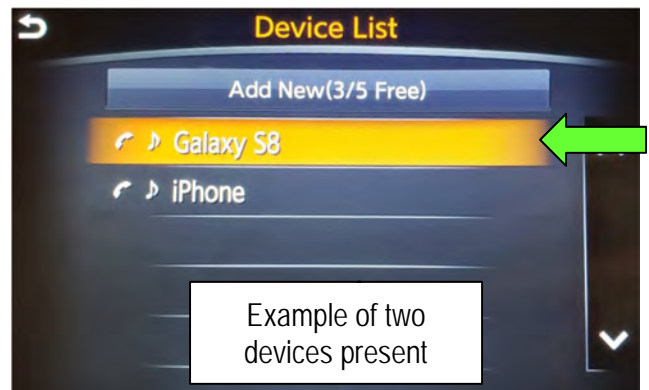
Figure 12

22. Is a device present in the Device List?

- **YES:** Select a device and then proceed to step 23.
- **NO:** Proceed to step 25.

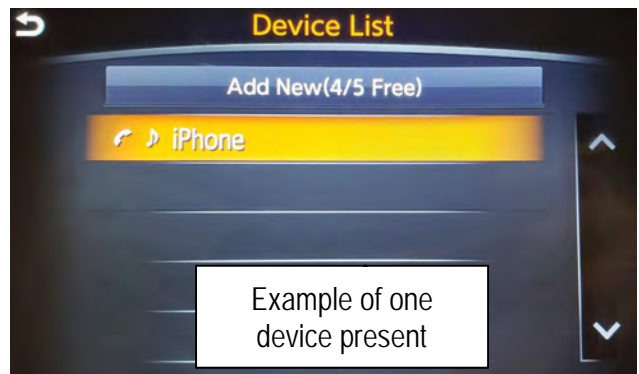
Figure 16

24. Are any devices still present in the Device List?

- **YES:** Select a device and then perform step 23 and 24 again.
- **NO:** Proceed to step 25.
