Technical Service Bulletin

SUBJECT:			No: TSB-19-54-001
QUICK CHARGING WITH ABB QUICK CHARGER STOPS DUE TO ISOLATION ERROR			DATE: February 2019
			MODEL: 2018-2019 Outlander PHEV
CIRCULATE TO:	<input type="checkbox"/> GENERAL MANAGER	<input checked="" type="checkbox"/> PARTS MANAGER	<input checked="" type="checkbox"/> TECHNICIAN
<input checked="" type="checkbox"/> SERVICE ADVISOR	<input checked="" type="checkbox"/> SERVICE MANAGER	<input checked="" type="checkbox"/> WARRANTY PROCESSOR	<input type="checkbox"/> SALES MANAGER

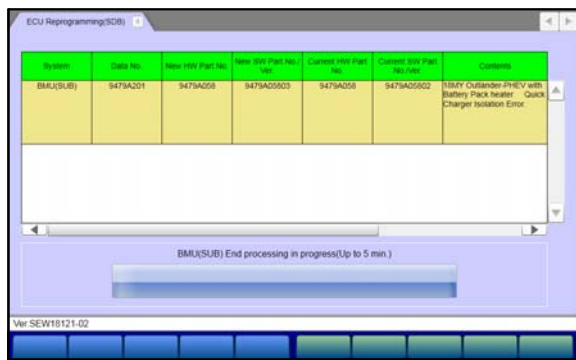
- g. Once the reprogramming is initiated, the screen shown will indicate the reprogramming progress.

NOTE: Do NOT disturb the cables or turn off the ignition during reprogramming.
