# SERVICE BULLETIN

HA19-001

## 2016-2018 TITAN/TITAN XD WITH AUTO A/C; VAST TEMPERATURE DIFFERENCE BETWEEN 61°F & 62°F SETTINGS

**APPLIED VEHICLES:** 2016-2018 Titan (A61)  
2016-2018 Titan XD (A61)  
**APPLIED SYSTEM:** Auto A/C ONLY

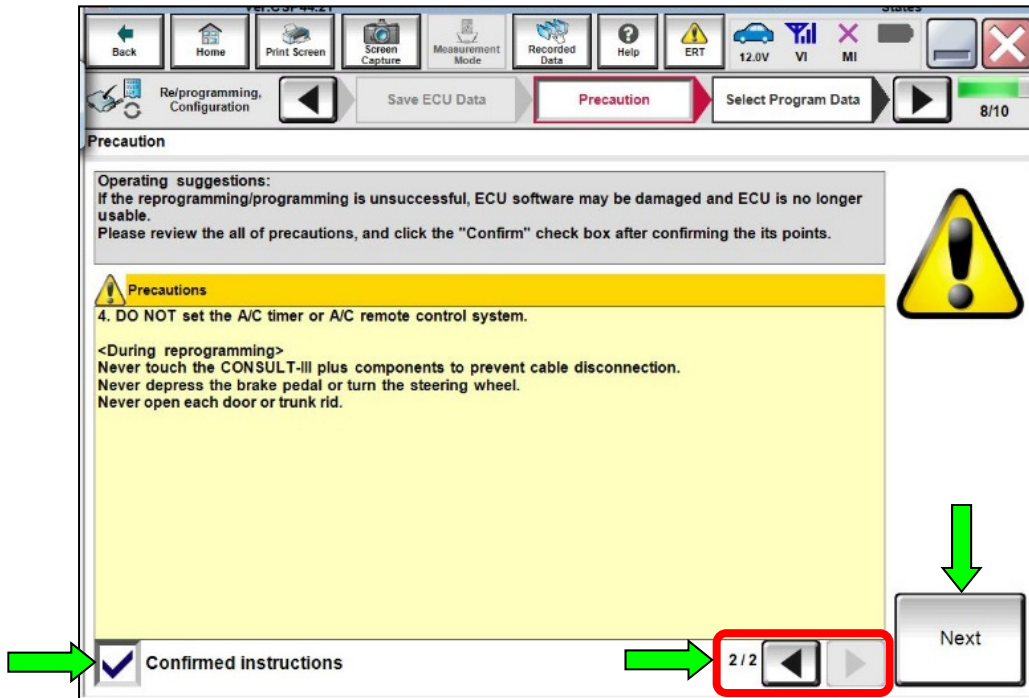
Figure 8

12. Read and follow all text on both screens, select the **Confirmed Instructions** box, and then select **Next** (see Figure 8).

- The second page will need to be selected before the **Confirmed Instructions** box can be selected.

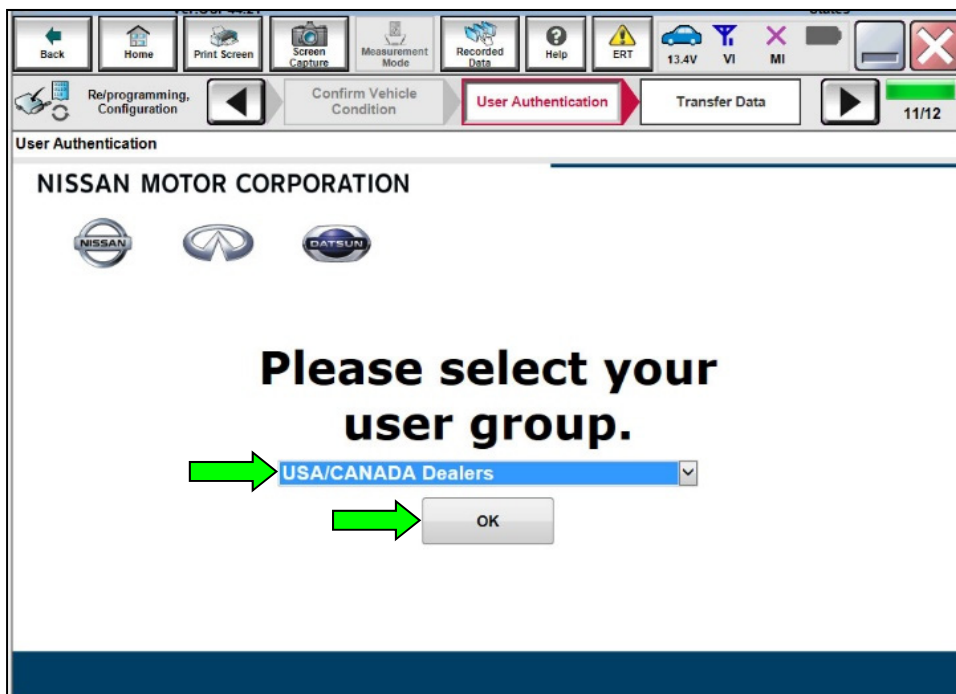
Figure 11

15. Select **USA/CANADA Dealers**, and then select **OK**.

- The screen below may not display if the CONSULT PC has remained ON since the last reprogramming.
