SERVICE BULLETIN

Classification:	Reference:	Date
EC16-013e	NTB16-037e	February 28, 2019

2016 TITAN XD; MIL ON WITH ENGINE DTCs STORED AND/OR IDLE FLUCTUATION

APPLIED VEHICLES: 2016 Titan XD (A61)
APPLIED ENGINE: Cummins 5.0L V8 Diesel

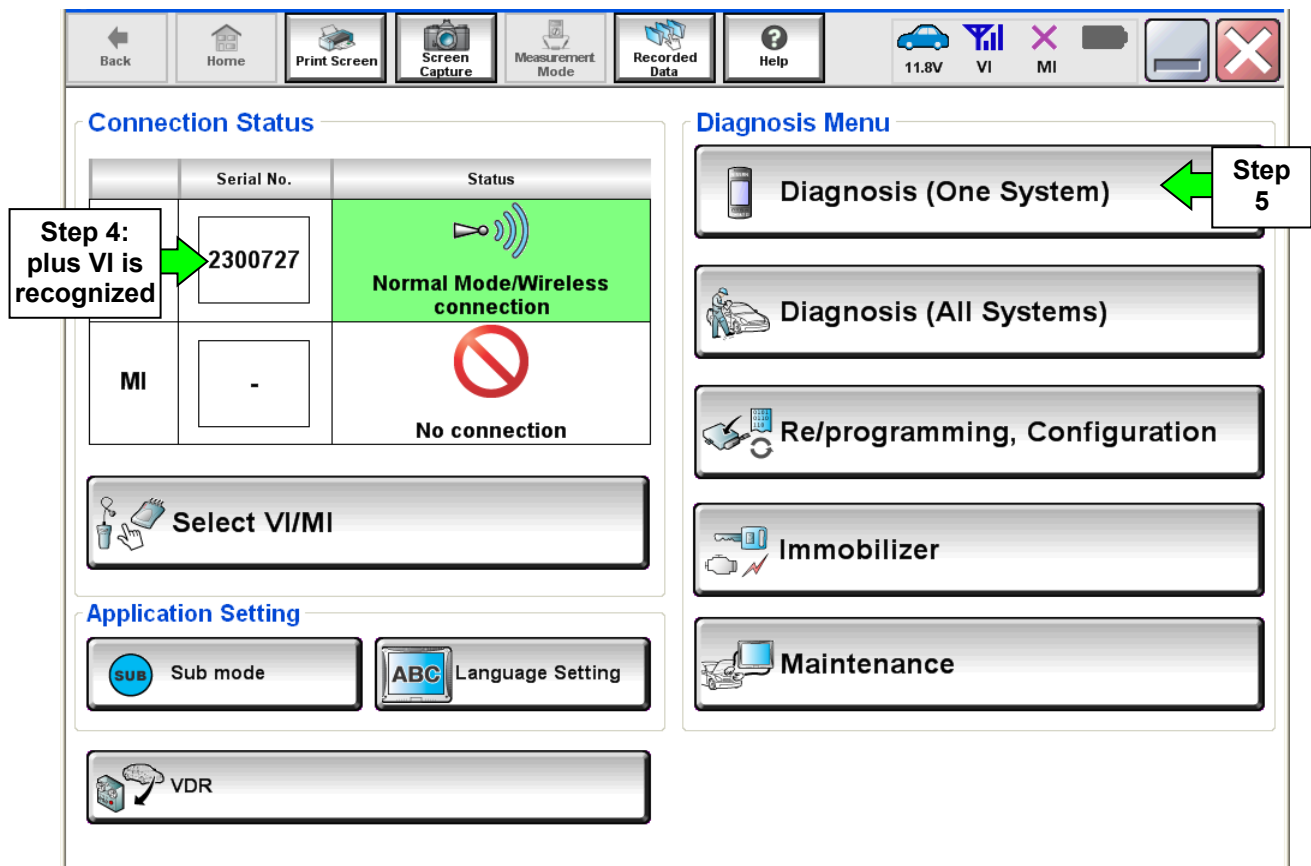
Figure A

1. Connect the CONSULT PC to the vehicle.
2. Open / start C-III plus.
3. Turn the ignition ON, with engine OFF (engine not running).
4. Wait for the plus VI to be recognized.
 - The **Serial No.** will display when the plus VI is recognized.
5. Select **Diagnosis (One System)**.

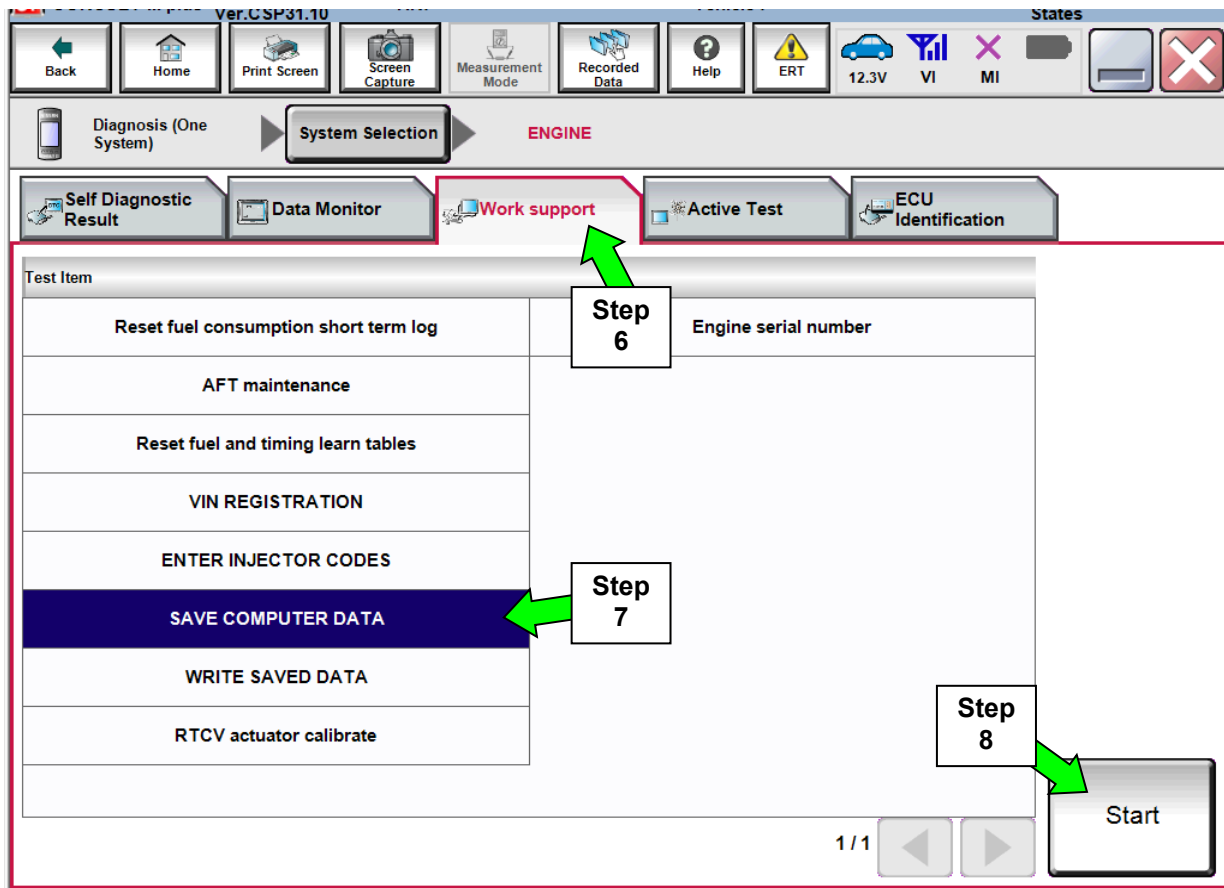
Figure B

6. Navigate C-III plus to Engine > Work Support (see Figure B).
7. Select **SAVE COMPUTER DATA**.
8. Select **Start**.

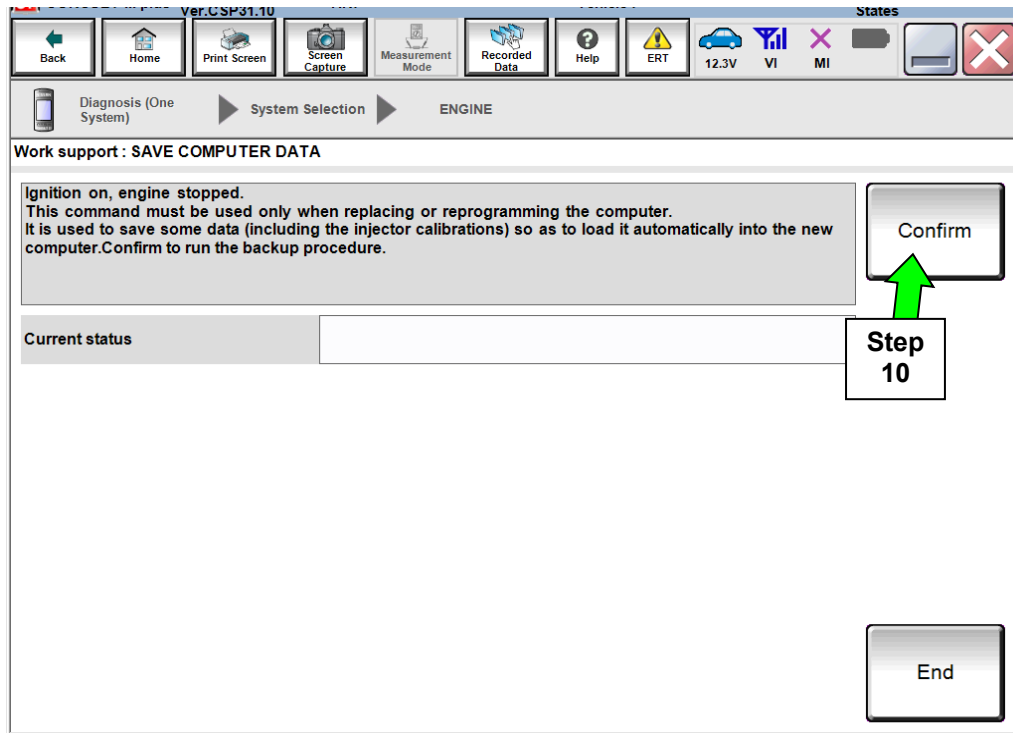
Figure C

9. Make sure the ignition is ON and the engine is OFF (engine not running).

10. Select **Confirm**.

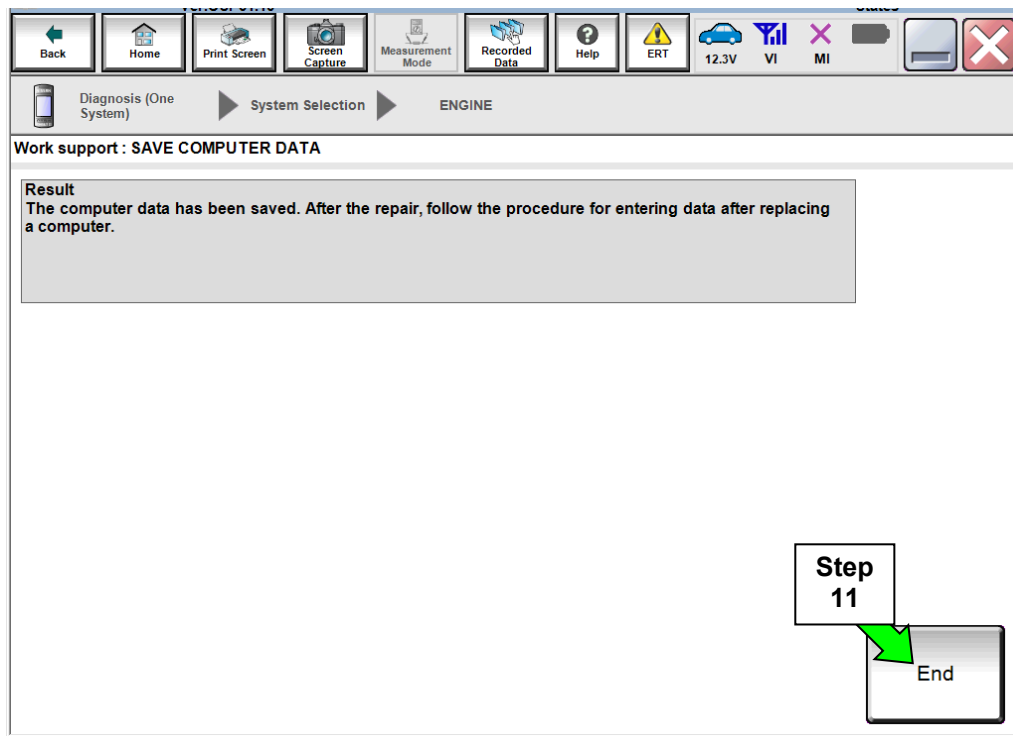
Figure D

11. Select **End**.

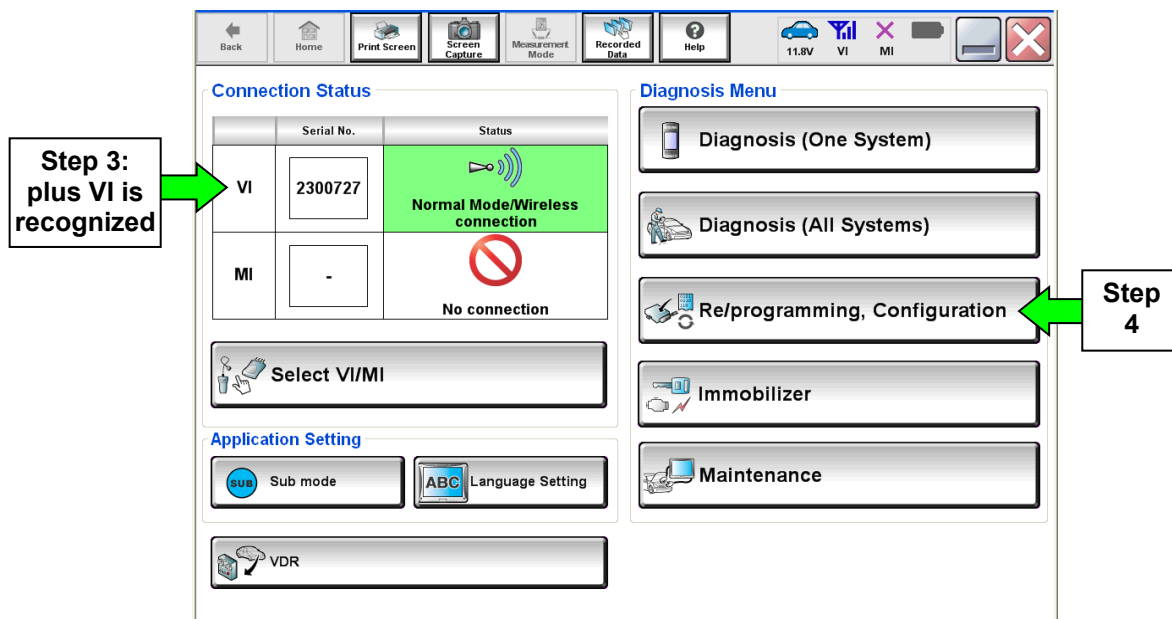
Figure 1

1. Return to the C-III- plus Home screen (see Figure 1).
2. Confirm the ignition is ON, with engine OFF.
3. Confirm the plus VI is recognized.
 - The **Serial No.** will display when the plus VI is recognized.
4. Select **Re/programming, Configuration**.

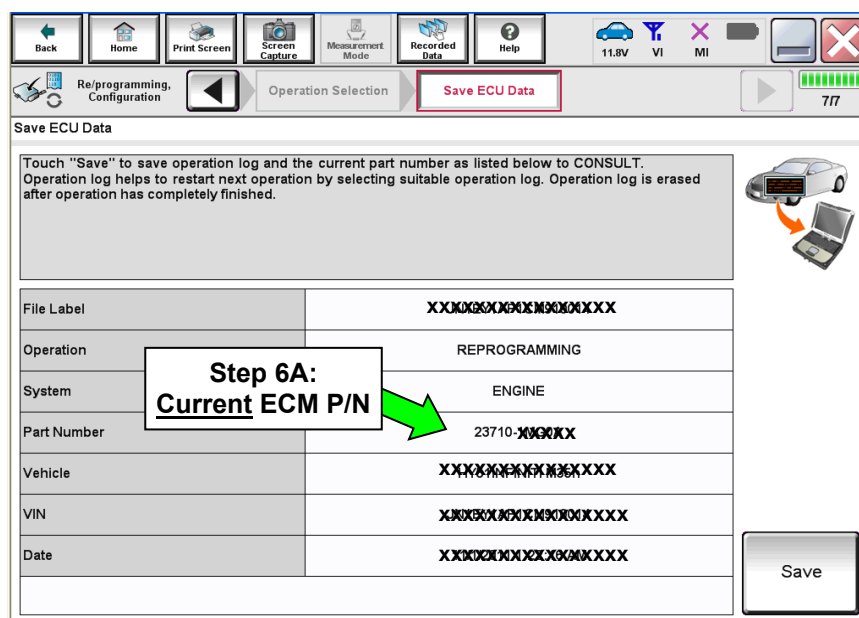
5. Follow the on-screen instructions and navigate C-III plus to the screen shown in Figure 2 on the next page.
6. When you get to the screen shown in Figure 2, confirm this bulletin applies as follows.
 - A. Find the ECM **Part Number** and write it on the repair order.

File Label	XXXXXXXXXXXXXXXX
Operation	REPROGRAMMING
System	ENGINE
Part Number	23710-XXXXX
Vehicle	XXXXXXXXXXXXXXXX
VIN	XXXXXXXXXXXXXXXX
Date	XXXXXXXXXXXX

Callout boxes indicate:

- Step 6A:** Current ECM P/N (pointing to the 'Part Number' field).

B. Compare the P/N you wrote down to the numbers in the **Current ECM Part Number** column in **Table A** below.

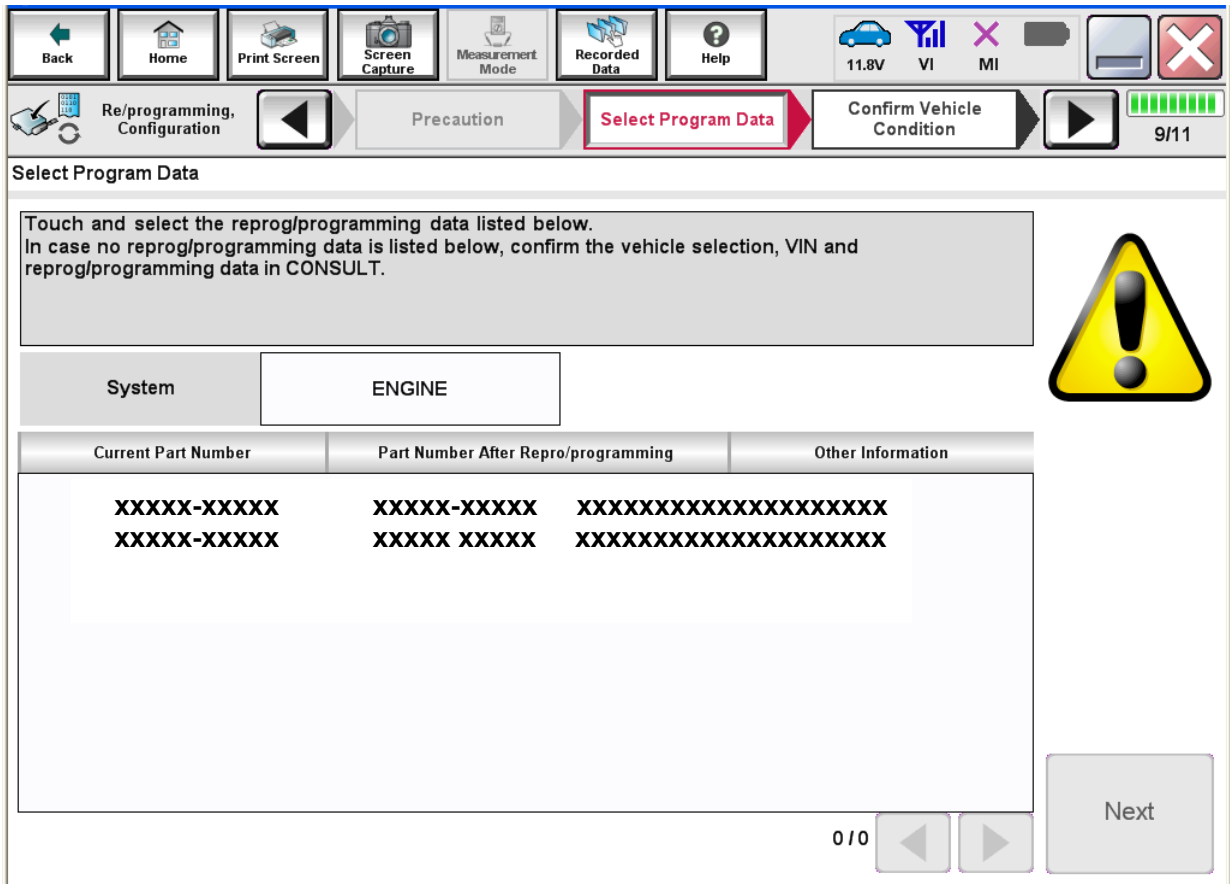
- In some cases, more than one new P/N for reprogramming is available.
 - If more than one new P/N is available, the screen in Figure 3 displays.
 - Select and use the reprogramming option that does not have the message “Caution! Use ONLY with NTBXX-XXX”.
- If you get this screen and it is blank (no reprogramming listed), it means there is no reprogramming available for this vehicle. Close C-III plus and refer back to ASIST for further diagnosis.

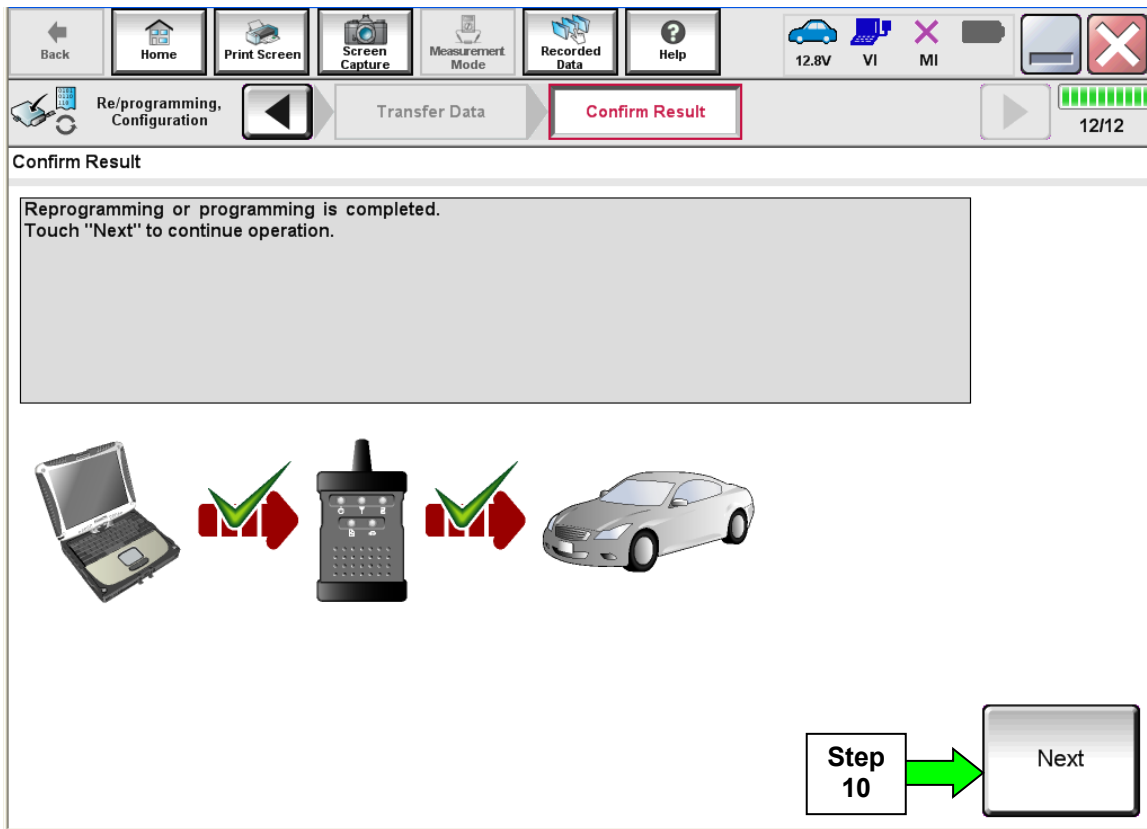
8. When the screen in Figure 4 displays, reprogramming is complete.

NOTE: If the screen in Figure 4 does not display (indicating that reprogramming did not complete), refer to ECM recovery on the next page.

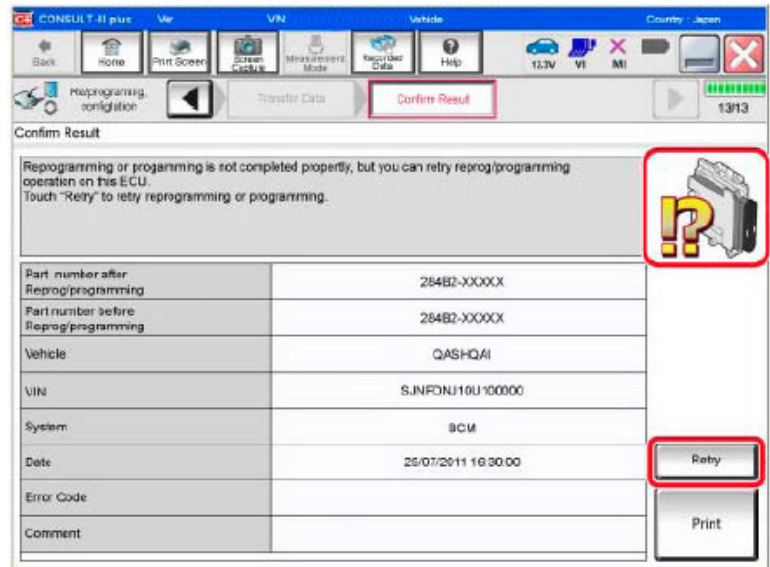
Figure 5

If reprogramming does not complete and the “!” icon displays as shown in Figure 5:

- Check battery voltage (12.0 - 15.5 V).
- Ignition is ON, engine OFF.
- External Bluetooth® devices are OFF.
- All electrical loads are OFF.
- **Select retry and follow the on screen instructions.**
- **“Retry” may not go through on first attempt and can be selected more than once.**

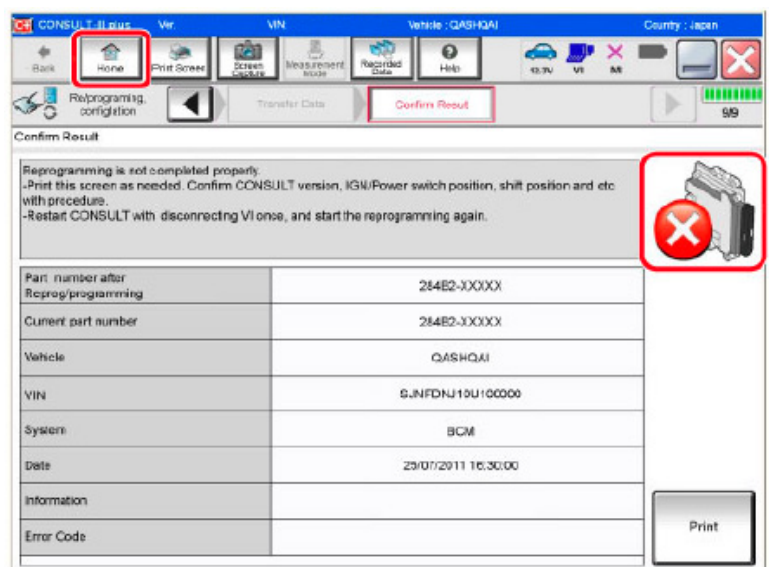
Figure 6

If reprogramming does not complete and the “X” icon displays as shown in Figure 6:

- Check battery voltage (12.0 - 15.5 V).
- CONSULT A/C adapter is plugged in.
- Ignition is ON, engine OFF.
- Transmission is in Park.
- All C-III plus / VI cables are securely connected.
- All C-III plus updates are installed.
- **Select Home, and restart the reprogram procedure from the beginning.**

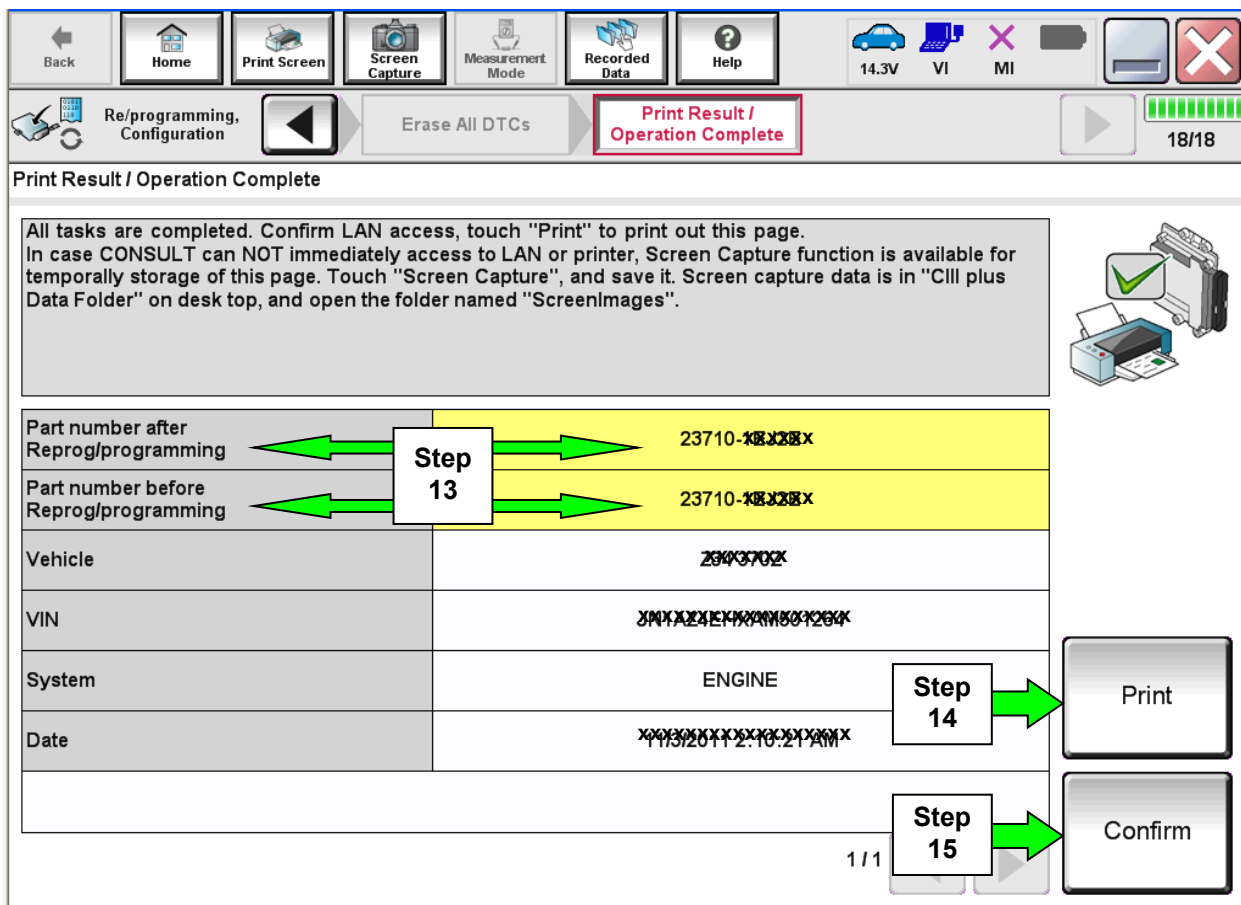
12. When the entire reprogramming process is complete, the screen in Figure 7 will display.

13. Verify the before and after part numbers are different.

14. Print a copy of this screen (Figure 7) and attach it to the repair order for warranty documentation.

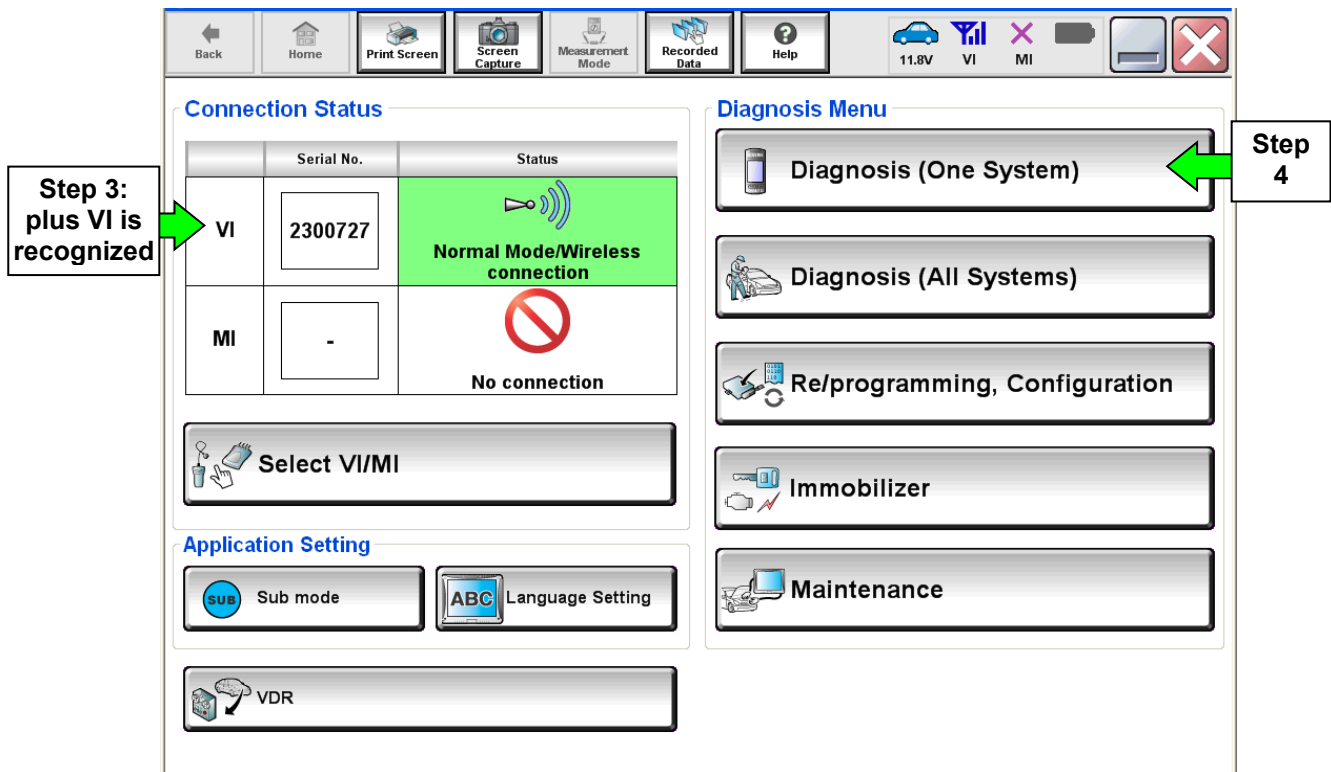
Figure 1A

1. Return to the C-III- plus Home screen (see Figure 1A).
2. Confirm the ignition is ON, with engine OFF.
3. Confirm the plus VI is recognized.
 - The **Serial No.** will display when the plus VI is recognized.
4. Select **Diagnosis (One System)**.

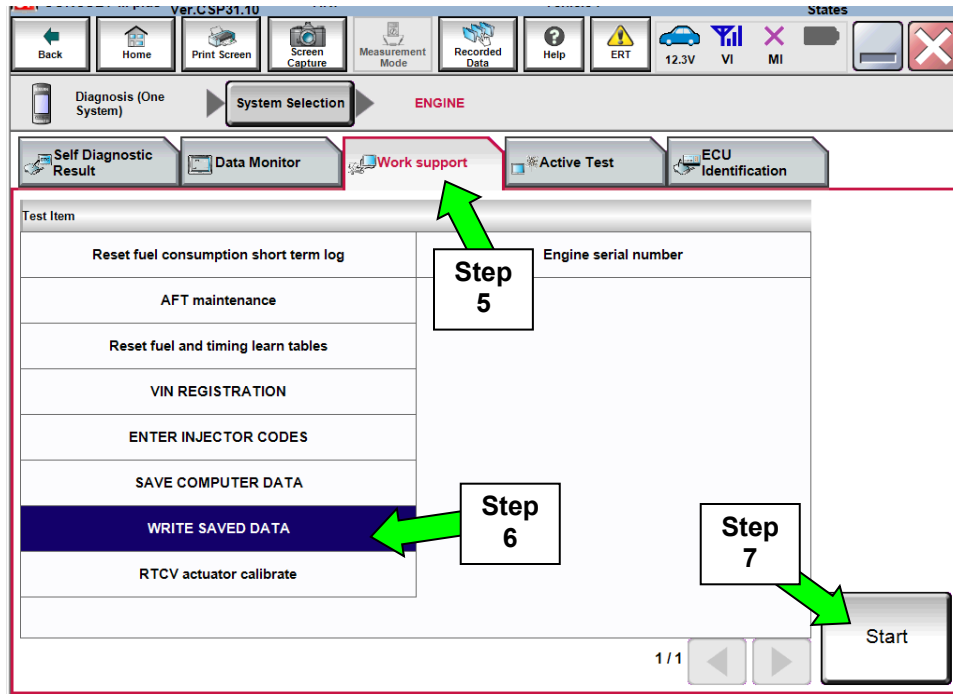
Figure 2A

5. Navigate C-III plus to Engine > Work Support (see Figure 2A).
6. Select **WRITE SAVED DATA**.
7. Select **Start**.

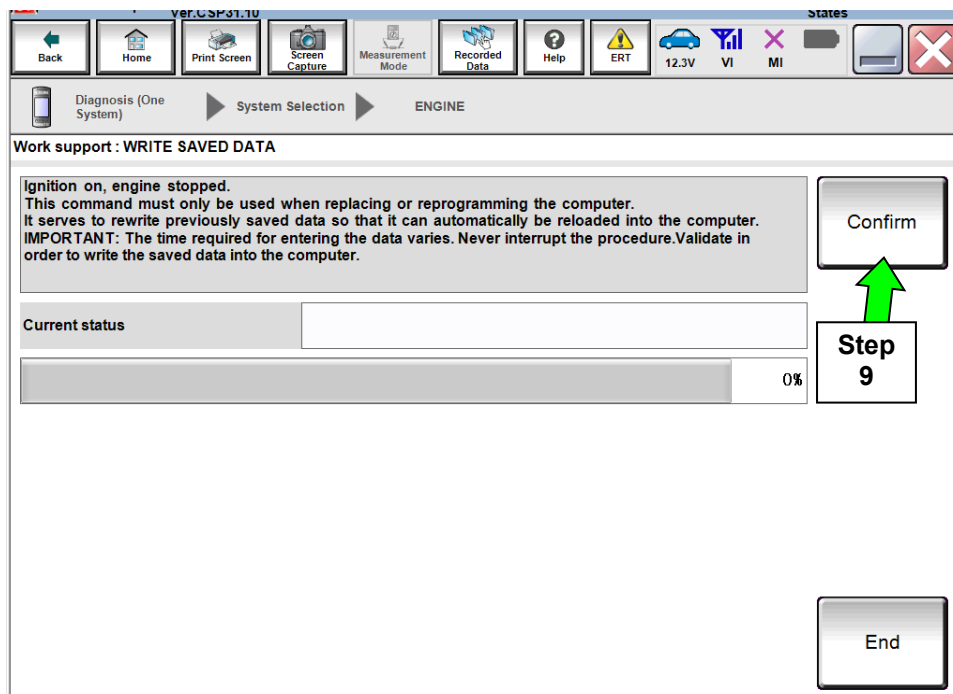
Figure 3A

8. Make sure the ignition is ON and the engine is OFF (engine not running).
9. Select **Confirm**.

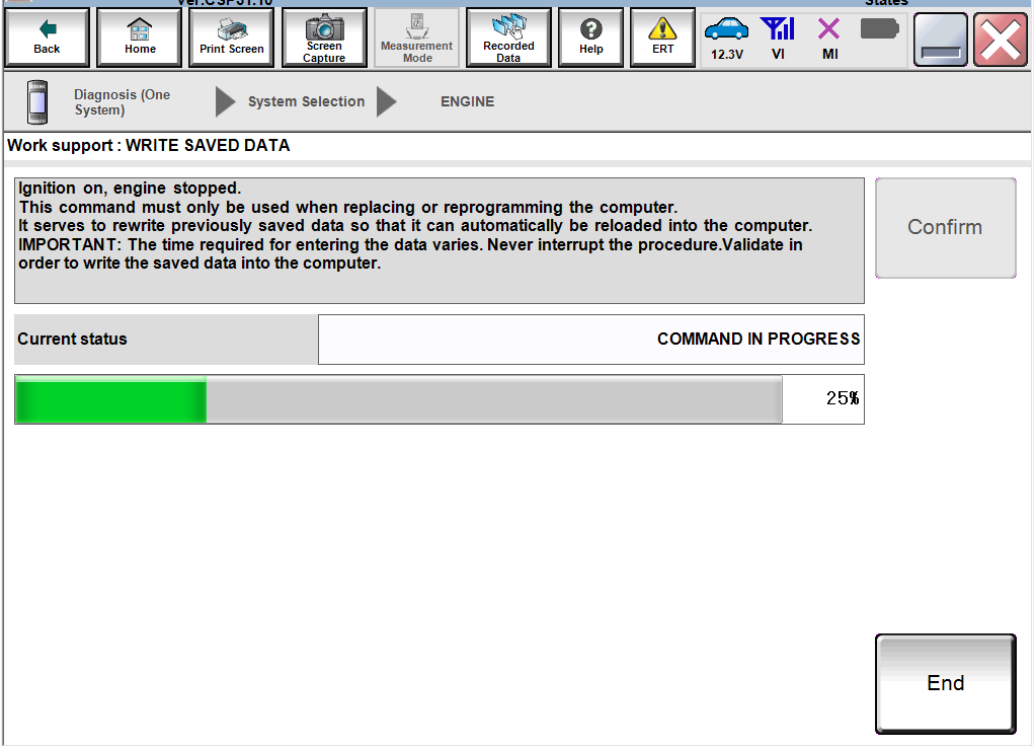
Figure 4A

10. Wait for the procedure to complete.

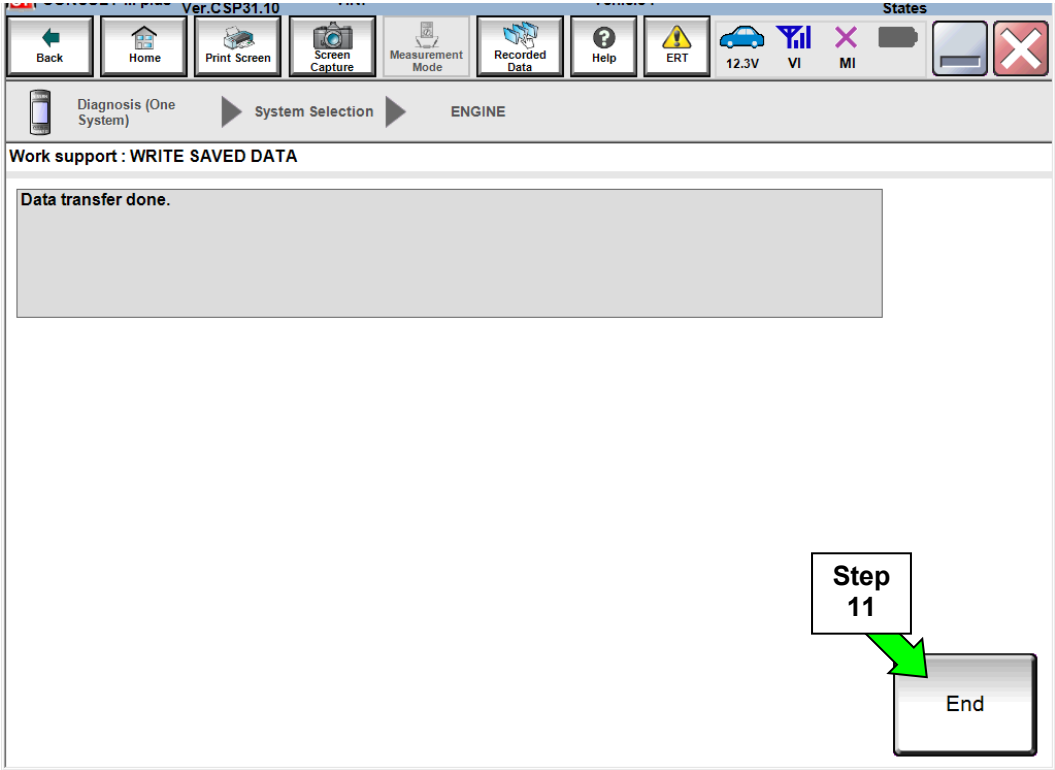
Figure 5A

11. Select **End**.
