Emissions Service Action

Code: 24DR

Subject	Engine Control Module (ECM) Software
Release Date	March 01, 2019
REVISION SUMMARY	Updated Work Procedure: Added note to perform Safety Recall 23R1 before performing the 24DR. (page 9).
Affected Vehicles	U.S.A.: 2013-2017 MY Beetle Convertible, Beetle, Jetta and 2014-2017 MY Passat CANADA: 2013-2017 MY Beetle & Jetta and 2014-2017 MY Beetle Convertible & Passat <i>Check Campaigns/Actions screen in Elsa on the day of repair to verify that a VIN qualifies for repair under this action. Elsa is the <u>only</u> valid campaign inquiry & verification source.</i> <ul style="list-style-type: none">✓ Campaign status must show "open."✓ If Elsa shows other open action(s), inform your customer so that the work can also be completed at the same time the vehicle is in the workshop for this campaign.
Problem Description	Current ECM software may cause unintended system faults. If present, these faults could lead to illumination of the malfunction indicator light (MIL). If the MIL is on, the vehicle will not pass an emissions inspection.

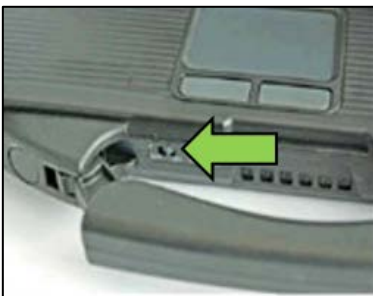
VAS 6150 & VAS 6150A
(Front panel behind handle)

- ✓ **The Bluetooth function of the scan tool is physically switched off <see pictures below>.**

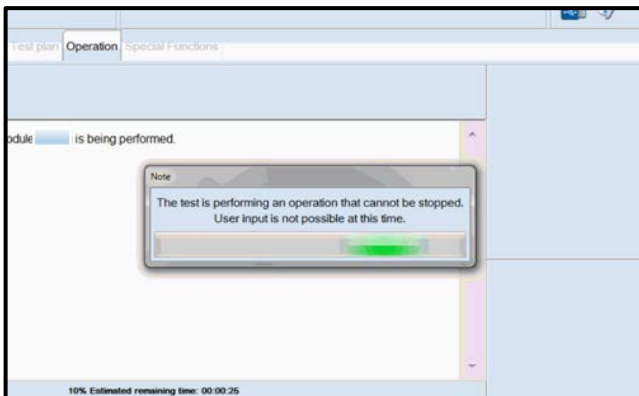
- Select “Accept” <arrow> and follow the on screen prompts.
- During the flash, this screen appears when the flash operations are performed:

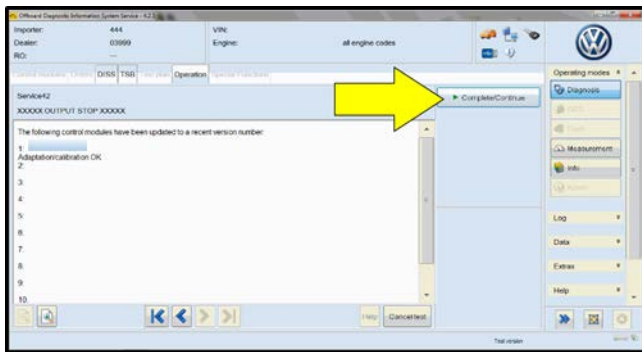
- Select Complete/Continue <arrow> after each operation is completed.

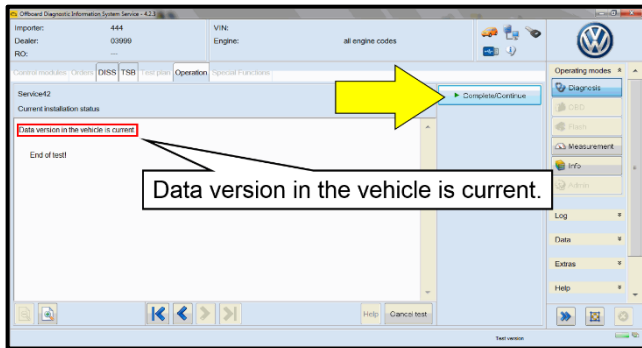
- When the SVM update is complete a confirmation message is displayed <as shown>.
- Select "Complete/Continue" <arrow>.

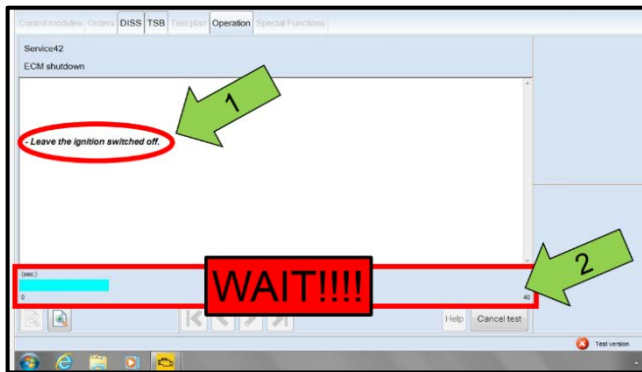
- It is **IMPERATIVE** that **ALL** of the ignition cycle on/off delay requests are fulfilled in their entirety during this flash process <arrow 1>.
- Failing to wait for the ignition on/off timing cycle to complete (progress bar and countdown timer <arrow 2>) before cycling the ignition on/off MAY damage a control module.
- Damage to control modules as a result of failing to wait the specified time displayed by the progress bar and countdown timer <arrow 2> are **NOT** covered under this action.

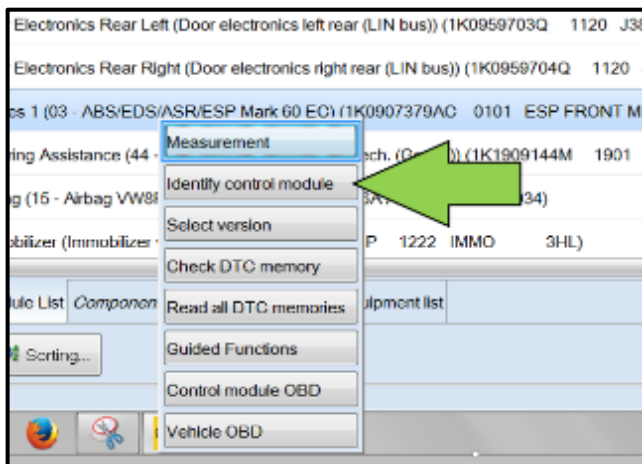
- After the software update is completed and before sending the GFF Log Online:
 - Select the "Control Module" tab.
 - Scroll down and right click on the module that was updated (0001).
 - Select "Identify Control Module" <arrow>.
