July 2017  
SF541AB

## Subject: Medallion Opti-View Instrument Panel Software Update

**Models Affected: Specific Freightliner Custom Chassis X-line motorhome chassis equipped with a Medallion Opti-View instrument panel, manufactured March 4, 2015, through March 6, 2017.**

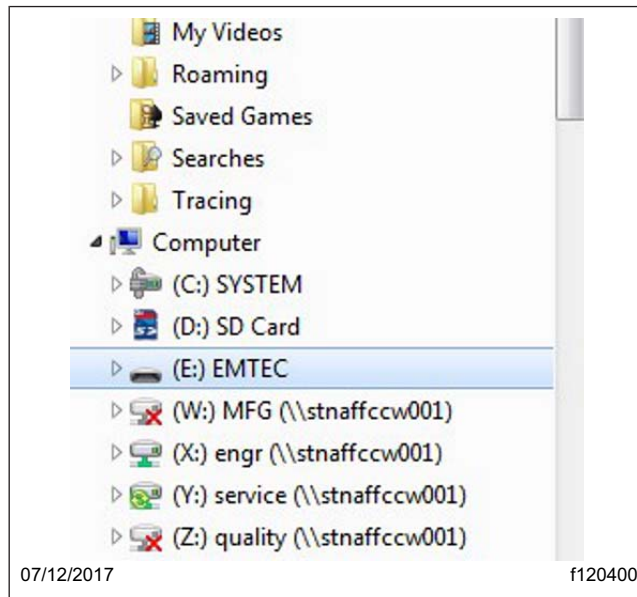
Fig. 1, Drive Letter Assigned to the Flash Drive

3. Install the correct flash drive (250k, 1 or 500k, 1) in an open port on the laptop. Make a note of the drive letter that flash drive was assigned (A:, B:, C:, etc.). See [Fig. 1](#).

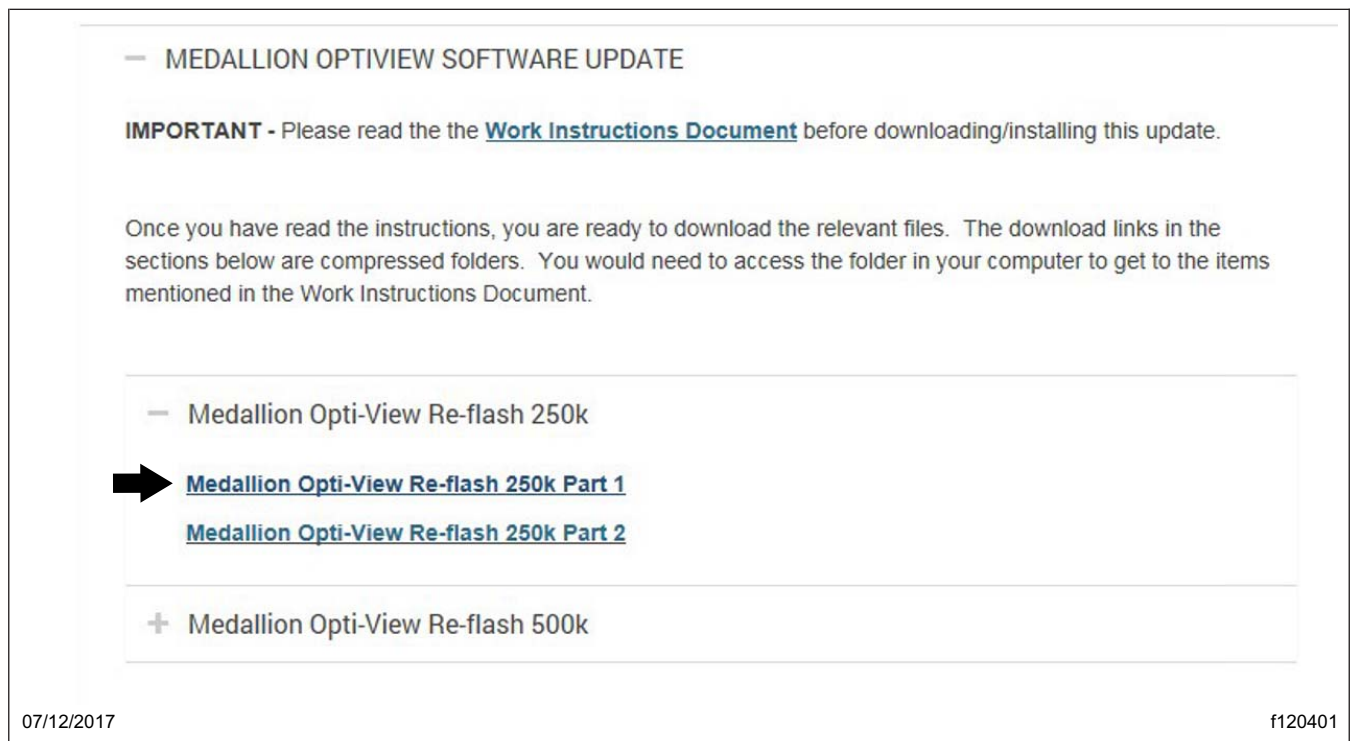
Fig. 2, Selecting the Medallion Opti-View Re-flash 250k Part 1

Select the part to download on the flash drive installed in the port. For example, "Medallion Opti-View Re-flash 250k Part 1." See [Fig. 2](#).

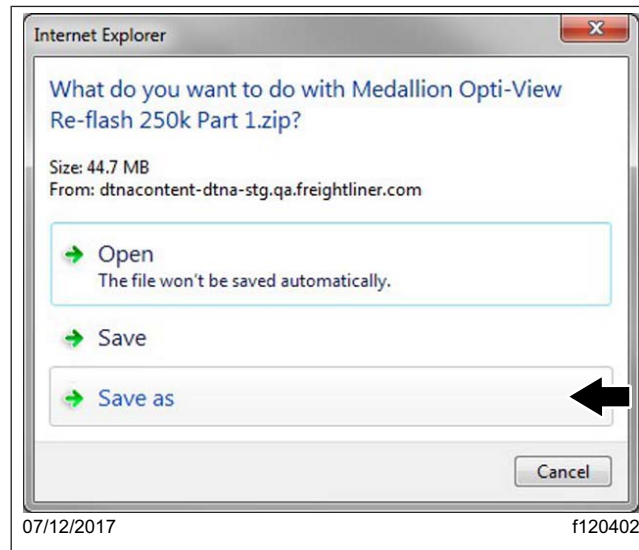
Fig. 3, "Save as" Screen

4. Select "Save as" and choose the drive letter from the previous step, then select "Save." See [Fig. 3](#) and [Fig. 4](#).

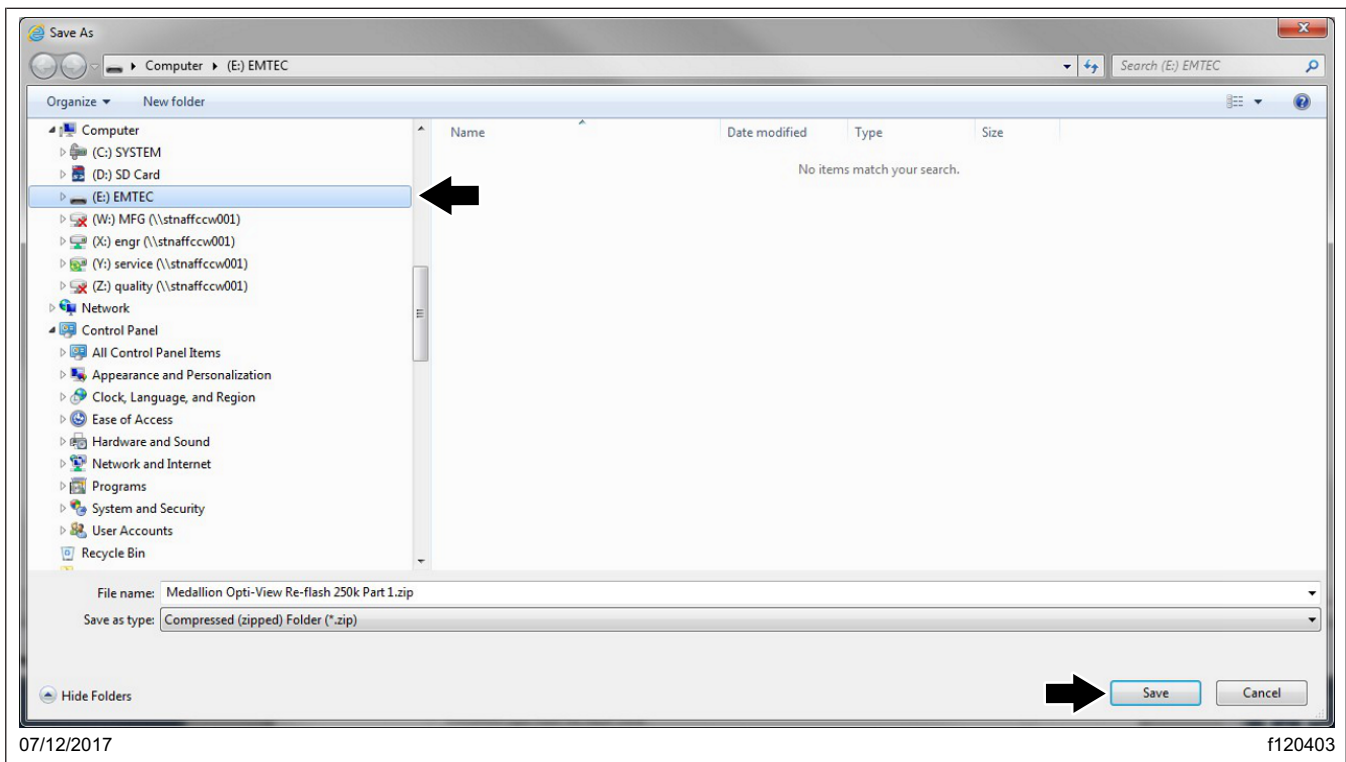
Fig. 4, Choosing the Drive Letter and Saving

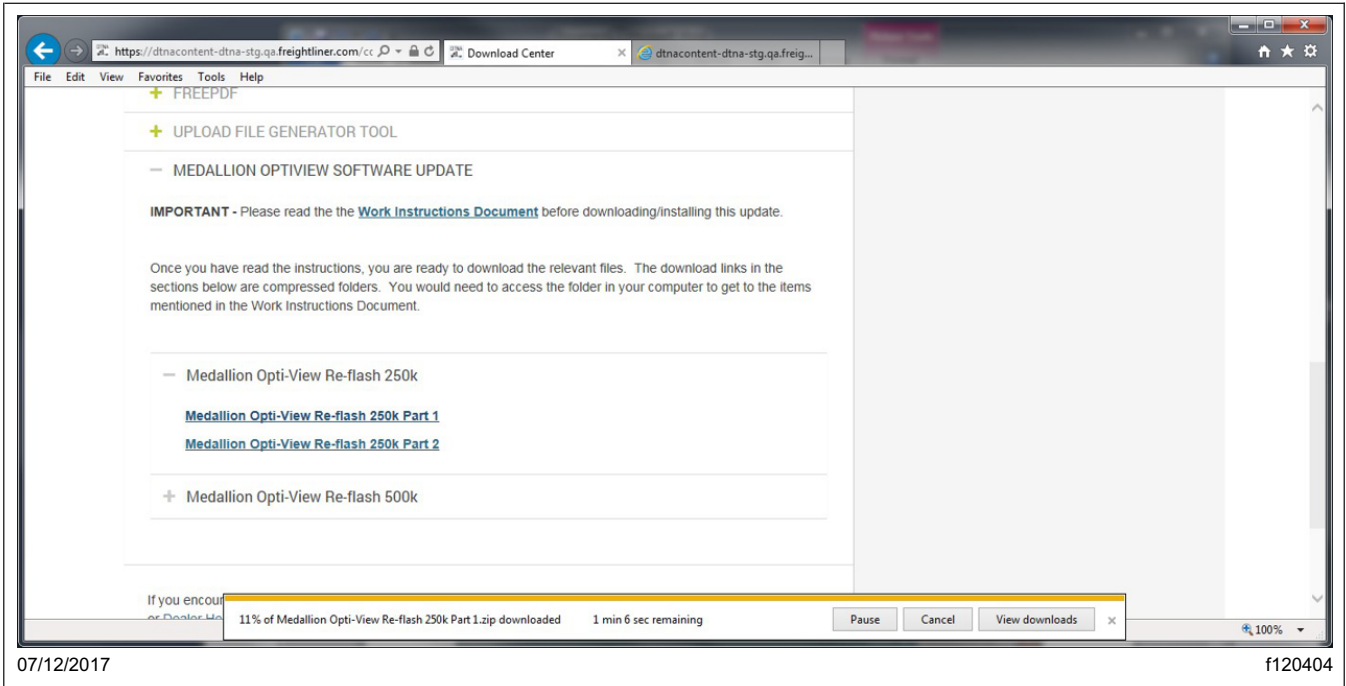
**Fig. 5, Download in Progress**

5. The download process begins and a progress window appears at the bottom of the screen. See [Fig. 5](#).

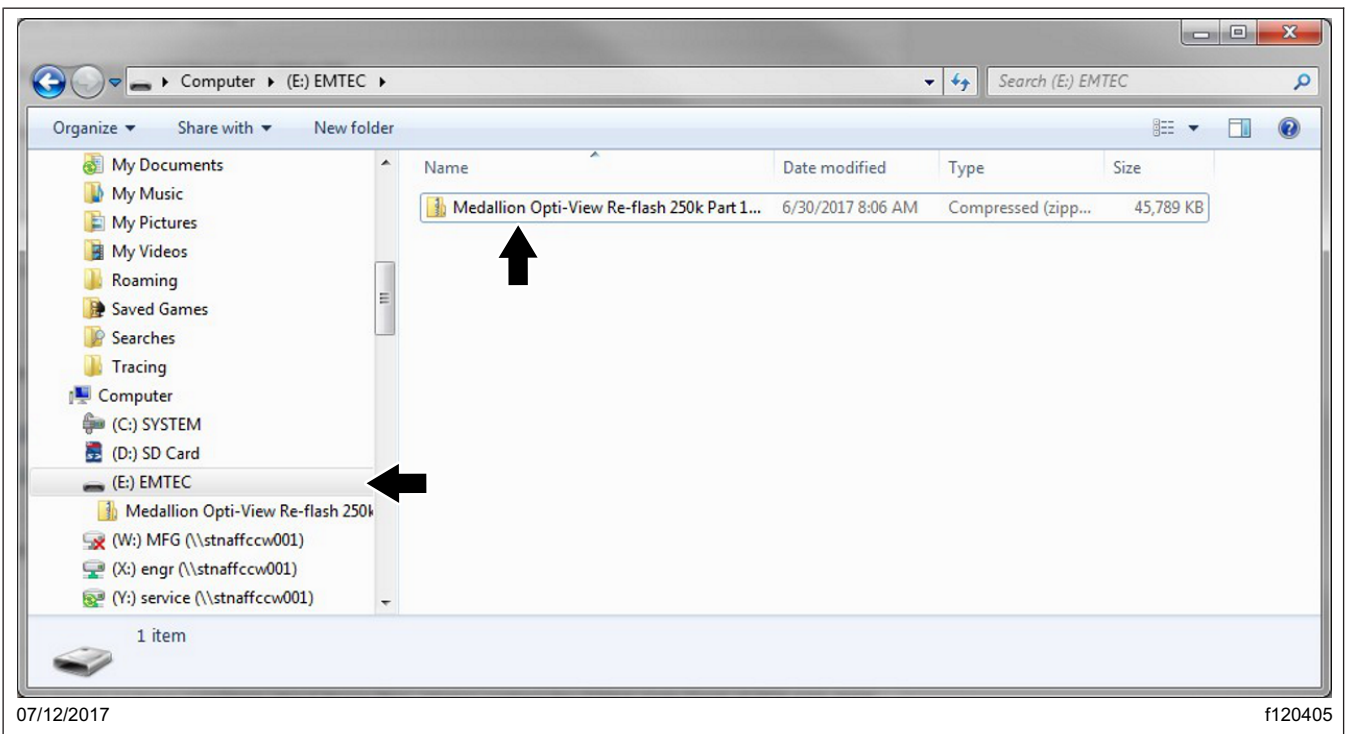
**Fig. 6, Verifying the Download**

6. When the download is complete, select "Open Folder" at the bottom of the screen and verify that it was downloaded to the flash drive. See [Fig. 6](#). In this example, "Medallion Opti-View Re-flash 250k Part 1" was downloaded on the flash drive marked "250k, 1" which was in drive E: on the laptop.

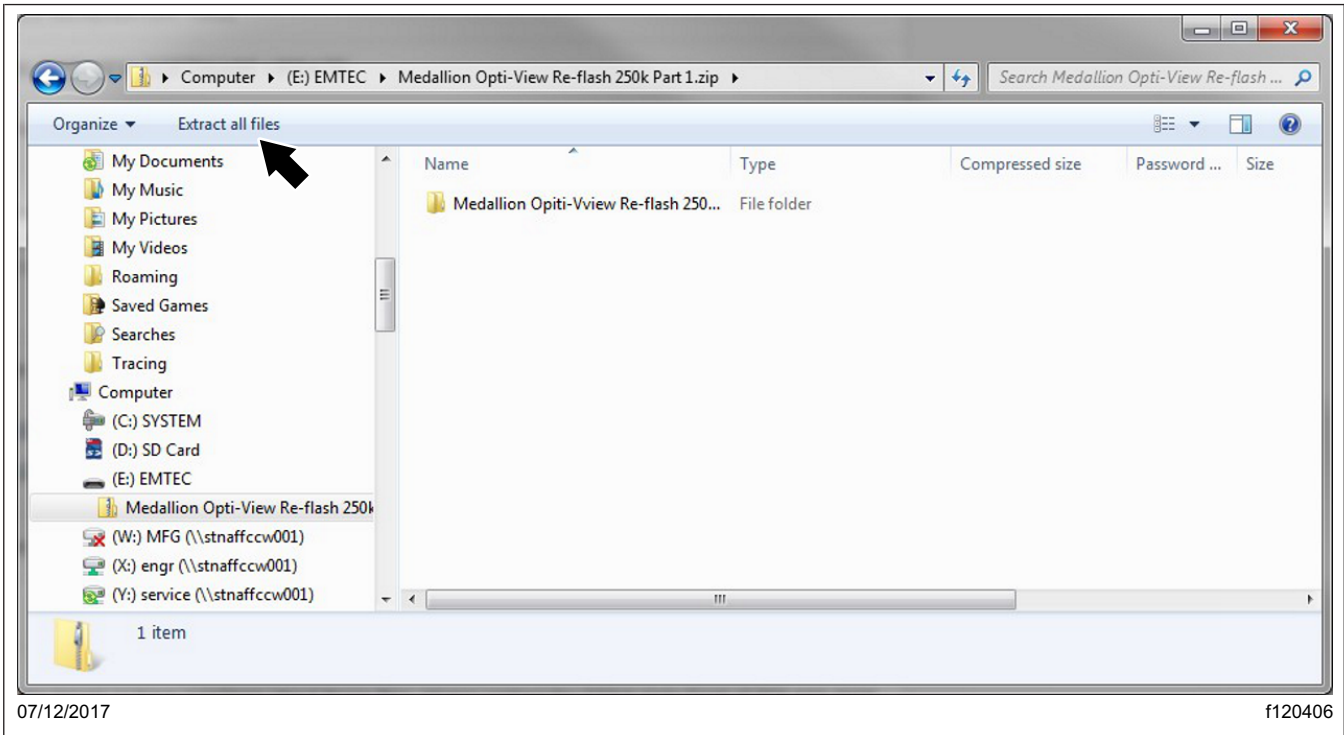
Fig. 7, "Extracting All Files" Screen

7. Double click the zip folder, then select "Extract all files." See [Fig. 7](#).

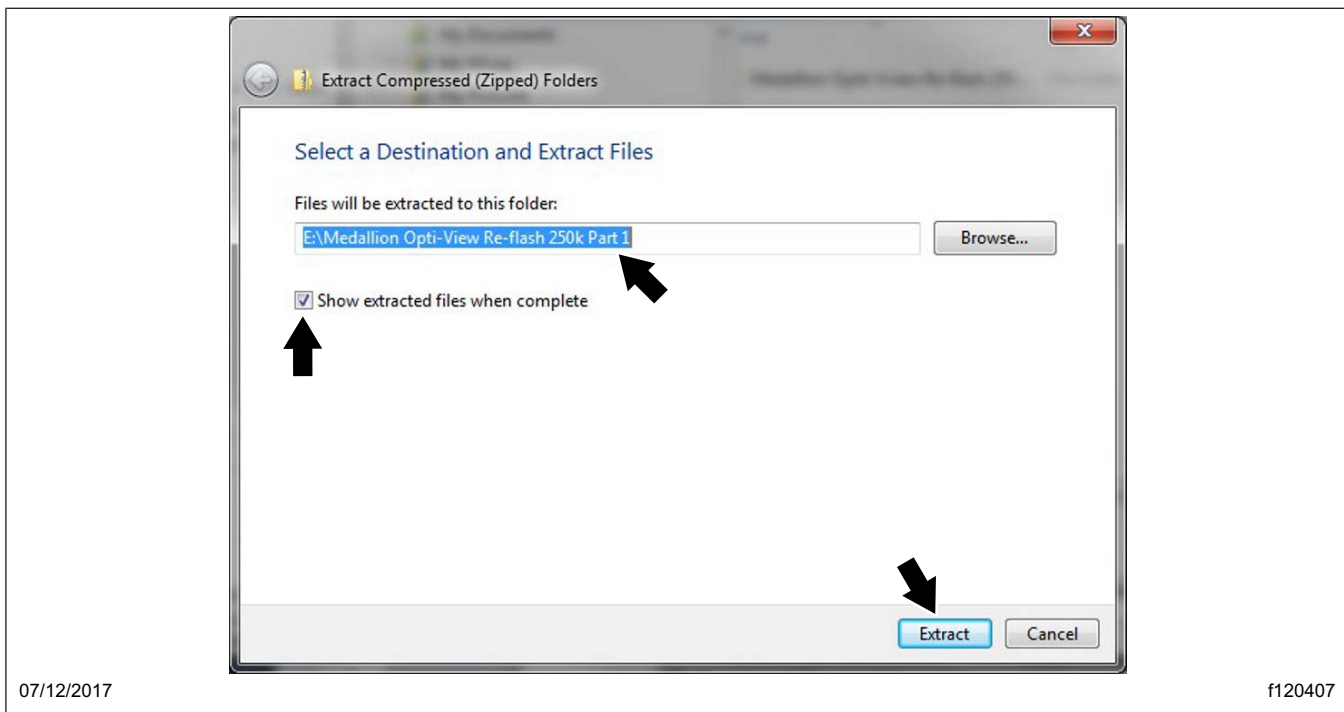
Fig. 8, Extracting Compressed (Zipped) Folders

8. In the next screen, allow the default location that appears (it should be the same as the zip folder location). Select the box labeled "Show extracted files when complete," then select "Extract." See [Fig. 8](#). The files will be unzipped. This process usually takes less than two minutes.

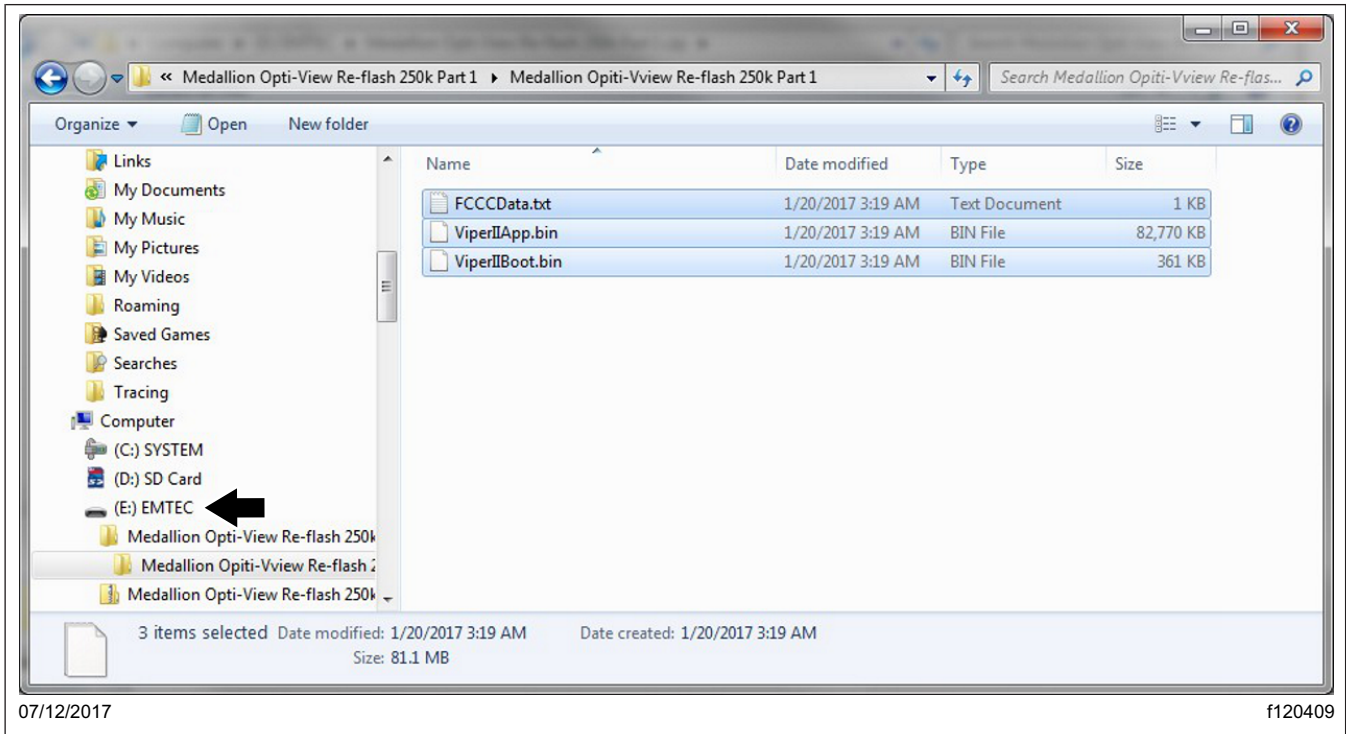
**Fig. 9, Copying Files in the New Folder**

9. Double click the folder that was created, then select and copy the three files inside the folder. Select the root drive letter of this folder. See [Fig. 9](#)

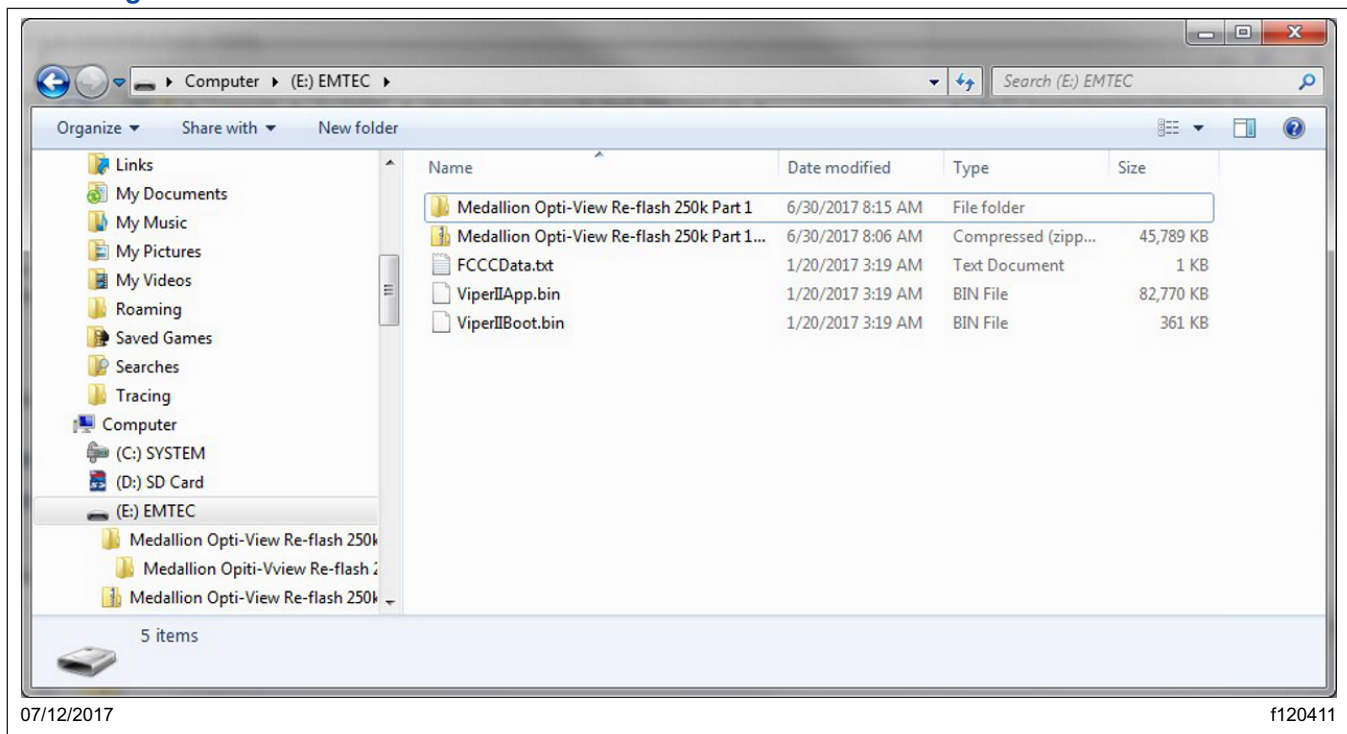
**Fig. 10, Deleting the Medallion Folders**

10. On the laptop, right click in an open area of the displayed window and select "Paste."
11. Delete the two Medallion folders shown in [Fig. 10](#). The three files are all that should be left on the drive. See [Fig. 11](#).

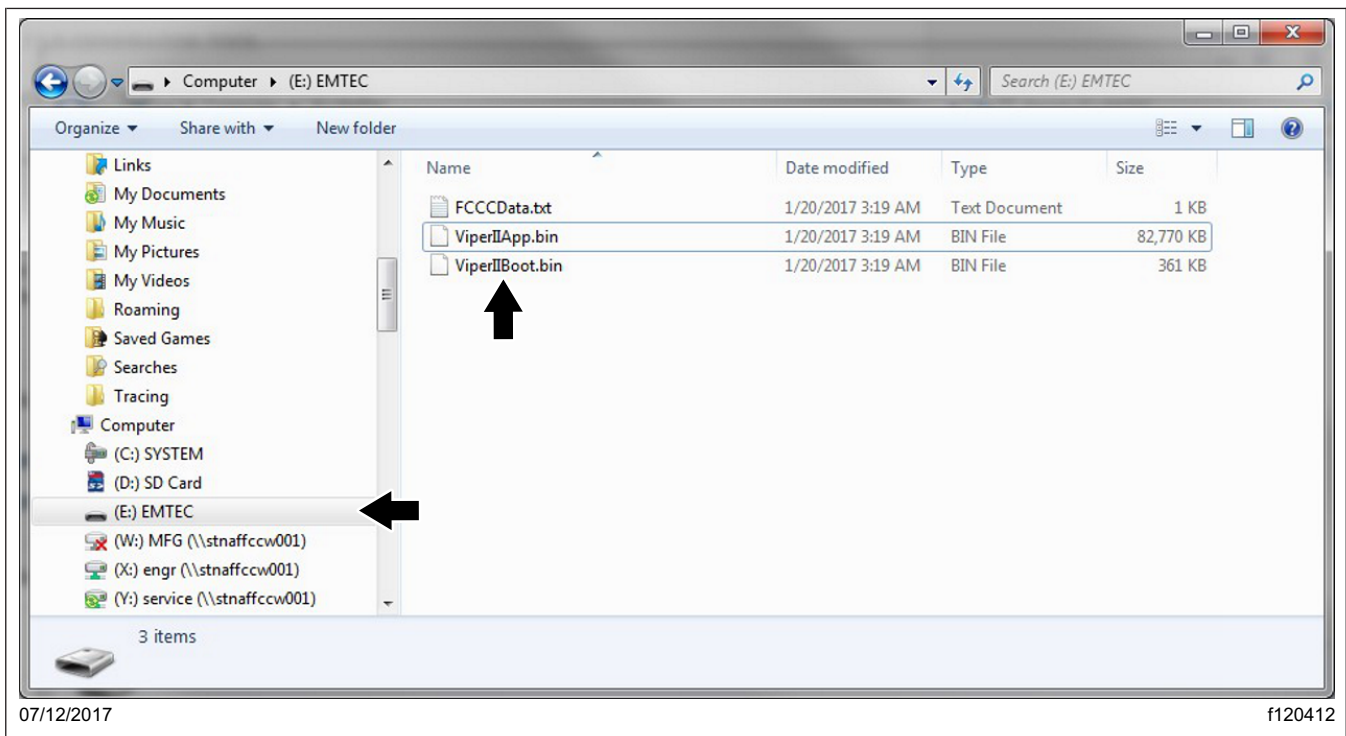
Fig. 11, Files Left on the Drive

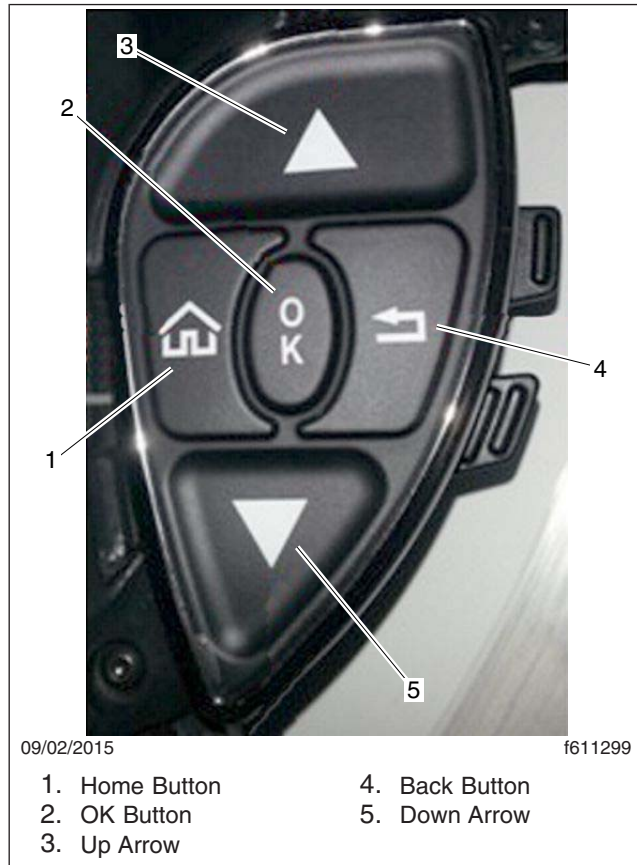
**Fig. 12, Menu Navigation Buttons**

4. Once the ECU is located, use the menu navigation buttons on the right-hand side of the steering wheel to access the Opti-View menu options. See [Fig. 12](#).
5. Press the home button, then press the down arrow and select "Diagnostics".
6. After selecting "Diagnostics," use the down arrow again and select "System Information," shown in [Fig. 13](#), then press the OK button.

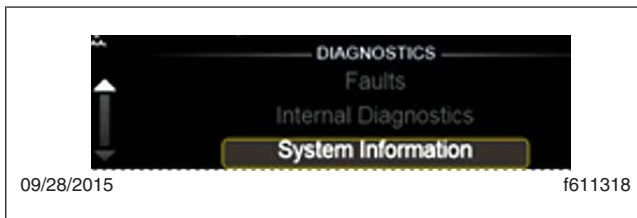
**Fig. 13, Selecting the System Information Sub-Menu**

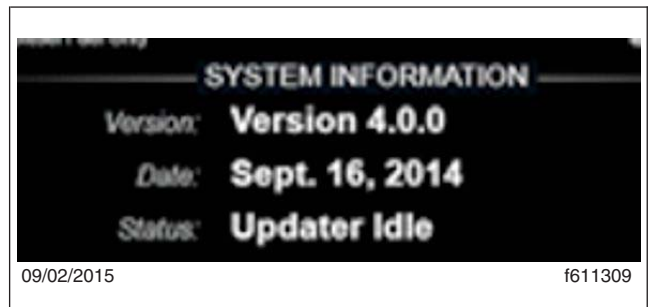
**Fig. 14, System Information**

System information will display in the center of the instrument panel. See [Fig. 14](#) for an example of the system information.

7. When "System Information" is displayed as shown in [Fig. 14](#), install the correct flash drive for the vehicle, 250k, 1 (for non-multiplex) or 500k, 1 (for multiplex), into either of the two USB ports. Press and hold the OK button until the ECU begins the software update. Once the software update begins, release the OK button.
