EL18-024b

ITB18-041b

2019 QX50; AUDIO SYSTEM WILL NOT TURN ON AND/OR SCREENS FREEZE UP AFTER HANGING UP A PHONE CALL

APPLIED VEHICLES: 2019 QX50 (J55)

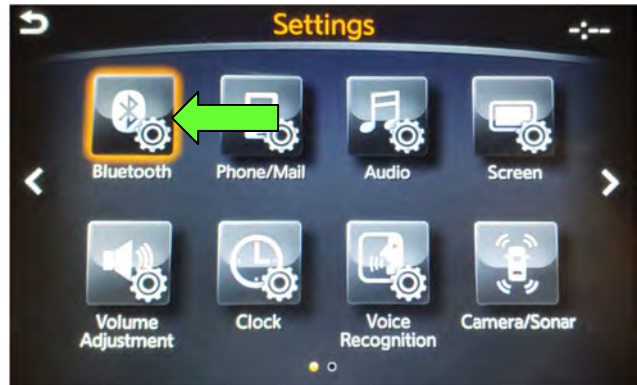
Figure 10

20. Open the Settings Menu and then select **Bluetooth**.

- The settings menu is accessed by selecting the settings app icon on the lower display.

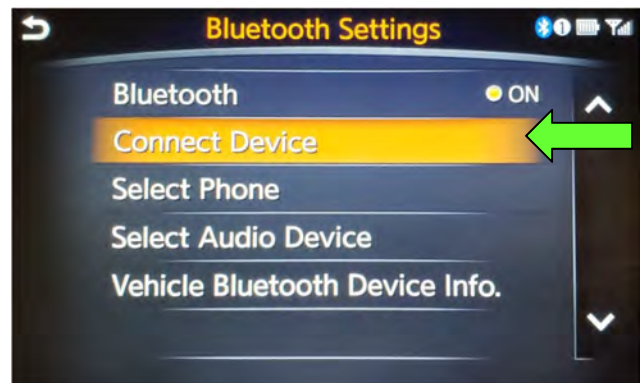
Figure 11

21. Select **Connect Device** from the Bluetooth Settings menu.

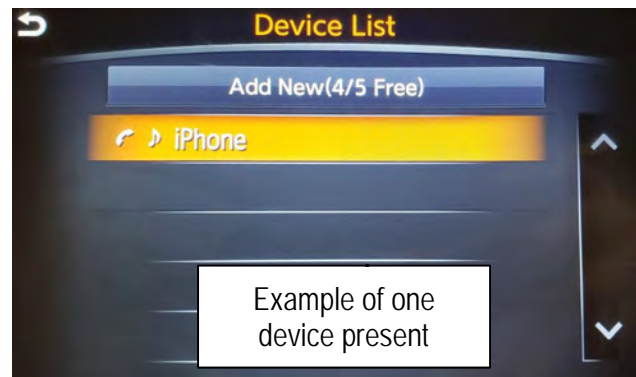
Figure 16

24. Are any devices still present in the Device List?

- **YES:** Select a device and then perform step 23 and 24 again.
- **NO:** Proceed to step 25.
