GROUP Product Improvement	MODEL See Model List on Page 1
NUMBER PI1803W/X (Rev 4, 04/10/2019)	DATE November 2018

PRODUCT IMPROVEMENT CAMPAIGN

SUBJECT: ENGINE REPLACEMENT INSTRUCTIONS
FOR DTC P1326 (PI1803W/X)

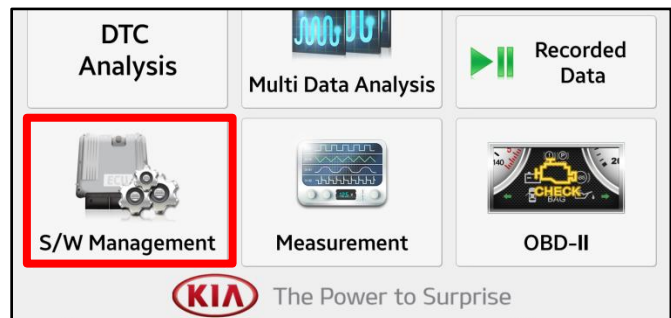
- From the KDS Home Screen, select S/W Management.

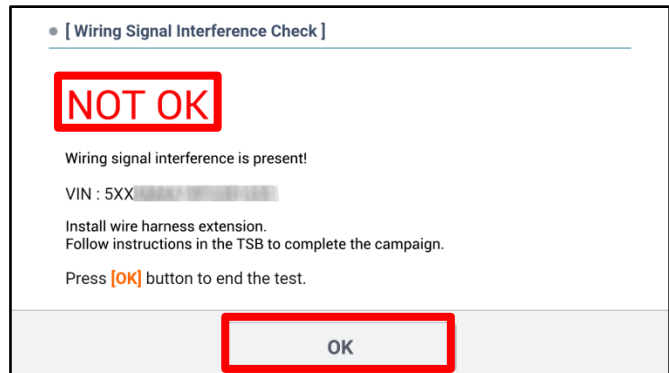
- If the result is "OK", **clear DTC P1326** and then proceed to the Engine Noise Inspection procedure below.

- If the result is "NOT OK", turn the engine off and proceed to **step 2** of the Knock Sensor (KS) Extension Harness Installation procedure on page 12.

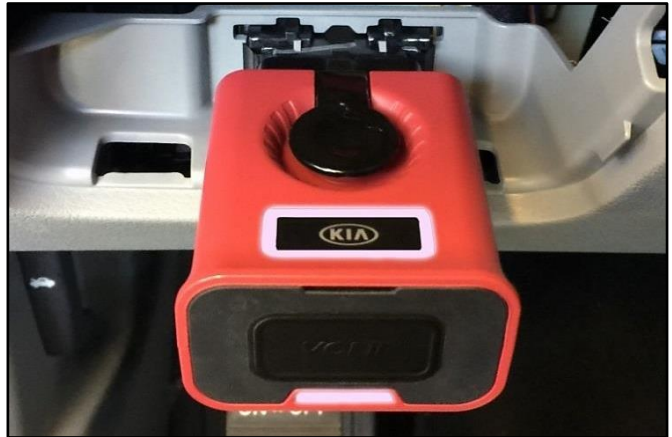
7. Connect the VCI-II to the OBD-II connector and launch the KDS application from the KDS tablet home page.

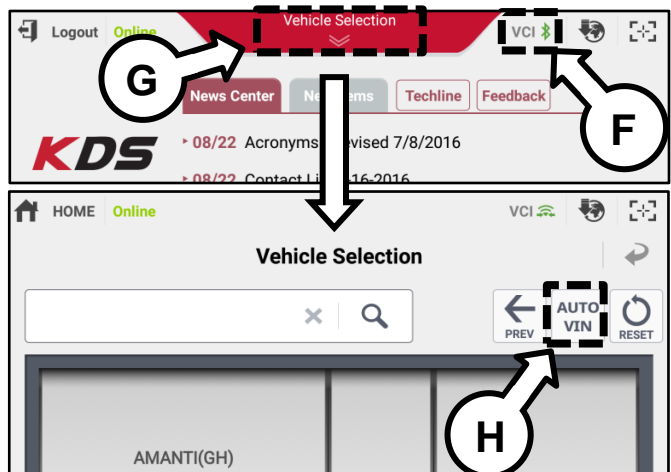
8. Confirm communication with VCI (F) and then configure the vehicle (G) using the **AUTO VIN** (H) feature.

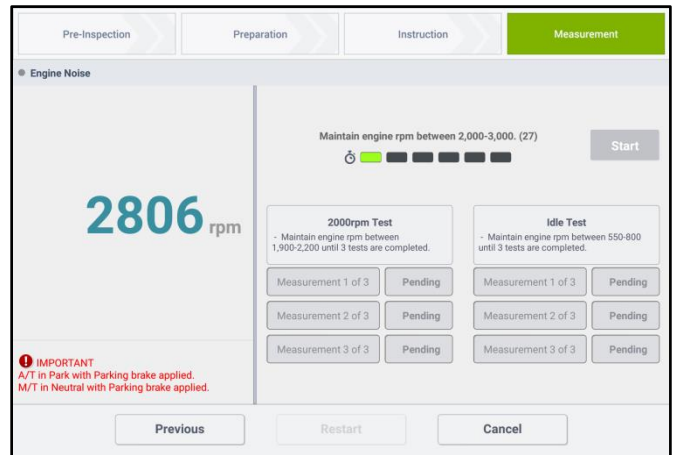
Once the RPM is in the specified range, the time count (green bars) will be initialized.

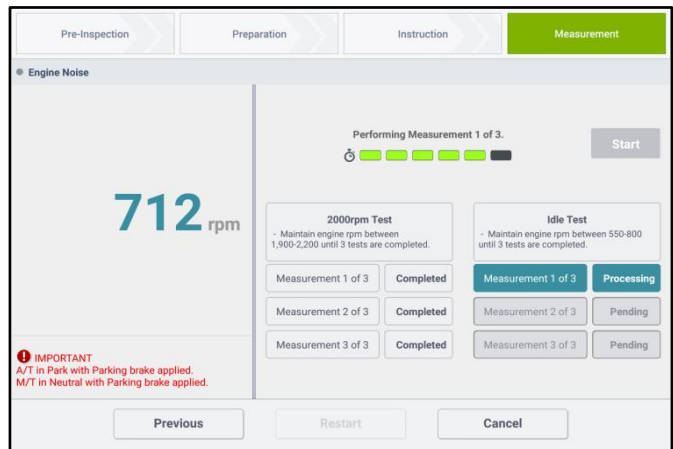
- The “Idle Test” will automatically begin. Keep the engine at idle and wait until all three (3) measurements are complete.

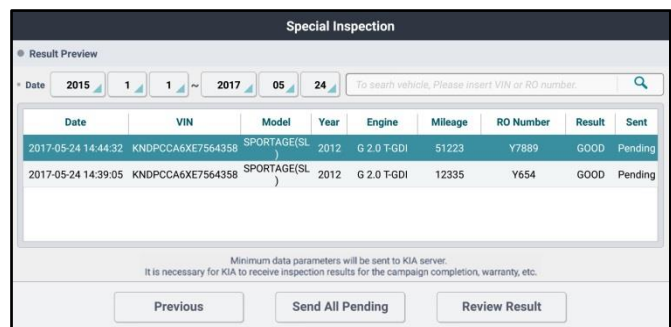
20. Select “Finish” to complete the engine noise inspection. Ensure the KDS is connected to the internet and the “Special Inspection” KDS application is open to automatically submit the results to the Kia Server. To save and/or print the results as PDF, select “Print”.

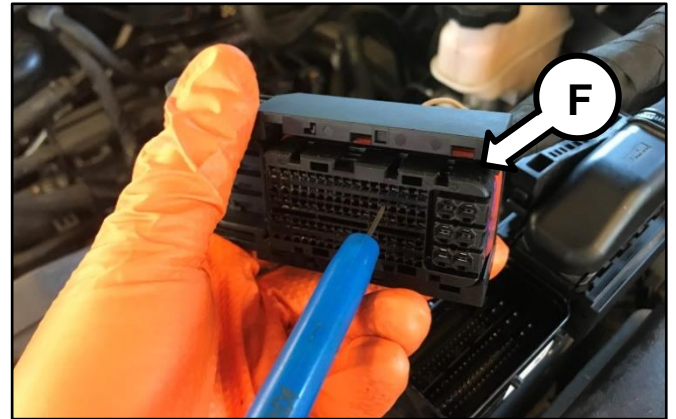
9. Remove the three (3) terminals **one at a time** and insert the new terminals of the extension harness into the ECU connector (F). Reinstall pin retainer (K) and reassemble the connector (F).

Pin	Extension Wire Color
44	Blue
45	Black
62	Red

NOTE: Be sure to note the rotational position of the terminals during removal. They are directional and need to be reinstalled in the same “clock” position.

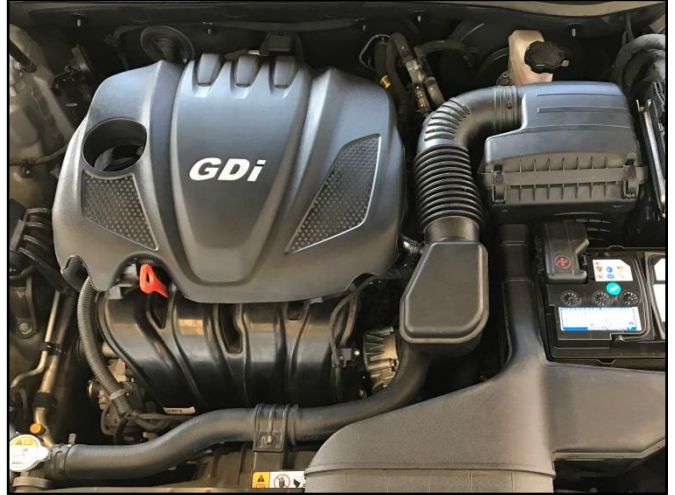
1. Remove the engine assembly by referring to the “Engine And Transmission (Transaxle) Assembly → Engine And Transmission (Transaxle) Assembly → Repair procedures” chapter in the applicable Shop Manual on KGIS.

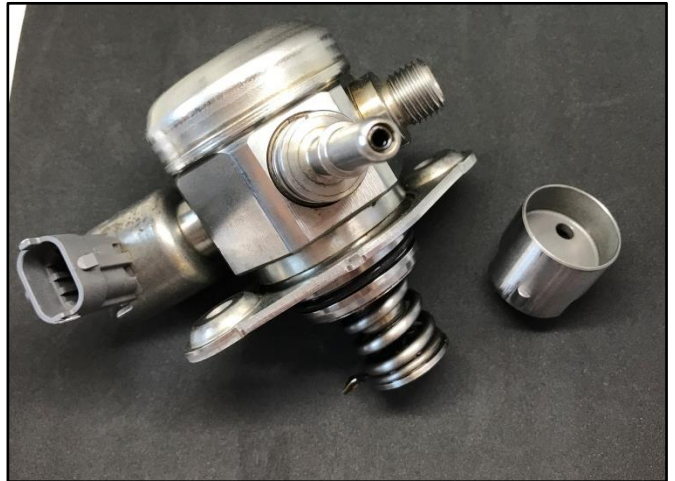
Tightening torques of pipe flare nut:

**19.5 – 23.9 lb.ft (26.5 – 32.4 N.m,
2.7 – 3.3 kgf.m)**
