SiriusXM[®] Radio Stops Working for Subscribers After the Trial Period and Apple CarPlay[™] Will Not Launch

Supersedes 18-082, dated August 10, 2018. See REVISION SUMMARY.

Year	Model	Trim	VIN Range
2018	Fit	Sport, EX, EX-L, and EX-L With Navigation	ALL

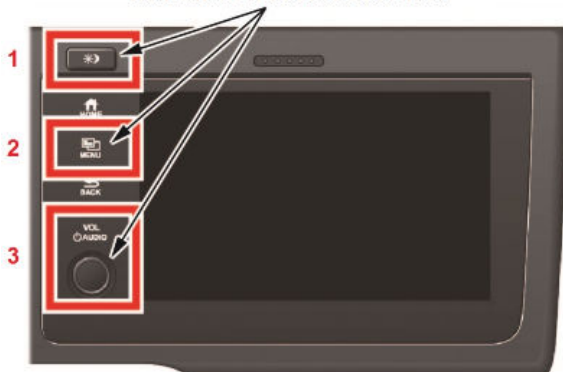
3. Once the download is complete, return to the vehicle.
4. Verify the software version.
 - 4.1. From the home screen, press the Day/Night button, **MENU** icon, and VOL/Power/AUDIO knob in sequence and hold them for about **5 seconds**.

Press these in sequence and hold them for about 5 seconds.

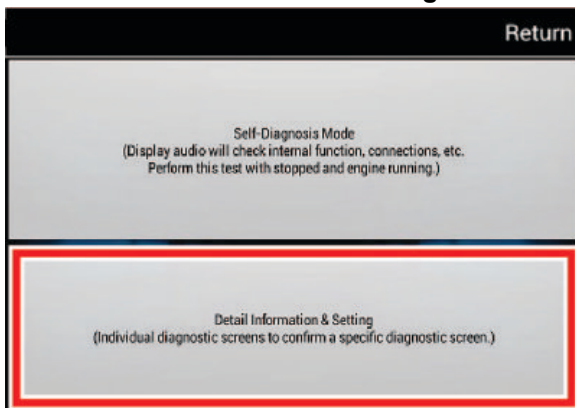
4.2. Select **Detail Information & Setting**.

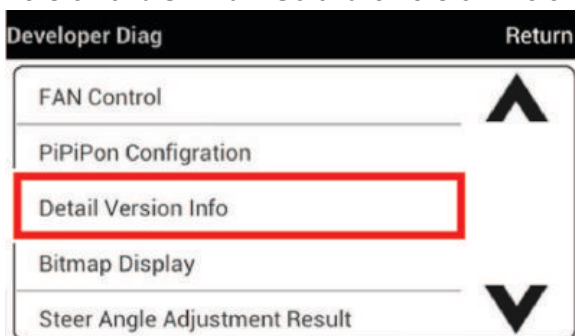
4.3. From the **Detail Information & Setting** screen, press and hold the **MENU** icon for **5 seconds** until the display transfers to the **Developer Diag** screen.

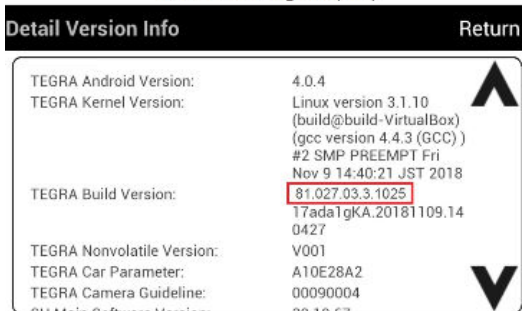
Models With Navigation (DA+)

4.4. From the **Developer Diag** screen, select **Detail Version Info**. Then, confirm the current **TEGRA Build Version** and **SH Main Software Version**. Refer to the tables below for current and new versions.

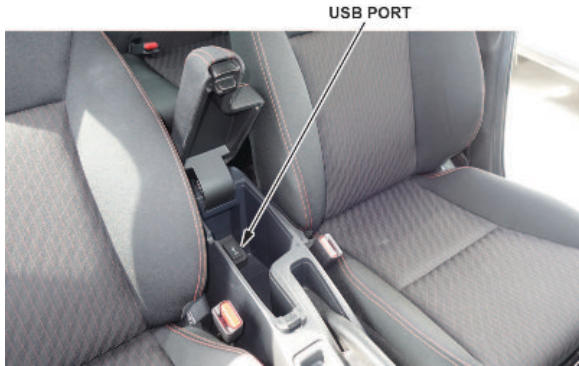
- Once the software update is downloaded onto the USB flash drive, insert it into the USB port.

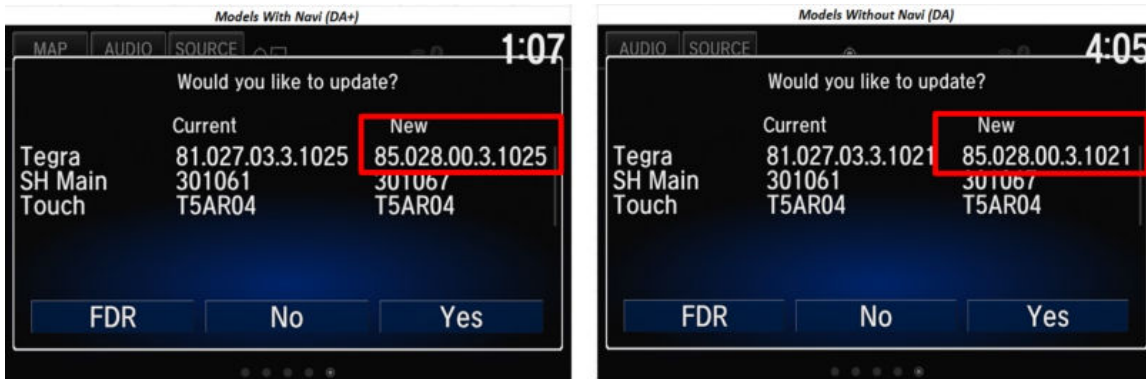
- A screen will automatically appear with the prompt **Would you like to update?**. Make sure each software version of **Tegra/Touch** in the **New** section are correct. Select **Yes** to update the software.

If the screen does not appear, the software may not have correctly downloaded onto the USB flash drive. Try to download the software again.

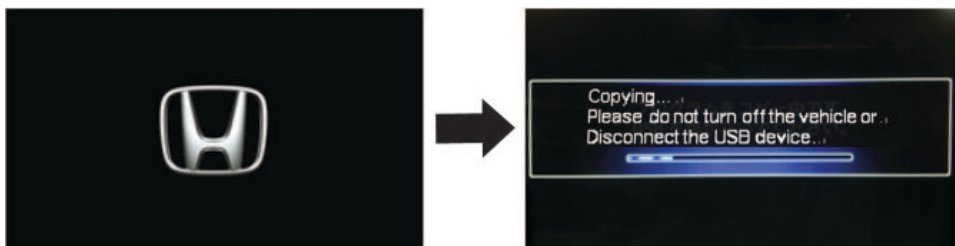
- After selecting **Yes**, the unit will reboot and the version update will start. The screen below will display for about **30 minutes**.

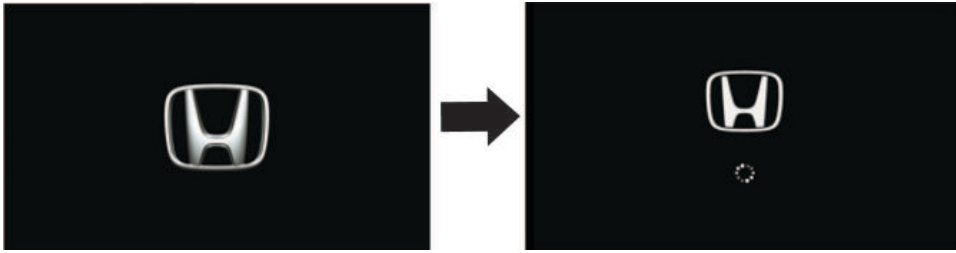
8. Once the update is complete, the unit will reboot again. Remove the USB drive tool from the port.

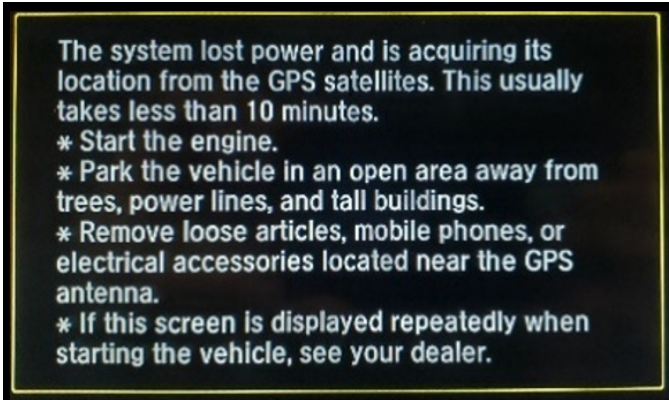
9. After the update is complete, the following screen will appear. To bypass this screen, press and hold the Day/Night button and **Home** icon.

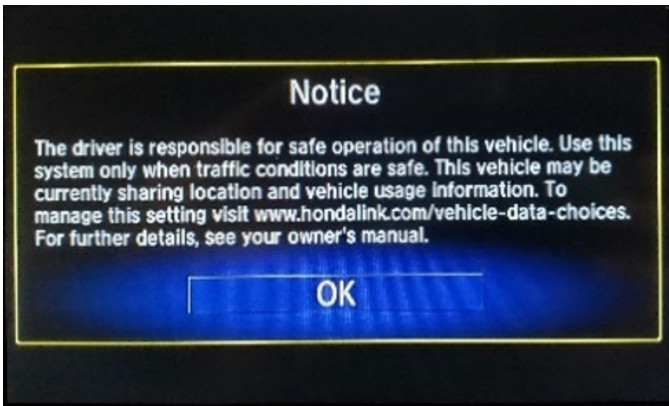
10. Select **OK**.

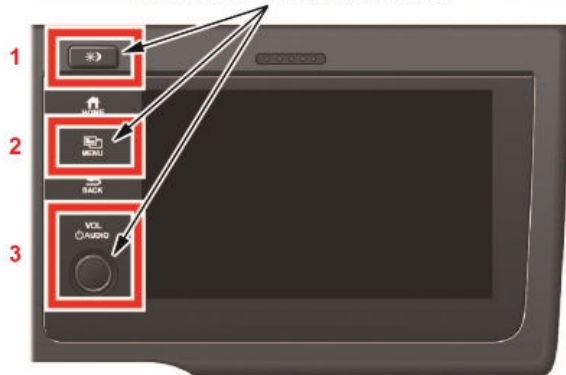
1. From the HOME screen, press the Day/Night button, **MENU** icon, and VOL/Power/AUDIO knob in sequence and hold them for about **5 seconds**.

Press these in sequence and hold them for about 5 seconds.

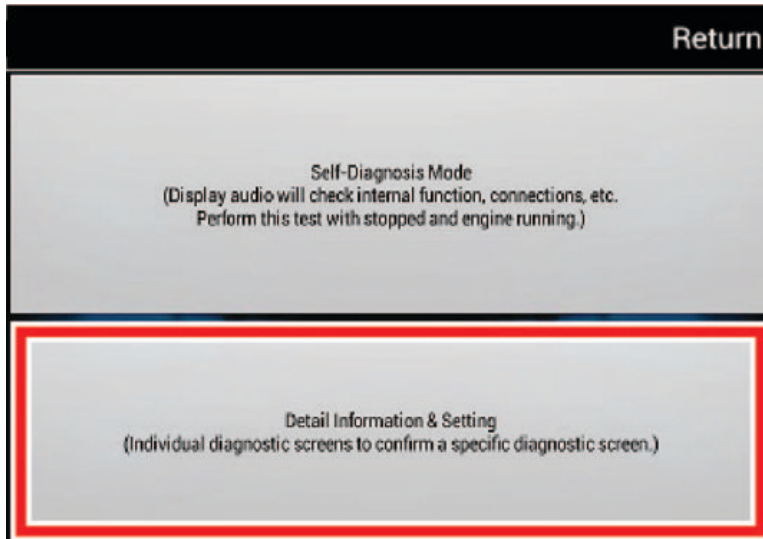
2. Select **Detail Information & Setting**.

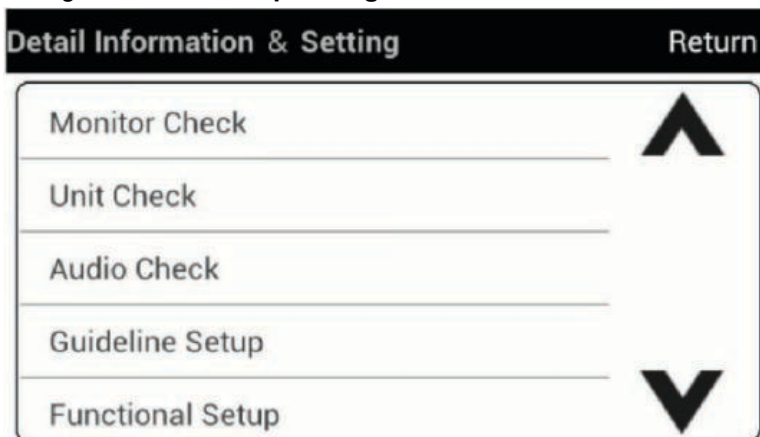
3. From the **Detail Information & Setting** screen, press and hold the **MENU** icon for **5 seconds** until the display changes to the **Developer Diag** screen.

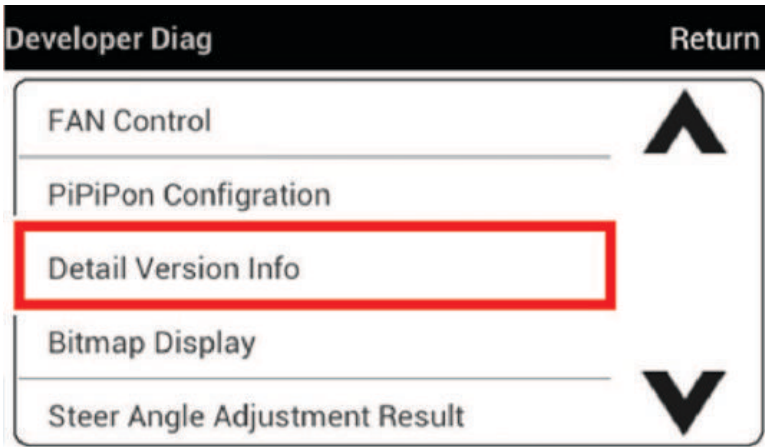
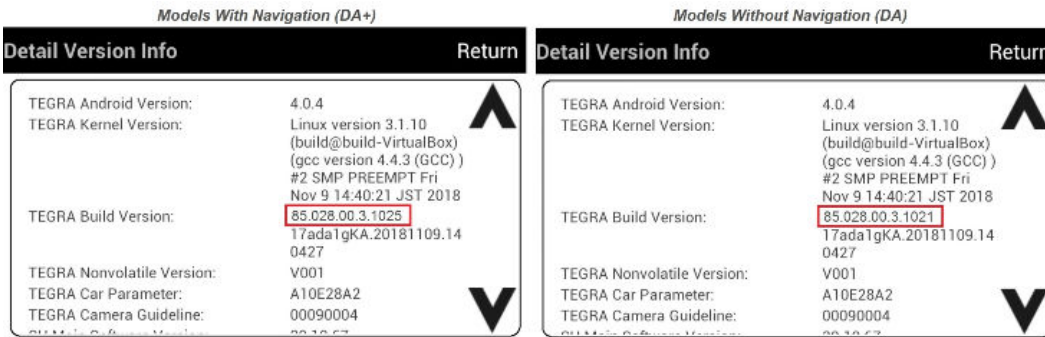
4. From the **Developer Diag** screen, select **Detail Version Info** and confirm the **TEGRA Build Version** and **SH Main Software Version**.

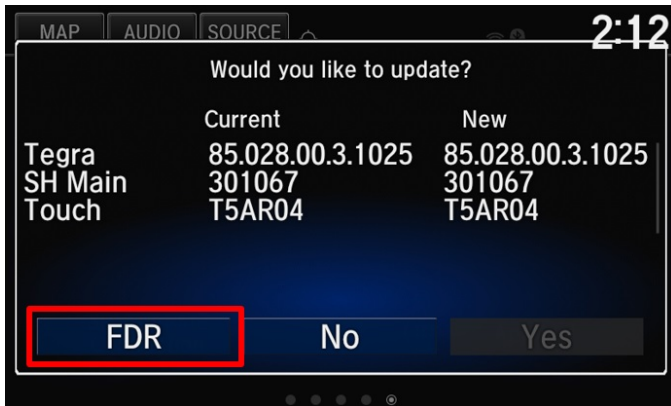
5. Insert the USB flash drive into the USB port to start the factory data reset (FDR) procedure.
6. A screen will automatically appear with the prompt **Would you like to update?**. Select **FDR**.

The FDR takes about **3 minutes** to complete.

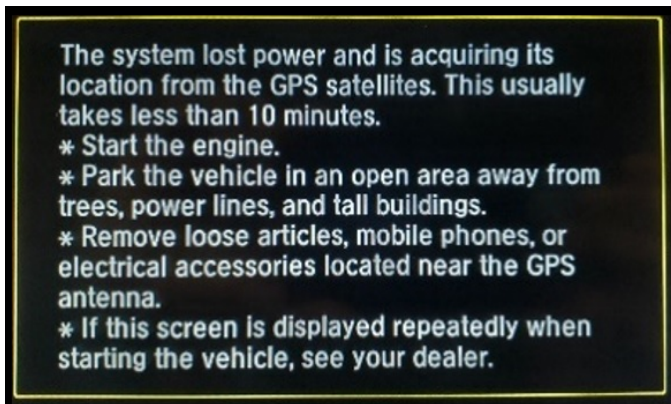
7. After the FDR is complete, the following screen will appear. To bypass this screen, press and hold the Day/Night button and **Home** icon.

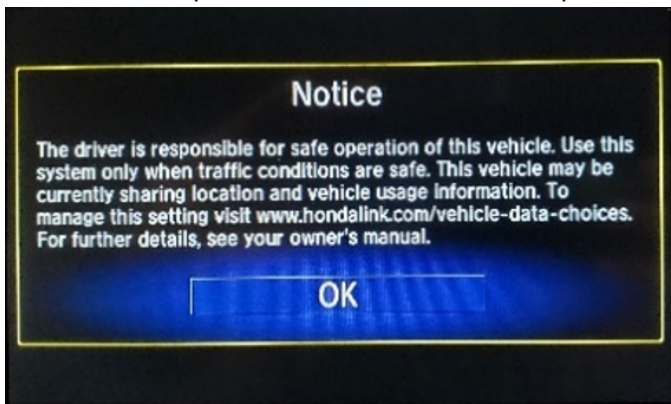
8. Select **OK**, and park the vehicle outside in an open area to acquire the GPS signal.
