PRODUCT CAMPAIGN BULLETIN

APPLICABILITY: 2018 Model Year Legacy, Outback, and BRZ Vehicles

NUMBER: WTZ-85R

SUBJECT: Harman Kardon Head Unit FMVSS 111 Noncompliance Recall

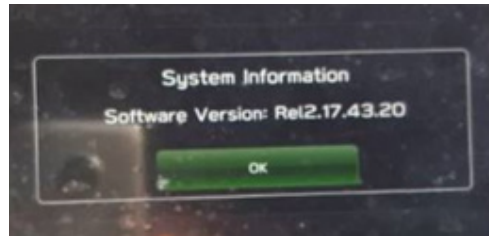
(EXAMPLE photo)

- Confirm the current Software Version ID. If the Current Version is **Rel_UO.18.43.20**, **STOP** as this latest update has already been installed. Otherwise, proceed to **Step 2** below.
