MODEL
2019MY
Forte (BDm)

NUMBER
204 (Rev 1, 05/24/2019)

TECHNICAL SERVICE BULLETIN

SUBJECT: SERVICE ACTION: ECU LOGIC IMPROVEMENT
FOR P0300, P0301, P0302, P0303, P0304 AND/OR P219C00,
P219D00, P219E00, P219F00 (SA378)

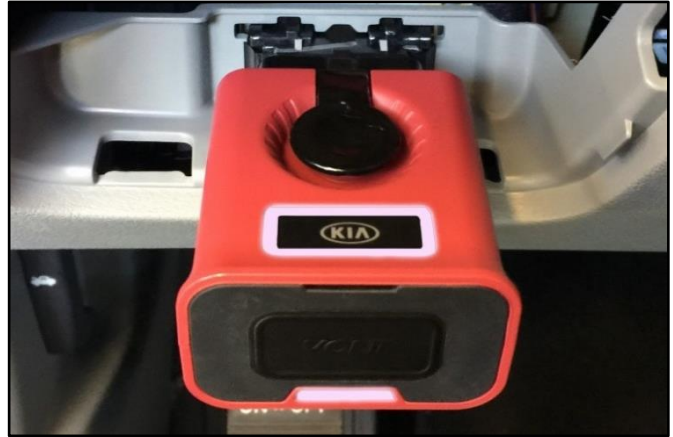
2. With the ignition ON, turn ON the KDS tablet. Select **KDS** from the home screen.

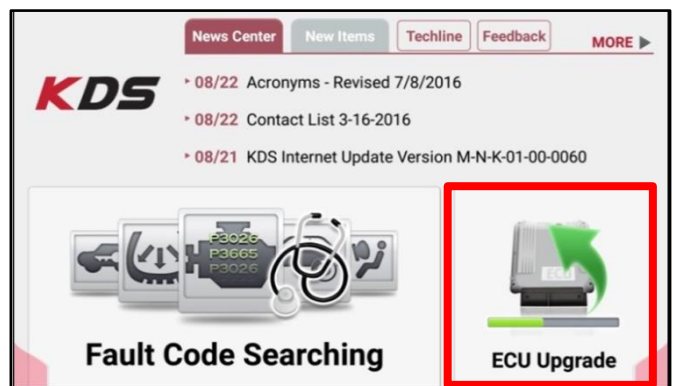
- The KDS will check the server for recently uploaded Events and then automatically download **Upgrade Event #406**.

The vehicle must be identified in Vehicle Selection to download an Event for that vehicle.

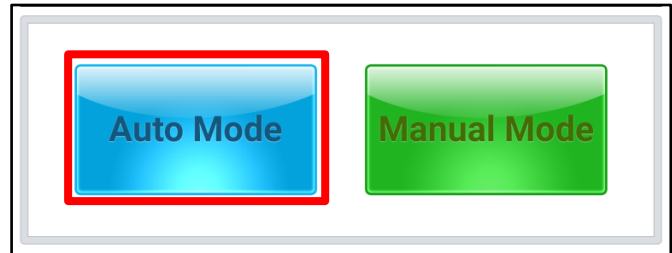
- Select the **Engine** system under the System selection menu.

Touch **ID Check (D)** and confirm that the latest update is available.

Select **Upgrade Event #406** and select **Upgrade** to continue.

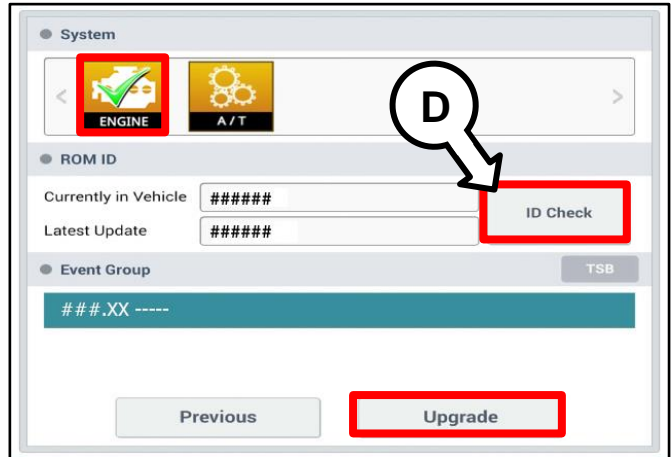
- The ECU upgrade will begin and the progress of the upgrade will appear on the bar graph. Upgrade part (1/2) (E) will download the upgrade event to the VCI-II. Upgrade part (2/2) (F) will upgrade the ECU.

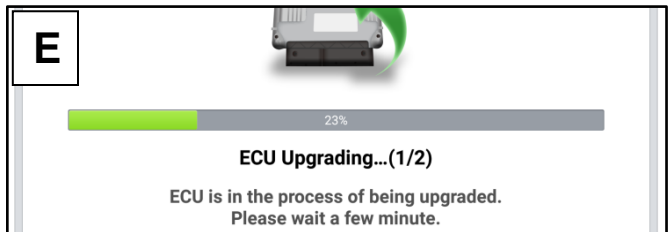
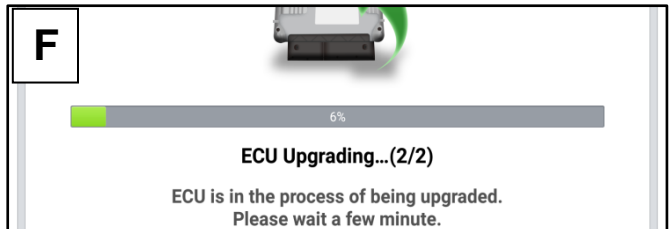
9. If a “Communication Fail” screen appears, verify that the VCI-II and KDS are communicating properly. Touch **OK** and restart the procedure from step 4.
