GROUP TRA	MODEL 2019MY Sorento (UMa)
	NUMBER 082	DATE May 2019
TECHNICAL SERVICE BULLETIN		
SUBJECT: SERVICE ACTION: 3.3 GDI 8AT TCU LOGIC IMPROVEMENT FOR DTC P0741 (SA387)

This bulletin provides the procedure to improve logic of the TCU (Transmission Control Unit) software on some 2019MY Sorento (UMa) 3.3L vehicles produced from January 24, 2018 to March 26, 2019, which may experience a malfunction indicator lamp (MIL) ON with DTC P0741. To correct this concern, apply the improved logic to the TCU using the KDS ECU Upgrade function as described in this bulletin. For confirmation that the latest reflash has been applied to a vehicle you are working on, verify the ROM ID using the table on page 2 of this bulletin. Before conducting the procedure, verify that the vehicle is included in the list of affected VINs.

DTC: P0741 – Torque Converter Clutch Circuit Performance or Stuck Off

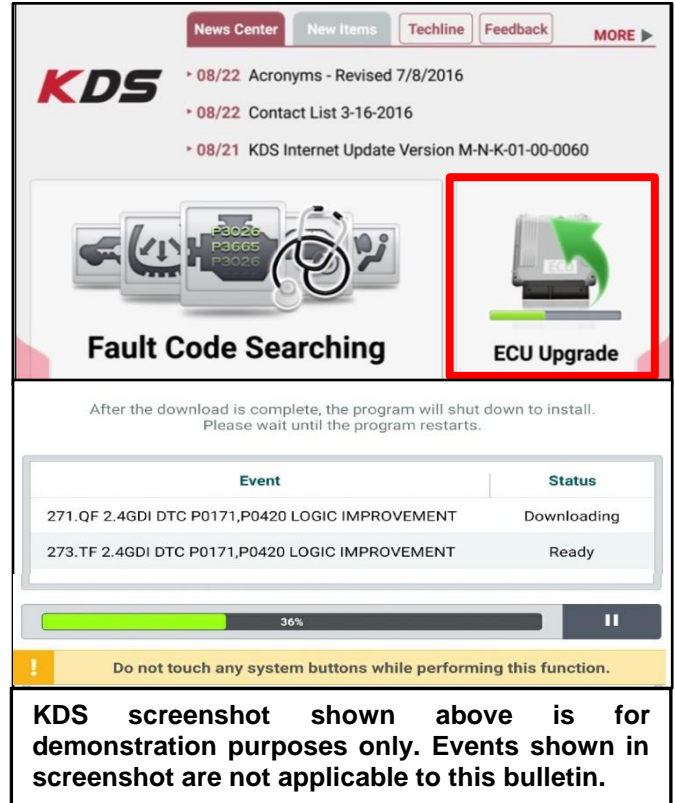
4. Select **ECU Upgrade**.
