GROUP <b>ENG</b>	MODEL <b>2017-2018MY Forte (YDm)</b>
	NUMBER <b>208</b>	DATE <b>June 2019</b>
<b>TECHNICAL SERVICE BULLETIN</b>		
SUBJECT: ECU LOGIC IMPROVEMENT FOR P0300, P0301, P0302, P0303, P0304 AND/OR P219C00, P219D00, P219E00, P219F00

This bulletin provides the procedure to improve the logic of the Engine Control Module (ECM) on some 2017-2018MY Forte (YDm) vehicles, produced from May 15, 2016 through July 27, 2018, which may experience a malfunction indicator lamp (MIL) ON with DTC P0300, P0301, P0302, P0303, P0304 and/or P219C00, P219D00, P219E00, P219F00. To correct this concern, apply the improved logic to the ECU using the KDS ECU Upgrade function as described in this bulletin. For confirmation that the latest reflash has been applied to a vehicle you are working on, verify the ROM ID using the table on page 3 of this bulletin.

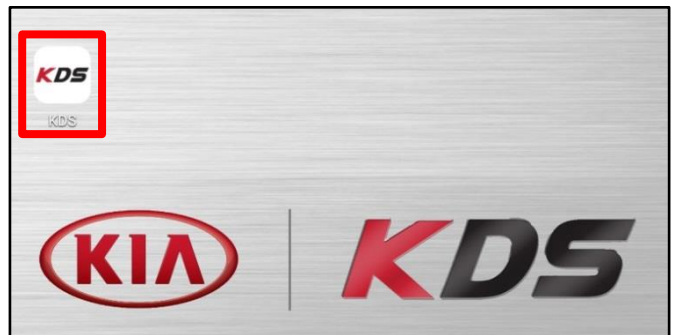
2. With the ignition ON, turn ON the KDS tablet. Select **KDS** from the home screen.
