July 4, 2019

Version 1

2015-18 Fit LX: *Bluetooth*[®] HandsFreeLink[®] Will Freeze After Calls and Voice Tags are Missing at Startup

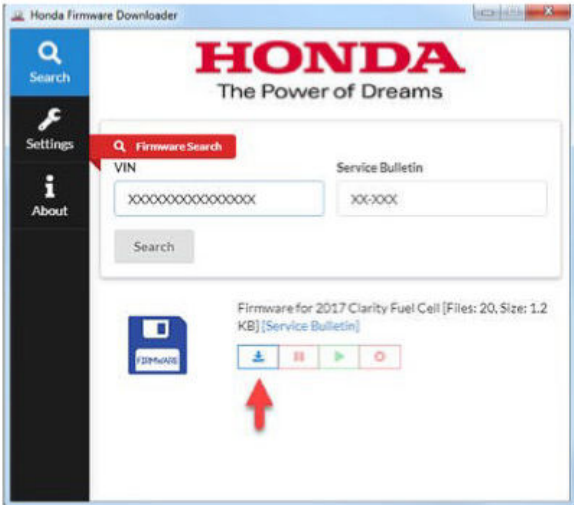
1. From your computer's desktop, open Honda Firmware Downloader. Refer to job aid *Honda Firmware Downloader* for additional information. Make sure that the USB flash drive tool is empty and formatted to FAT 32.
2. Enter the VIN. This is important as the software can be different depending on the model year level. Enter the service bulletin number, then select the download icon when the correct software is found.

The software download may take up to **10-15 minutes** depending on the size of the file.

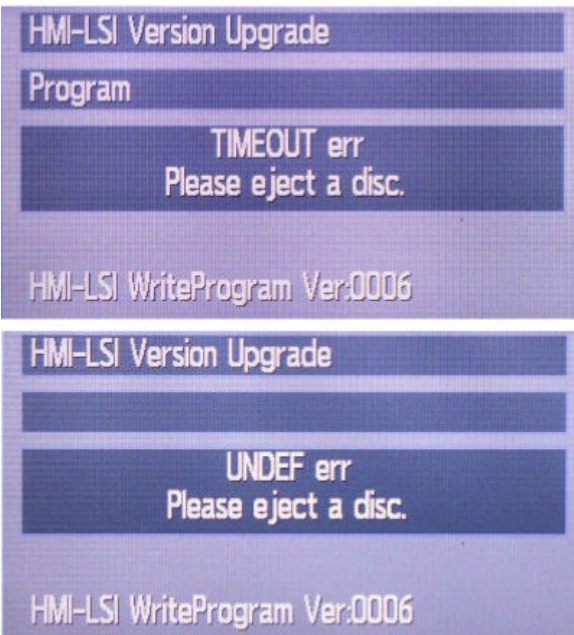
3. Once the download is complete, return to the vehicle.
4. Verify the software version. Download the update software to the vehicle's USB that will be used.

If at any time during the update process a **TIMEOUT err** or **UNDEFINE err** message appears, check the USB flash drive for damage, or use a different one.

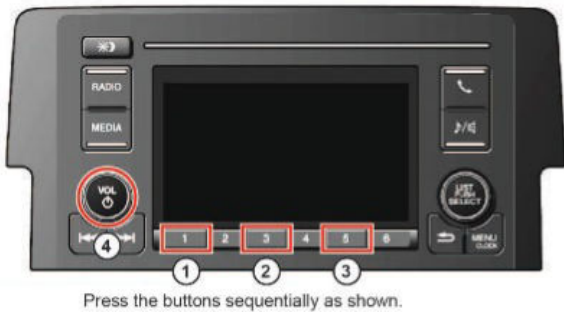
6. With the audio unit turned off, press the buttons in order as shown.

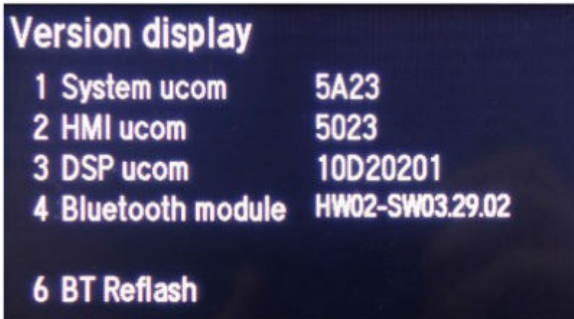
This will let you view the **Version display** screen and verify the candidate software version is up-to-date.

If the software versions do not match the ones listed in the table below, do not update the audio unit because you can damage it.

Software Details	Valid Software Version	Valid Software Version
Model Year	2015-17 Fit	2018 Fit
System ucom	0052 or 0B52 (two possible versions could show)	7008
HMI ucom	0052	7B08
DSP ucom	10430202	11420202
Bluetooth module	HW02-SW03.13.70	HW02-SW03.29.02

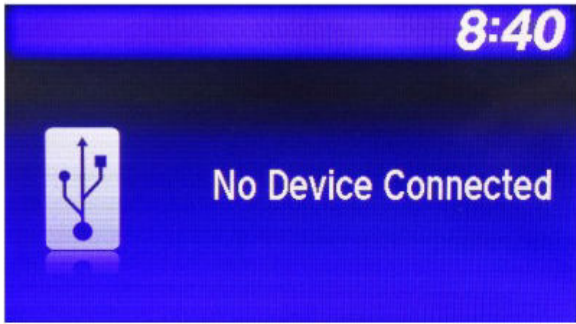
8. Set Audio Source to USB mode by pressing the MEDIA button.

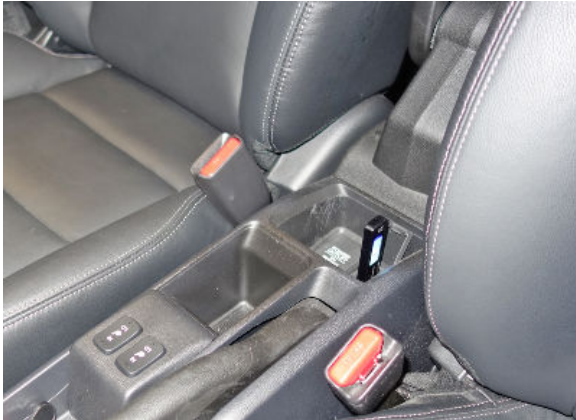
9. Update the audio unit software by plugging in the USB flash drive into the USB port. The audio unit will automatically detect the USB flash drive and start the update process.

Never disconnect the battery, turn the ignition to OFF, disconnect the USB drive tool, or press the **BACK** button while the update is in progress.

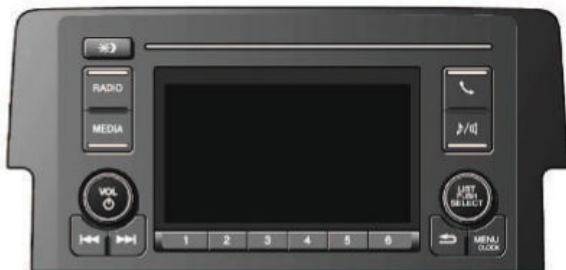
- **Sys Ver Up**

The screen will go black, and the buttons will begin blinking. The blinking will speed up, you will hear a beep every 10% of progress.

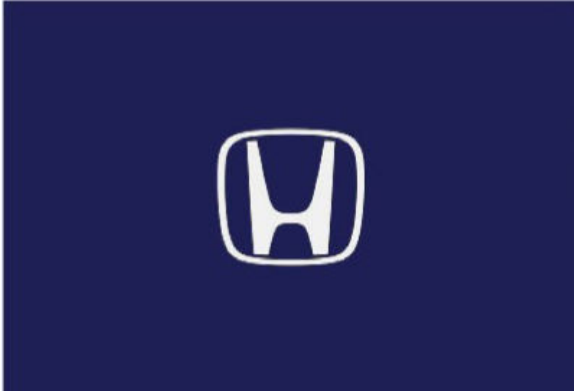
- **Complete SW Ver**, You will hear a long beep, then the Honda logo will appear, and the audio unit will turn off when the software update is complete.

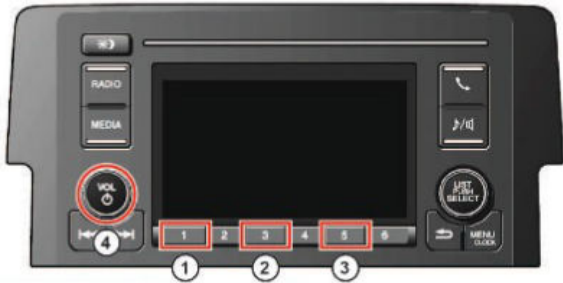
1. With the audio unit turned off, press the buttons in the order as shown.

Press the buttons sequentially as shown.

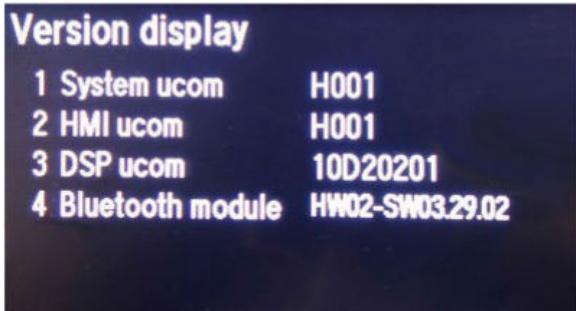
This will let you view the **Version display** screen and verify the software version was updated.

Software Details	Updated Software Version	
Model Year	2015-17 Fit	2018 Fit
System ucom	L052	7A08
HMI ucom	0052	7B08
DSP ucom	10430202	11420202
Bluetooth module	HW02-SW03.13.70	HW02-SW03.29.02

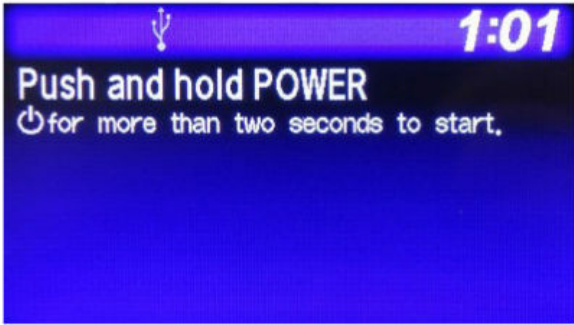
3. Remove the USB flash drive.
4. Press and hold the VOL/Power button to sync the security code.
