PRODUCT CAMPAIGN BULLETIN

APPLICABILITY: 2018 Model Year Legacy, Outback, and BRZ Vehicles

SUBJECT: Harman Kardon Head Unit FMVSS 111 Noncompliance Recall

NUMBER: WTZ-85R
DATE: 01/03/19
NHTSA ID: 18V-935
REVISED: 07/11/19

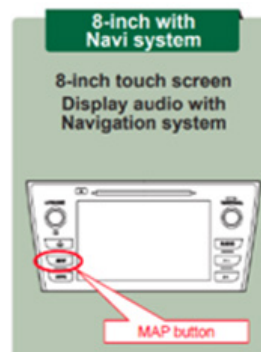
This procedure and the related reprogramming files apply to the following audio / navigation head unit:

Multimedia System Type	Descriptive Features
8.0 Inch Audio / Navigation System	Map Button in Top Row Center

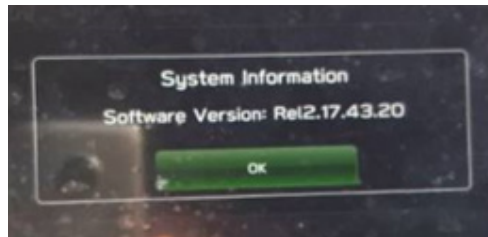
(EXAMPLE photo)

- Confirm the current Software Version ID. **If the Current Version is Rel_U0.18.43.20, Rel_A1.19.12.20 or Rel_A1.19.17.20, STOP** as the latest update has already been installed. Otherwise, proceed to **Step 2** below.

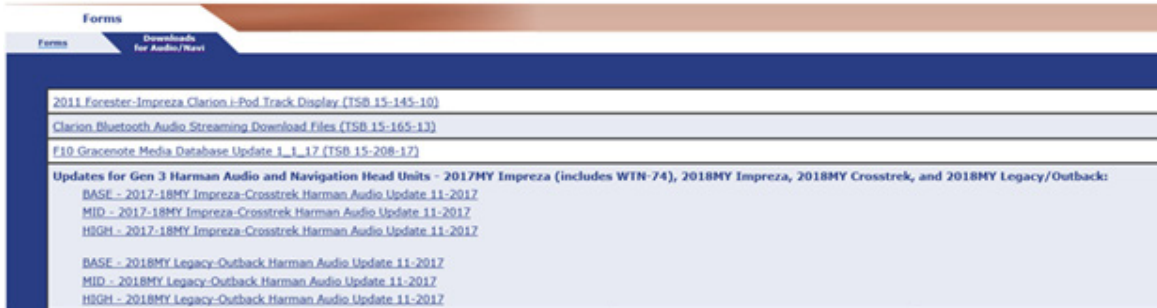
- If the files are being **downloaded from Subarunet**, they will be .zip files and must be unzipped before they can be used. An EXAMPLE image of the Subarunet links page is provided below.
