SERVICE BULLETIN

Classification: EI19-015	Reference: NTB19-047	Date: June 17, 2019
-----------------------------	-------------------------	------------------------

2019 MURANO; BACK DOOR WILL RELEASE, BUT WILL NOT RAISE WITH BACK DOOR REQUEST SWITCH

APPLIED VEHICLE: 2019 Murano (Z52)
APPLIED VIN AND DATE: Built before 5N1AZ2M(*) (*)KN 136509 / April 26, 2019

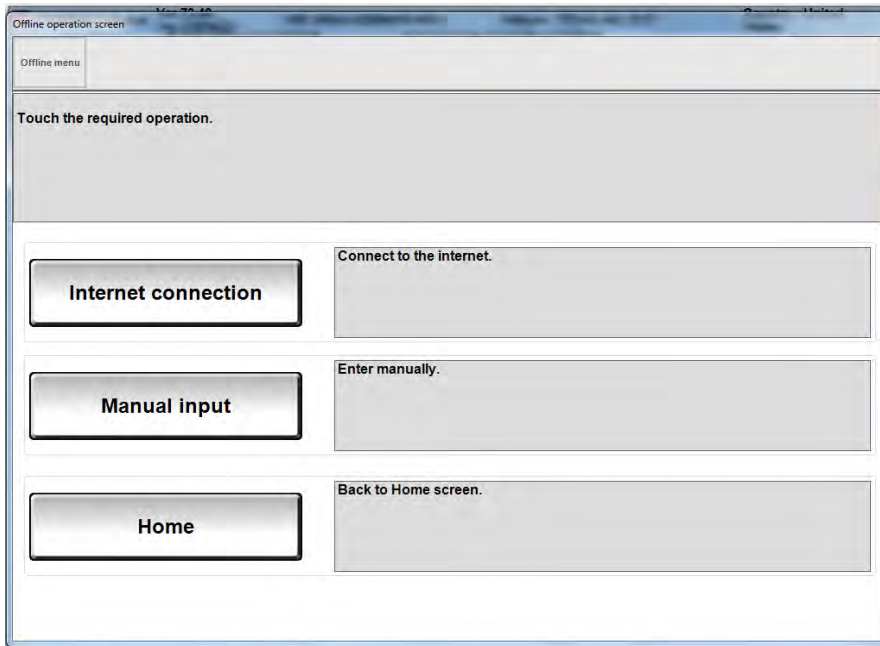
- The above screen may not display if the CONSULT PC has remained ON since the last reprogramming.
- If the CONSULT PC is not connected to the Internet, the screen in Figure 16 will display.
