**SERVICE INFORMATION BULLETIN**

**APPLICABILITY:** 2015-2017MY Legacy and Outback  
 2015-2016 Impreza  
 2015-2017 Crosstrek  
 2016-2018MY Forester  
 2016-2018MY WRX

**NUMBER:** 15-205-16R

**SUBJECT:** Reprogramming File Availability to Address Operational Concerns with “Gen 2.0” and “Gen 2.1” Fujitsu-TEN (F10) / Denso-TEN (D10) Navigation and 7” Display Audio Units

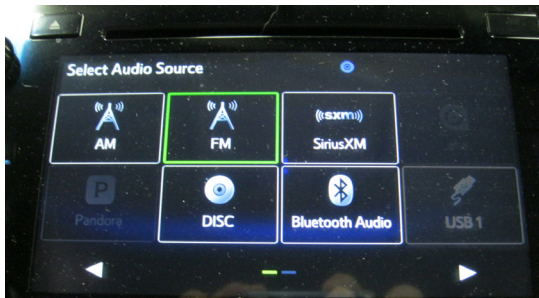
- Turn the ignition / key (ACC) “ON”.

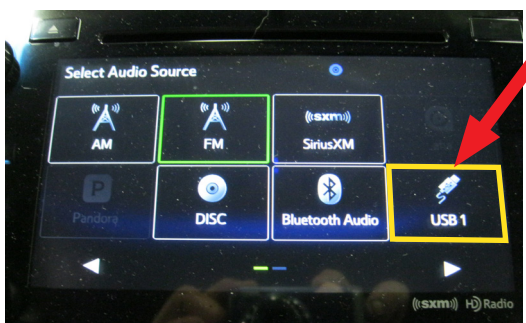
- Press the “AUDIO/TUNE” button.  
The Select Audio Source screen will appear.

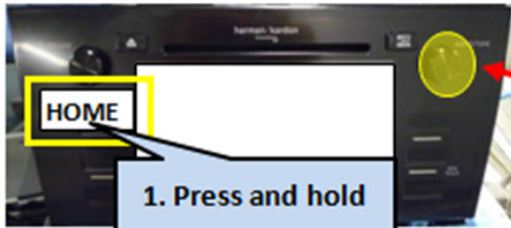
- Once the USB icon is illuminated, switch the unit into “Diagnosis Mode” by pressing and holding the HOME button while pressing the “AUDIO/TUNE” button 5 (five) times.

2. Press "AUDIO/TUNE" button 5 times

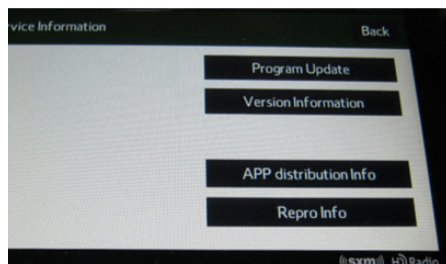
- Press “Program Update” then follow the sequence shown in the screen shots on the next page

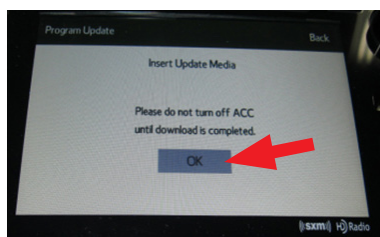
Wait for “OK” to activate  
(turn black)

**NOTE:** The “OK” button will not activate (turn black) if the wrong Update File(s) are on the flash drive. Re-format the flash drive and reload the proper Update Files starting from the beginning of Step 2.

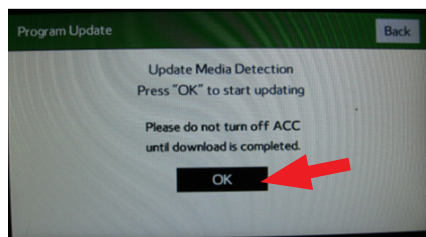
Press “OK”

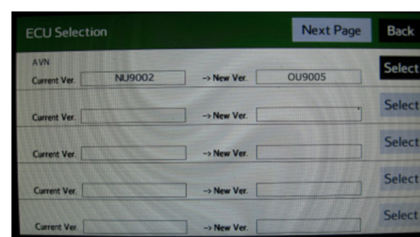
Press “SELECT”

**CAUTION:** Confirm the intended new version is displayed before clicking Select.

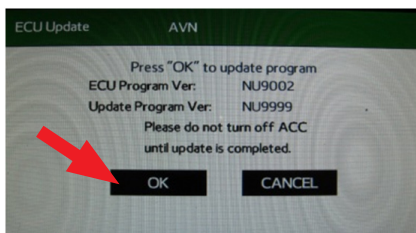
Press “OK”

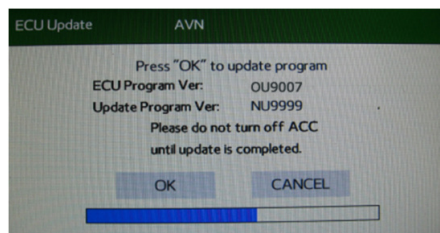
Once the updating starts, the status bar may need to complete more than once and could take up to about 15 minutes.

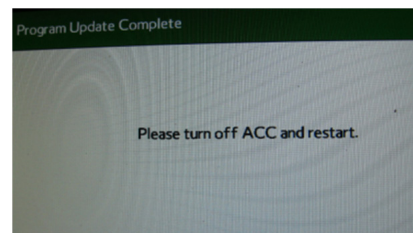
Turn off ACC

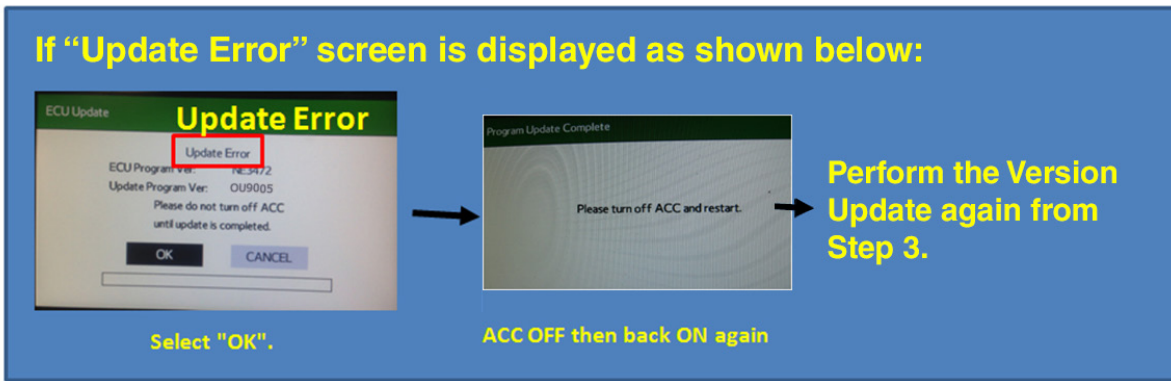
If the progress bar stops, please wait 15 minutes. If the progress bar does not change even if after 15 minutes, turn ACC OFF and back ON again then, restart the update procedure from **Step 4**.

**IMPORTANT:** Do not turn the ACC (ignition / key) off or disconnect the flash drive from the USB port during updating.

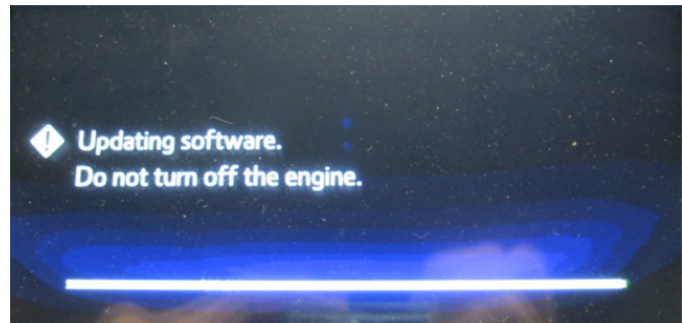
- Once the update completes successfully, turn the ACC off, **WAIT 30 SECONDS** then turn it back on again.
- **WAIT 60 SECONDS.**
- After the unit boots back up, the "Updating software" screen and its status bar will be displayed. This update may take up to 5 minutes to complete.

When the Software Updates complete, the unit will restart automatically. Once the STARLINK opening screen is displayed, remove the flash drive from the USB port and turn the ignition off. **CRITICAL STEP:** Before proceeding further, perform **Step 1** (Version Check Procedure) again to confirm the updated software installation from Drive "1" was successful. When the update is successful, the new software version number will be displayed. If OK, proceed with installation of the Drive "2" update (repeat **Step 4**, Update Software Installation). If the updated versions are not displayed, **Step 4** using Drive "1" must be repeated. Once the software and CAN version updates are confirmed, insert Drive "2" and repeat **Step 4**.

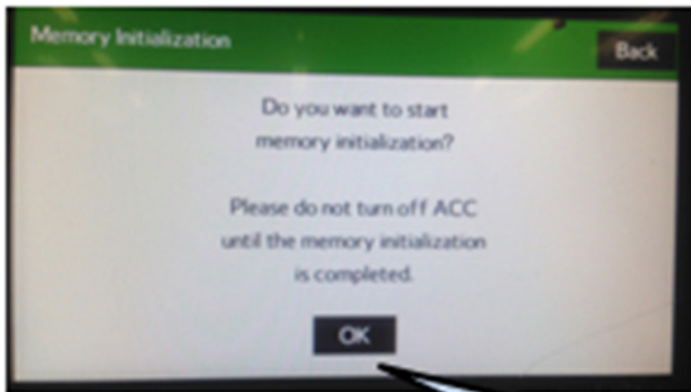
- Press “Memory Initialization”

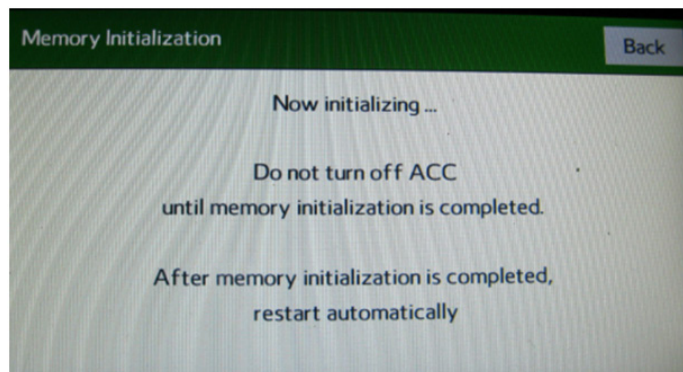
- Press and **HOLD** the “OK” button until the screen shown below is displayed (5 to 10 seconds).

This screen will be displayed for about 1 minute while the unit restarts. After restart, the Loading screen and its status bar will be displayed. After the status bar completes, the Main Menu screen will be displayed. To complete the updating procedure, you must go through the series of Initial Setup screens, reset the radio station presets and re-pair any mobile devices (where applicable).

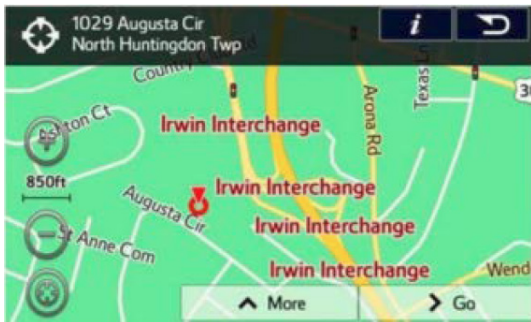
- Audio output is lost after a few minutes when listening to Sirius/XM satellite radio.
- Bluetooth feature becomes inoperative.
- HD Radio “freezes” after a few minutes of play.
- Back-Up Camera “help lines” do not appear.
- Map location is inconsistent between Navigation display and iPhone when using the iPhone’s Google Maps with the phone connected to the USB port in console.
- Roads or interchanges have the same name displayed multiple times.

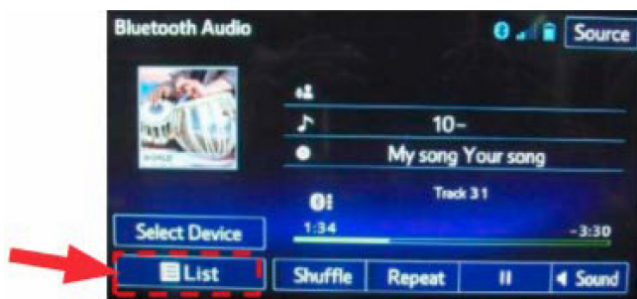
- “LIST” soft touch key is not displayed on Bluetooth Audio screen while using Bluetooth audio feature with an Apple device utilizing iOS8 software version.

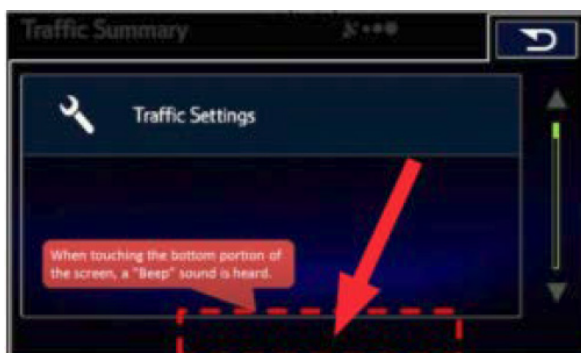
- “Beep” sound heard when touching the bottom of the display screen where no function soft touch keys are displayed.

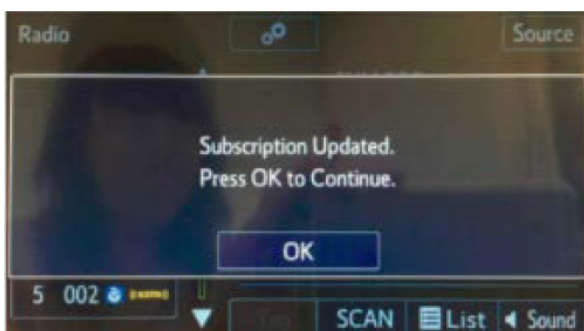
- SXM caution message screen is displayed in English even when French language operation settings are selected.
