SERVICE PROGRAM BULLETIN

APPLICABILITY: 2018 MY Legacy
 2018 MY Outback
 2017-2018 MY Impreza
 2018 MY Crosstrek

NUMBER: WUA-86R

SUBJECT: Harman Kardon Head Unit Reprogramming

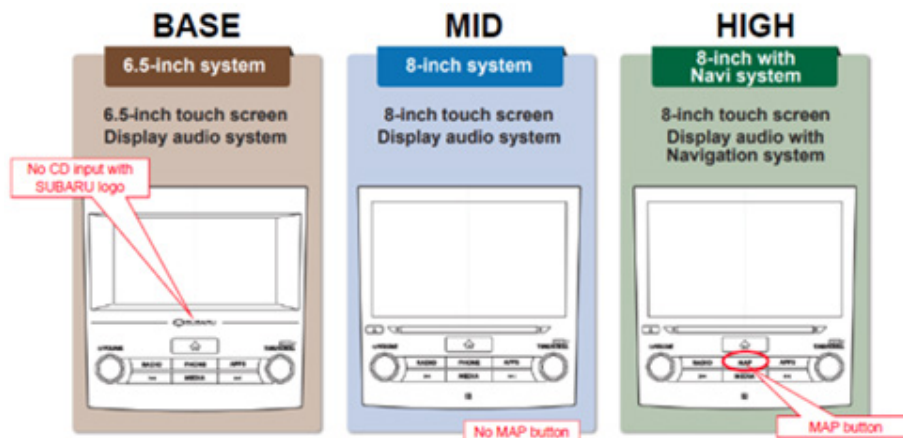
2017-18MY Impreza and 2018MY Crosstrek:

Multimedia System Type	Descriptive Features
6.5 Inch Display Audio System (Base)	No CD slot / Eject Button
8.0 Inch Display Audio System (Mid)	Phone Button in Top Row Center
8.0 Inch Audio / Navigation System (High)	Map Button in Top Row Center

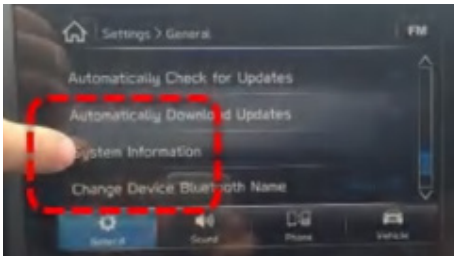
- From the Settings > General screen, scroll down to and then touch “System Information”.

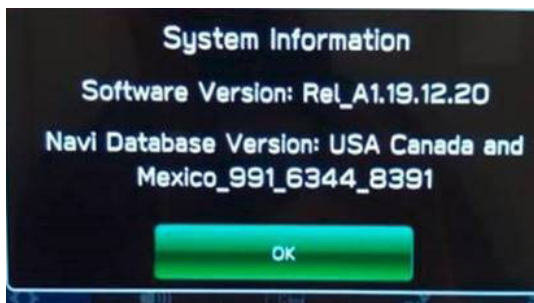
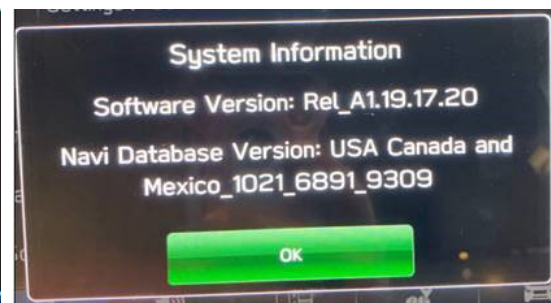
(EXAMPLE photos)

- Confirm the current Software Version ID. If the Current Version is **Rel_A1_19_17_20** or **Rel_A1_19_12_20, STOP** as this latest update has already been installed. Otherwise, proceed to **Step 2** below.

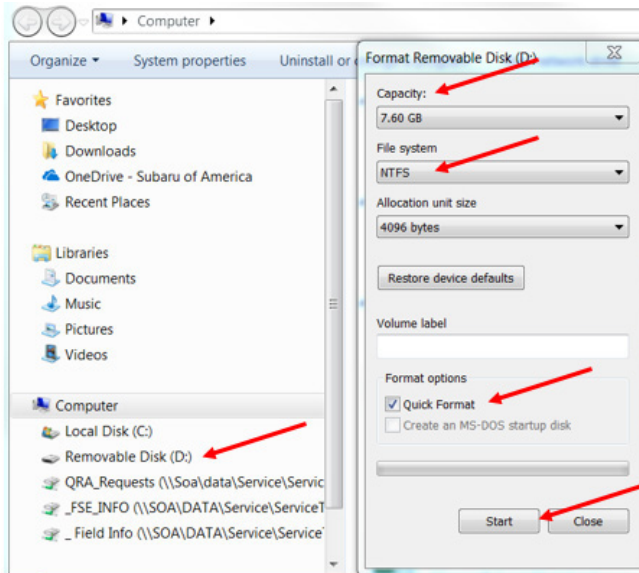
- Make sure the USB flash drive contains no other files.
- Right click on the corresponding “Removable Disk”.
- Select “Format”.
- From the File System drop-down menu, select “NTFS”
- Check the “Quick Format” box (if not already done).
- Click on “Start” to format the USB flash drive.

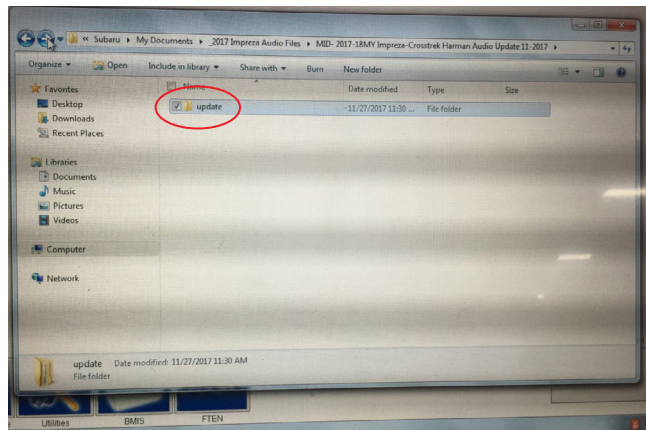
- Double-click on the required file (for this example, select the file entitled “BASE-17-18 Impreza-18 Crosstrek-18-Legacy-Outback-18-BRZ-HARMAN AUDIO UPDATE-NOVEMBER 2018”) and the Update file will display as shown.

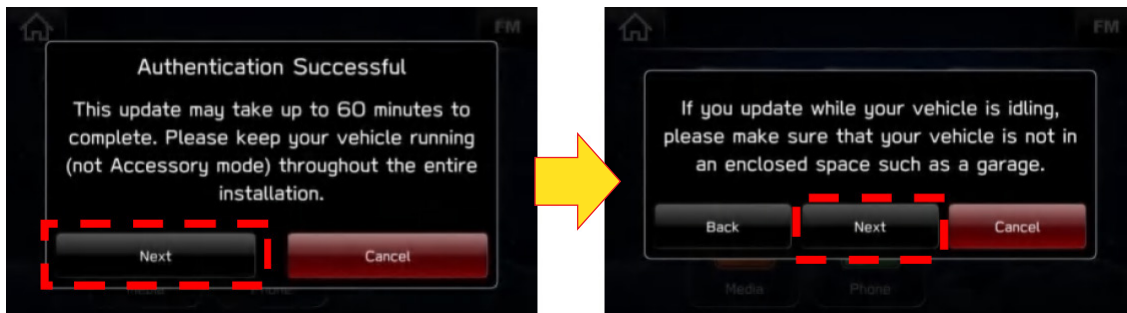
- After the unit “authenticates” the USB flash drive, press “Next” and after the second screen is displayed, press “Next” again.

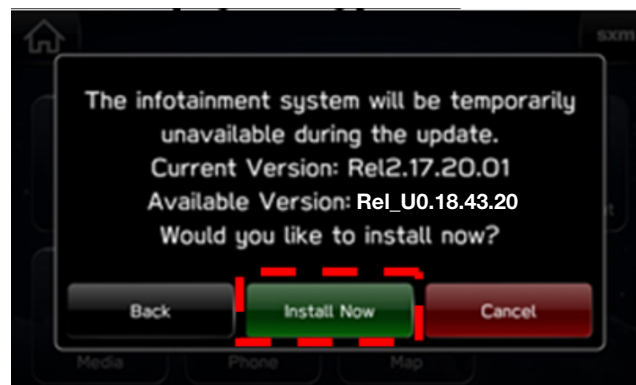
- The current and available software version information will be displayed. The Available Version I.D should be **Rel_UO.18.43.20**.

- After confirming the Available Version, press “Install Now” to start the reprogramming process.

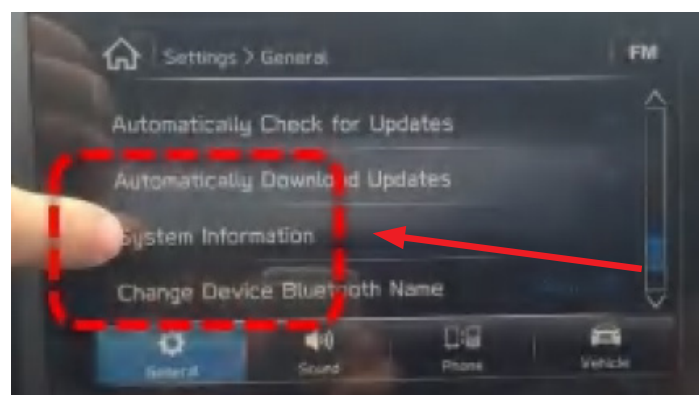
- From the Settings > General screen, scroll down to and then touch “System Information”.

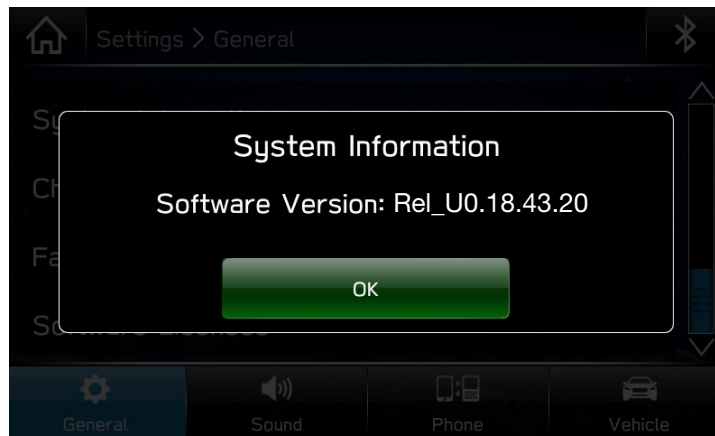
- Confirm Software Version is now “Rel_UO.18.43.20”.
