Bluetooth® HandsFreeLink® Will Freeze After Calls, and Voice Tags are Missing at Startup

Supersedes 18-122, dated November 6, 2018; see REVISION SUMMARY

Year	Model	Trim	VIN Range
2016-17	Pilot	LX	ALL

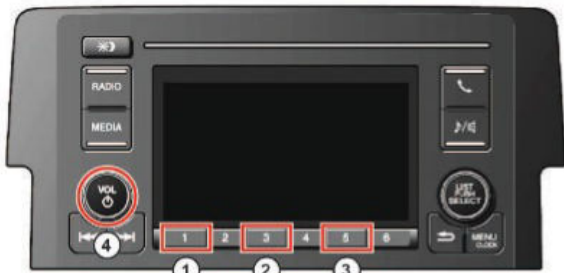
- Turn the ignition to ON.
- With the audio unit turned off, press the buttons in order as shown.

Press the buttons sequentially as shown.

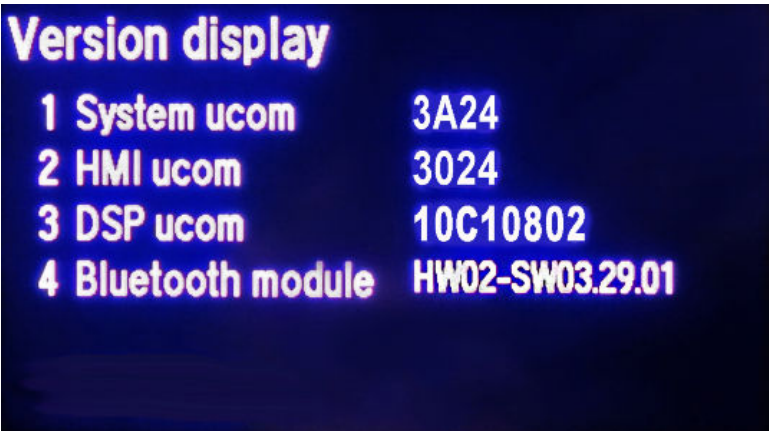
This will let you view the **Version display** screen and verify the candidate software version is up-to-date.

If the software versions do not match the ones listed in the table below, do not update the audio unit because you can damage it.

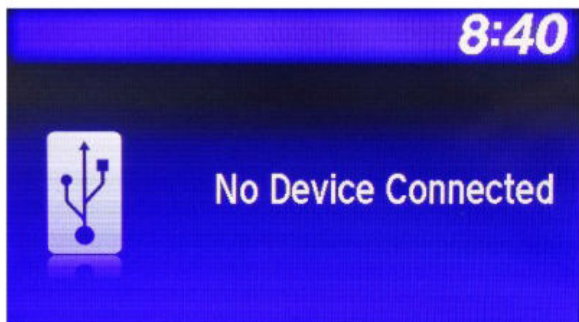
- Exit the **Version display** screen by pushing the Vol/Power button.
- Set Audio Source to USB mode by pressing the MEDIA button.

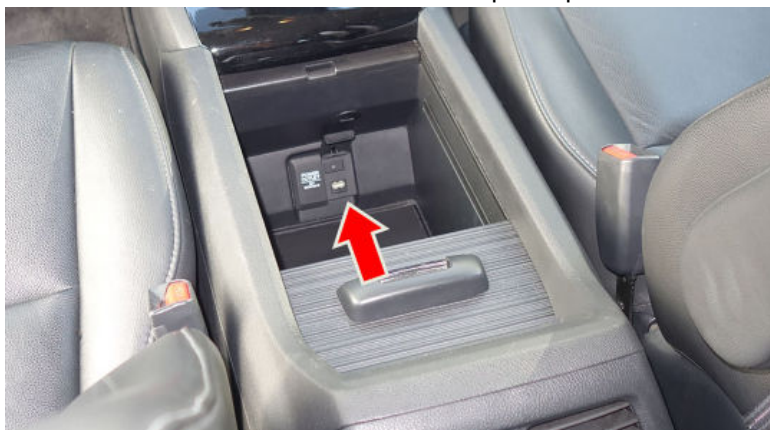
- Update the audio unit software by plugging the USB flash drive into the USB port. The audio unit will automatically detect the USB flash drive and start the update process.

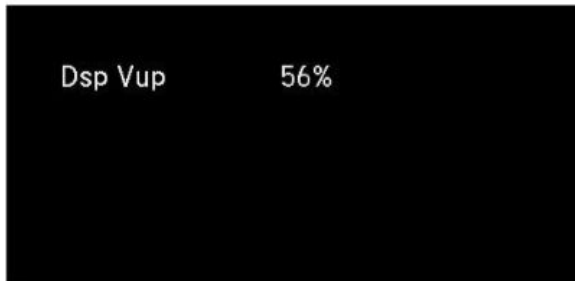
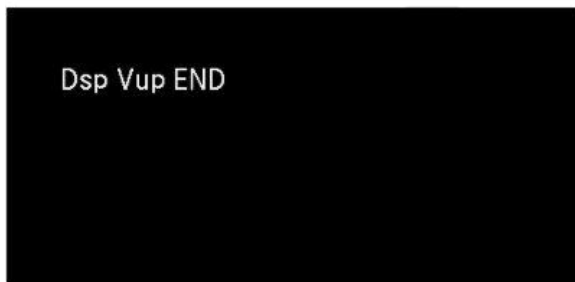
- **DSP Vup**

You will see the following screens as the update runs:

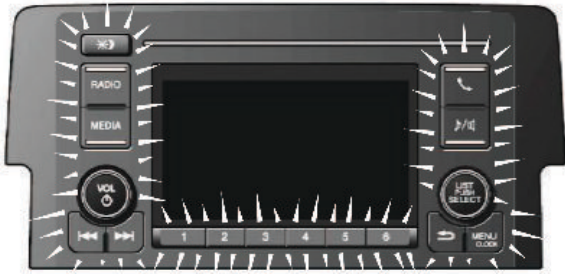
The screen will go black, and the buttons will begin blinking. The blinking will speed up, and you will hear a beep every 10% of progress.

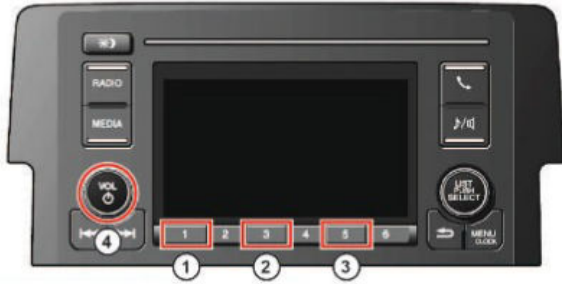
1. With the audio unit turned off, press the buttons in order as shown.

Press the buttons sequentially as shown.

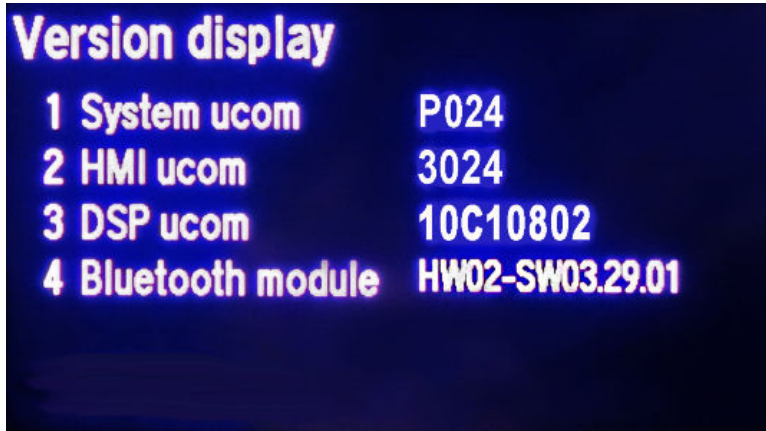
This will let you view the **Version display** screen and verify the software version was updated.
