GROUP <b>ENG</b>	MODEL <b>2016-2017MY Optima (JFa) 1.6T GDI</b>
	NUMBER <b>206</b>	DATE <b>July 2019</b>
<b>TECHNICAL SERVICE BULLETIN</b>		
SUBJECT: <b>1.6T GDI ULEV MIL ON LOGIC IMPROVEMENT FOR P0128</b>

This bulletin provides the procedure to improve the logic of the ECU (Electronic Control Unit) on some 2016-2017MY Optima (JFa) 1.6T GDI ULEV DCT vehicles, produced from September 28, 2015 through September 03, 2016, which exhibit a MIL (Malfunction Indicator Lamp) illuminated with DTC P0128, even though there are no system faults. To correct this concern, apply the improved logic to the ECU using the KDS ECU Upgrade function as described in this bulletin. For confirmation that the latest reflash has been applied to a vehicle you are working on, verify the ROM ID using the table on page 2 of this bulletin.

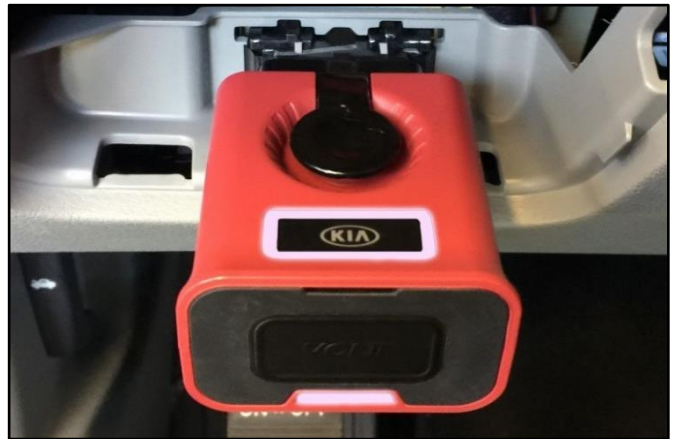
1. Connect the VCI-II to the OBD-II connector, located under the driver's side of the instrument panel.

The ECU upgrade function on KDS operates wirelessly. It is not necessary to perform the upgrade via USB cable.

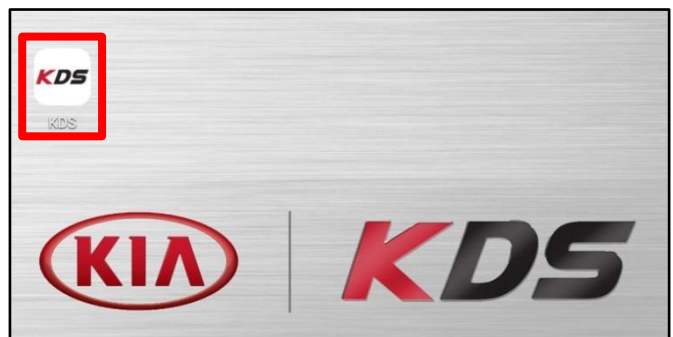
2. With the ignition ON, turn ON the KDS tablet. Select **KDS** from the home screen.

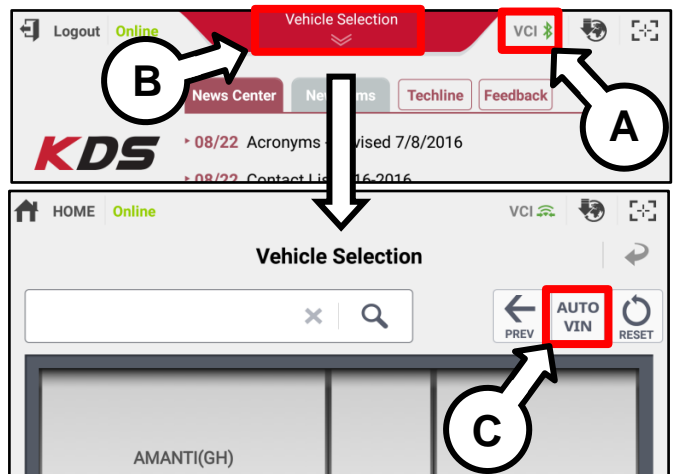
3. Confirm communication with VCI (A) and then configure the vehicle (B) using the **AUTO VIN** (C) feature.

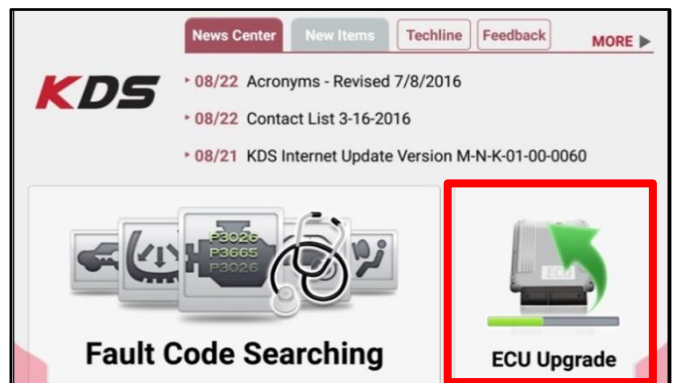
4. Select **ECU Upgrade**.

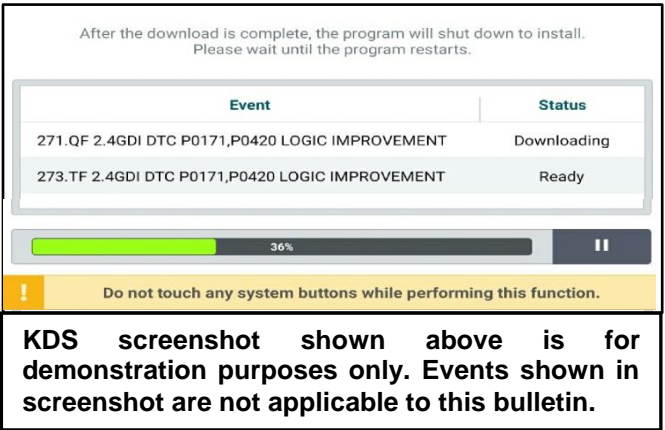
- The KDS will check the server for recently uploaded Events and then automatically download **Upgrade Event #304**.

**\* NOTICE**  
 The vehicle must be identified in Vehicle Selection to download an Event for that vehicle.

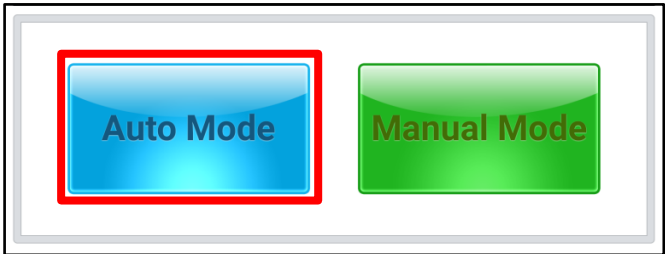
- Select **Auto Mode**.

**CAUTION**  
 Do NOT attempt to perform a Manual Mode upgrade **UNLESS Auto Mode fails**. Always follow the instructions given on the KDS in either Auto or Manual mode.

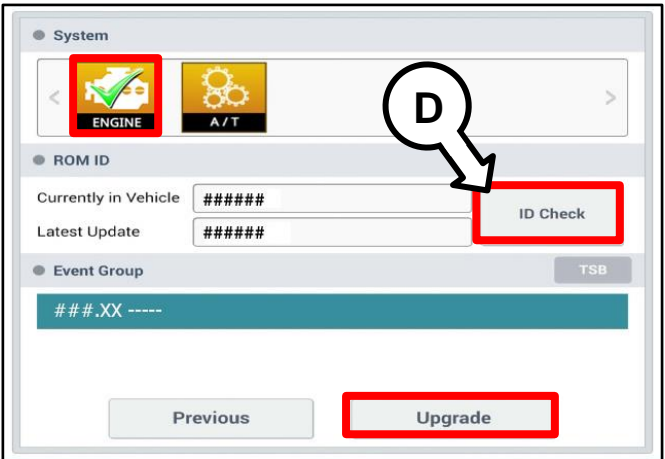
- Select the ENGINE system under the System selection menu.

Touch **ID Check (D)** and confirm that the latest update is available.

Select **Upgrade Event #304** and select **Upgrade** to continue.

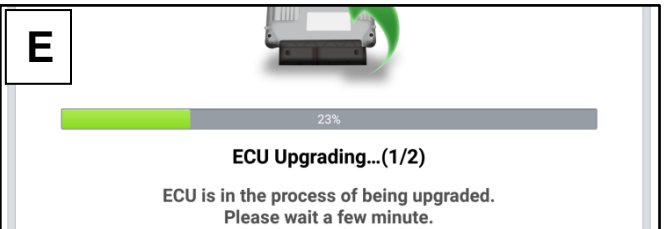
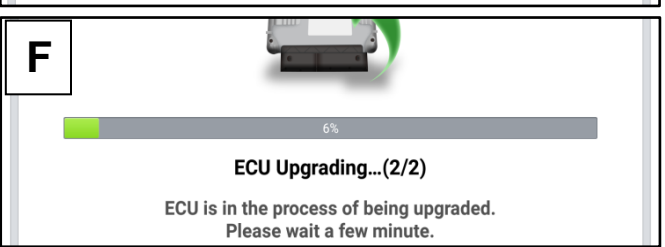
- The ECU upgrade will begin and the progress of the upgrade will appear on the bar graph. Upgrade part (1/2) (E) will download the upgrade event to the VCI-II. Upgrade part (2/2) (F) will upgrade the ECU.

**CAUTION**  
 Do not touch the system buttons (like 'Back', 'Home', 'etc.') while performing ECU Upgrade.

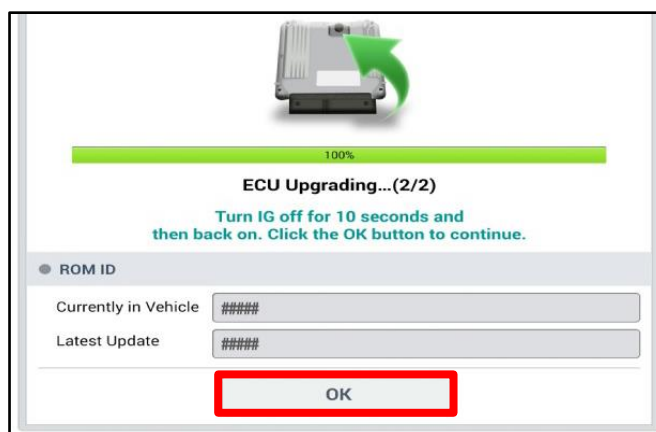
10. When instructed on the KDS, turn the ignition **OFF** for ten (10) seconds then back on. Touch **OK** to continue.

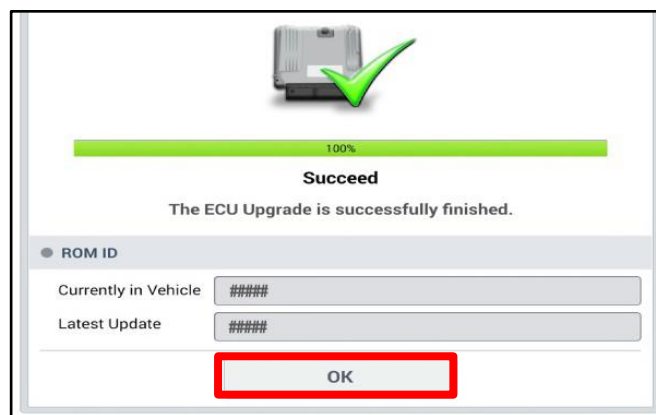
11. Once the upgrade is complete, touch **OK** to finalize the procedure.

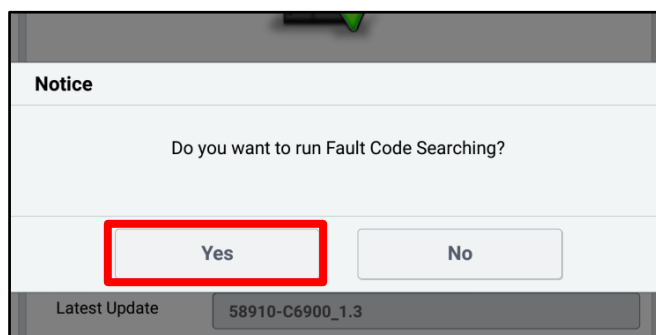
12. When prompted, select **YES** to check for Diagnostic Trouble Codes (DTC) and erase any DTCs stored such as EPS, ESC, and TPMS that may have been set during the upgrade.
