# Service Action

## Code: 91U7

<b>Subject</b>	<b>Infotainment System Software – Security Patch</b>
<b>Release Date</b>	July 18, 2019
<b>Affected Vehicles</b>	<b>U.S.A. &amp; CANADA: Certain 2015-2017 Model Year Audi Vehicles</b> <i>Check Campaigns/Actions screen in Elsa on the day of repair to verify that a VIN qualifies for repair under this action. Elsa is the <u>only</u> valid campaign inquiry &amp; verification source.</i> <ul style="list-style-type: none"><li>✓ Campaign status must show “open.”</li><li>✓ If Elsa shows other open action(s), inform your customer so that the work can also be completed at the same time the vehicle is in the workshop for this campaign.</li></ul>
<b>Problem Description</b>	Audi has determined that a software update is needed to improve the security of the vehicle’s infotainment system.
<b>Corrective Action</b>	Update infotainment system software.
<b>Parts Information</b>	Software update only; no parts needed.

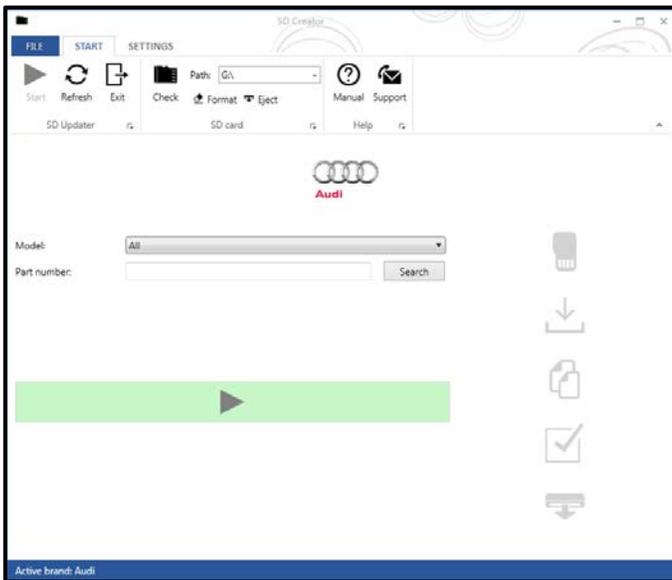
## Required SD Card

- A SD Card will need to be created using the SD Creator program. Refer to the chart below to create the correct card based on VIN criteria.
- Reference the latest version of TSB 2047812 for additional information on the use of the SD Creator program.

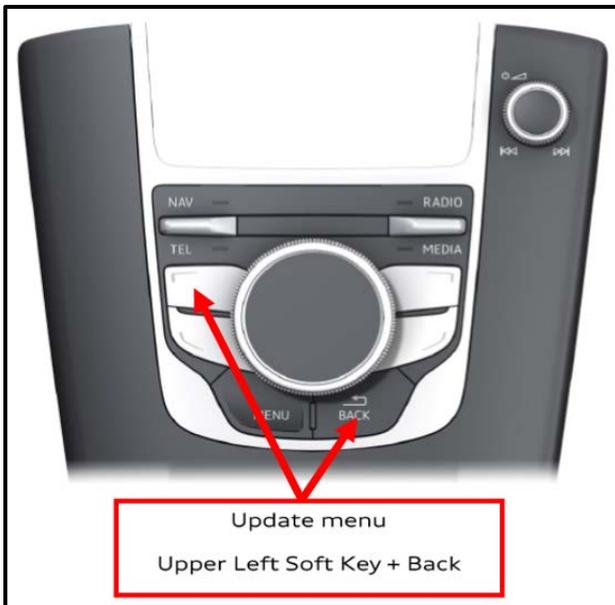
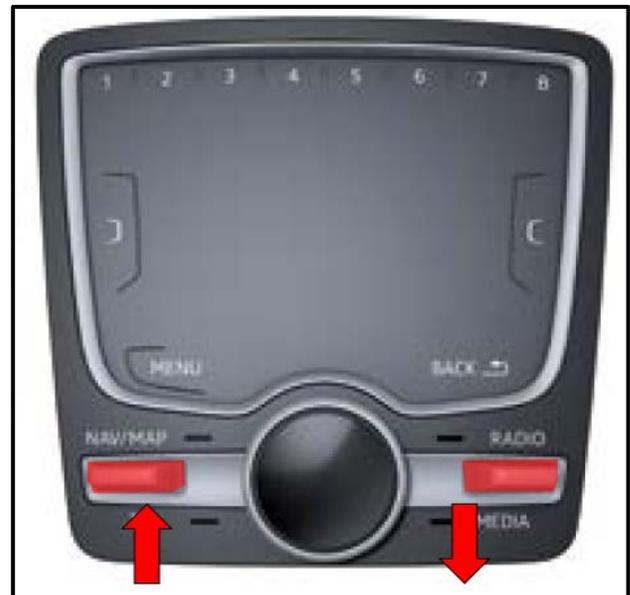
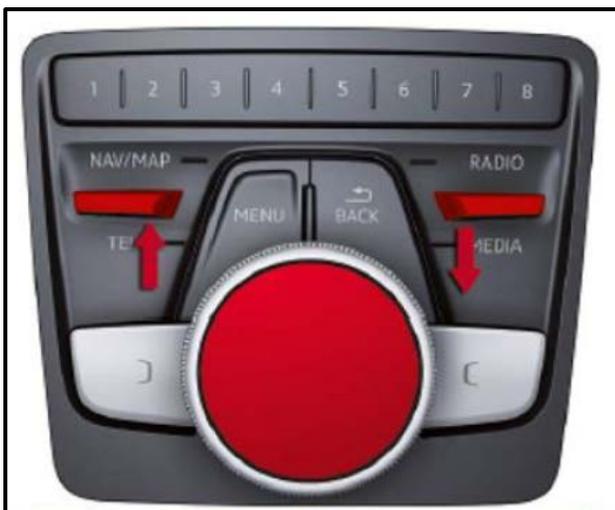
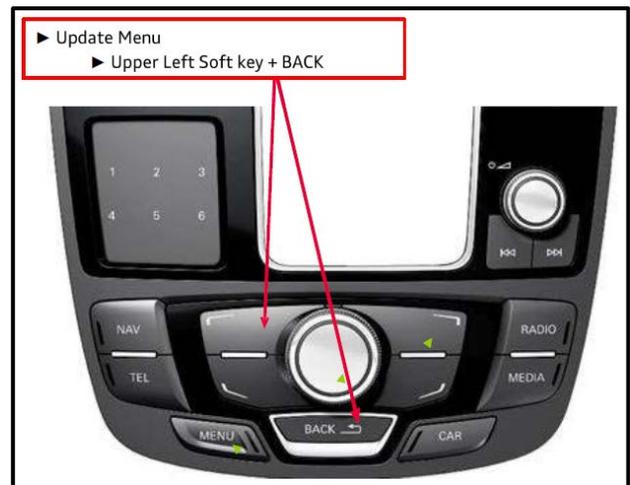
- Insert SD card in SD card reader.
- Initiate software update via the Update Menu (Red Engineering Menu - REM):
  - Press the button combination shown based on what MMI system is installed.
  - The buttons must be pressed simultaneously.
- Navigate the Update Menu using the rotary knob and start the update.

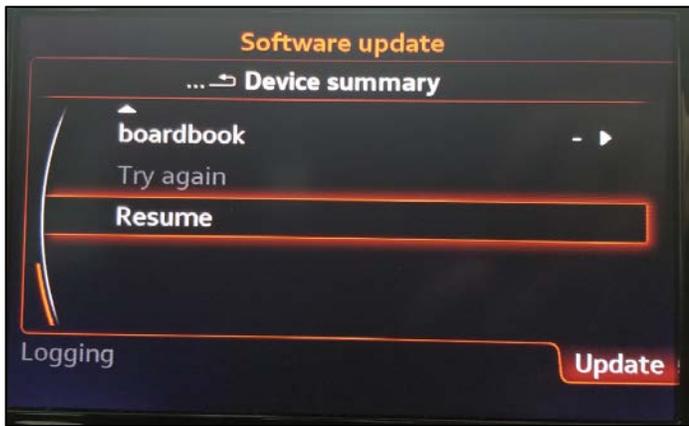
- When the “Device summary” screen appears, scroll down and select “Resume”.

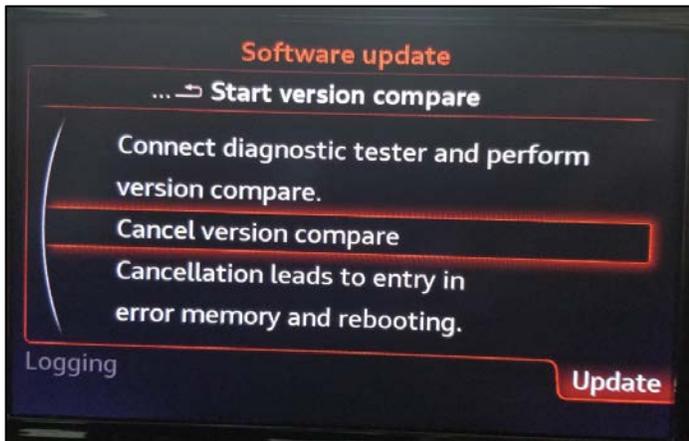
**STOP! STOP!**

- When this message appears, do not make any further selections in the MMI.
- **Proceed to Section C and complete the software update documentation via SVM.**

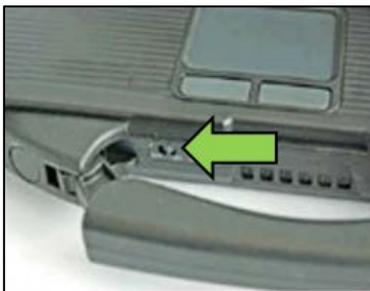
**VAS 6150 & VAS 6150A**  
(Front panel behind handle)

- ✓ **The Bluetooth function of the scan tool is physically switched off <see pictures below>.**

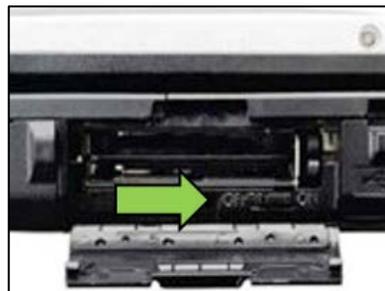
**VAS 6150B**  
(Right side behind WIRELESS door)

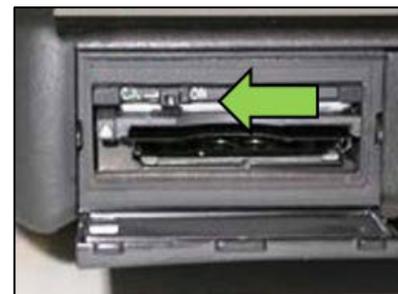
**VAS 6150C**  
(Left side behind SC/EX door)

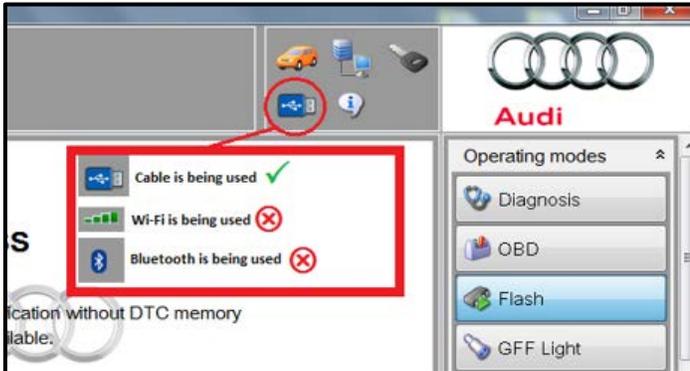
- Confirm that scan tool is communicating with the diagnostic head by USB cable.
  - If the Bluetooth or WiFi symbol is shown, then disconnect the diagnostic head from the vehicle and reconnect the USB cable to the diagnostic head and then reattach to the vehicle.

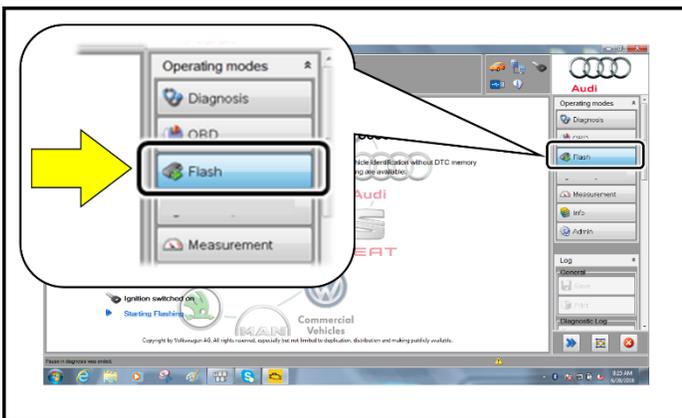
- From the home screen of the scan tool highlight “Flash” <1>.
- Follow the on-screen prompts.

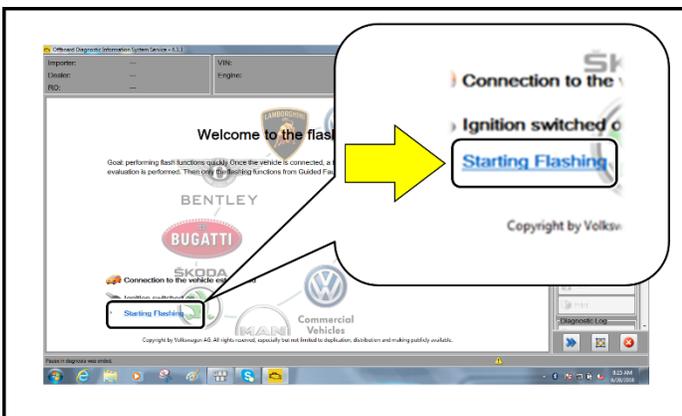
- Select “Starting Flashing” and follow the on-screen prompts.

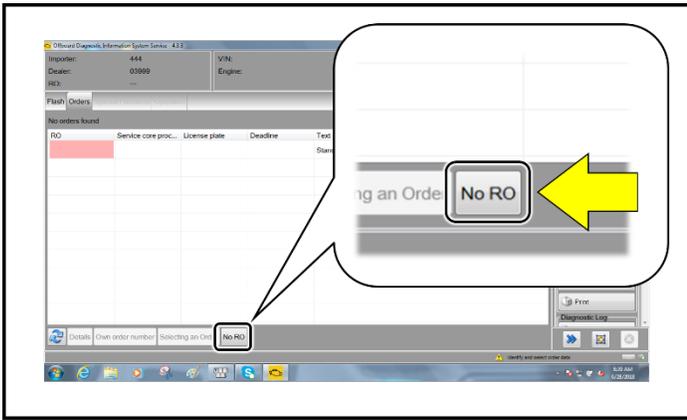
- Select "No RO".

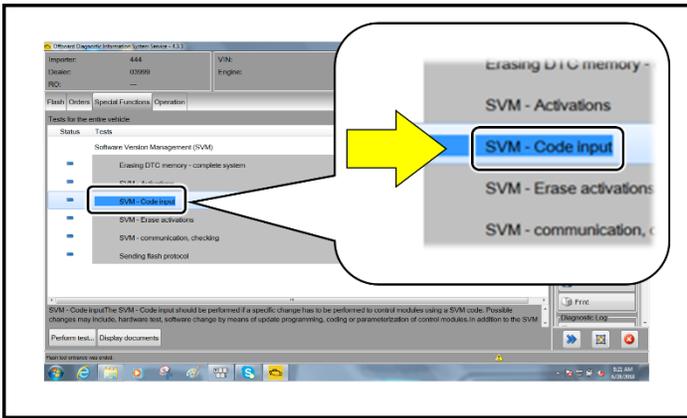
- Highlight "SVM – Code Input".

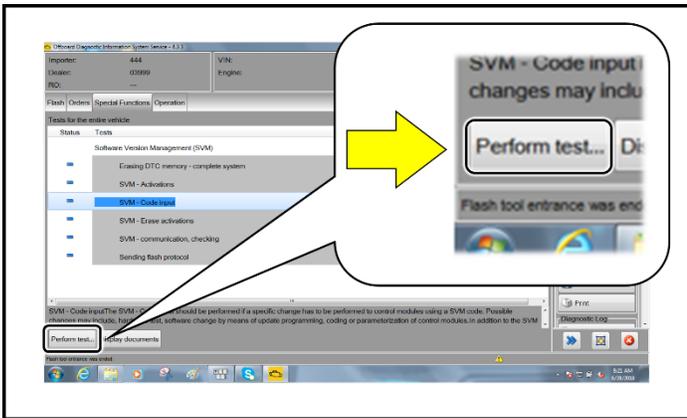
- Select "Perform test".

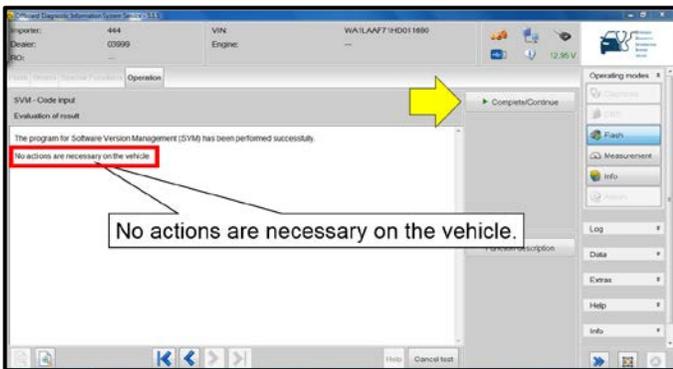
- When the update has completed successfully, this message will appear.
- Select "Complete/Continue" <arrow>.
- Follow the on-screen prompts.

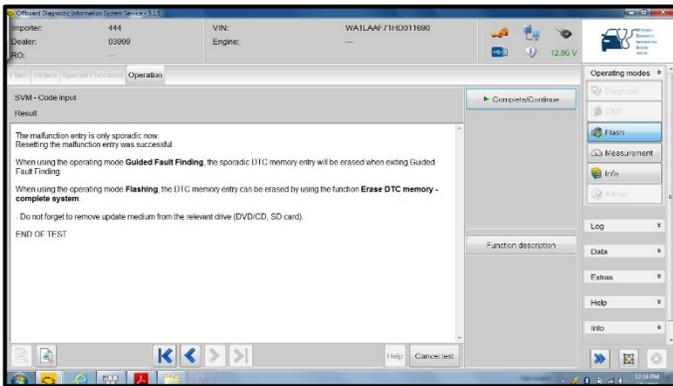
- This message appears after the SVM test plan completes.
- When exiting the Flash program, all faults should clear, including the B201A "Checking software version management" fault that sets during MMI updates.
- There should be no need to clear faults using Guided Fault Finding or by any other method.

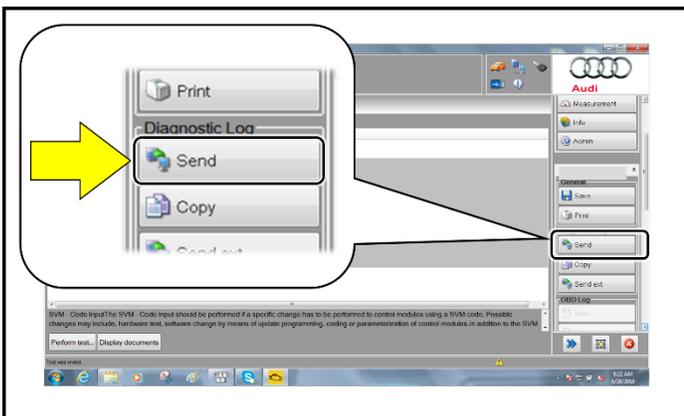
- After receiving confirmation that the flash completed successfully, select "Send" to send the diagnostic protocol online.
- Follow the on-screen prompts.

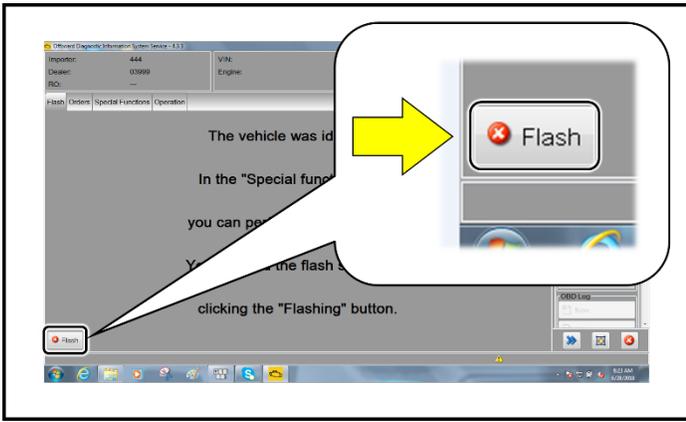
- Click “Flash” to exit the flash session.
- **Proceed to Section C.**
