Service

Category Engine/Hybrid System

Section Emission Control Market USA

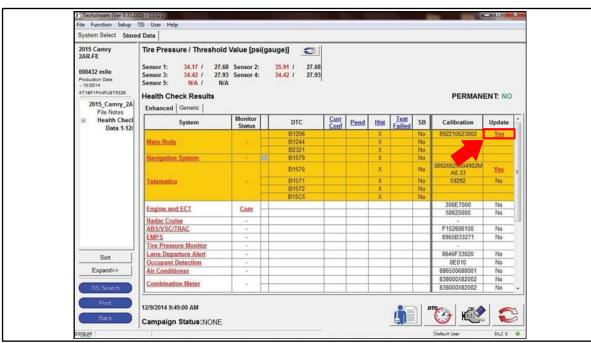
Figure 8.

- Note ANY DTCs stored in systems that will be flash reprogrammed.
- Clicking the <u>Yes</u> link will automatically launch TIS and perform a calibration search.

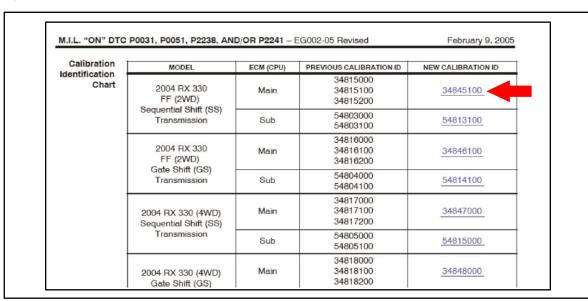
Figure 10.

- Click the appropriate calibration ID and reprogram the vehicle's ECU with Techstream.
 - A. AFTER reviewing the procedures outlined in the selected Service Bulletin, click the appropriate calibration ID link by matching the vehicle's current calibration ID to the Previous Calibration ID in the Calibration Identification Chart.

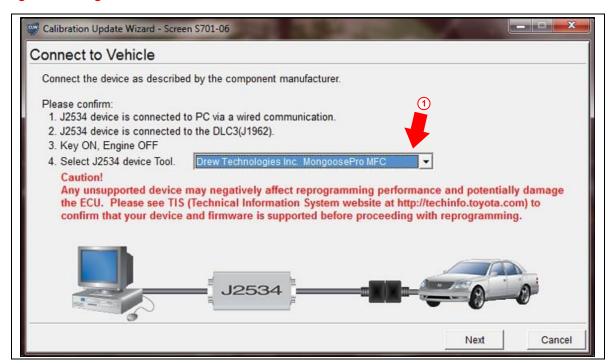
Figure 13. Using Techstream 2.0 or Techstream Lite

Then, click Next.

1 Select Correct Device Tool ("MongooseMFC," "MongoosePro MFC," or "MongoosePro MFC2" [green])

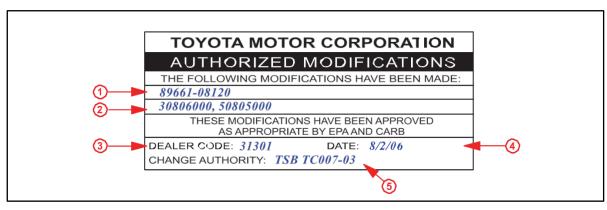
Figure 24.

- 4. Attach the Authorized Modifications Label.
 - A. Using a permanent marker or ballpoint pen, complete the Authorized Modifications Label and attach it to the vehicle. The Authorized Modifications Label is available through the MDC, P/N 00451-00001-LBL.

1	Replacement ECU Part Number
2	Calibration ID(s)
3	Dealer Code

5 Service Bulletin or Campaign Number
