GROUP ELE	MODEL 2019MY Forte (BDm)
	NUMBER 183 (Rev 1, 08/01/2019)	DATE July 2019
TECHNICAL SERVICE BULLETIN		
SUBJECT: SERVICE ACTION: IBU SMART TRUNK LOGIC IMPROVEMENT (SA390)

This bulletin provides the procedure to improve the logic of the Integrated Body Control Unit (IBU-BCM) on some 2019MY Forte (BDm) vehicles, produced from July 16, 2018 through June 3, 2019, which may exhibit improper function of the smart trunk operation and/or a parasitic battery draw. To correct this concern, apply the improved logic to the IBU using the KDS ECU Upgrade function as described in this bulletin. For confirmation that the latest reflash has been applied to a vehicle you are working on, verify the ROM ID using the table on page 2 of this bulletin. Before conducting the procedure, verify that the vehicle is included in the list of affected VINs.

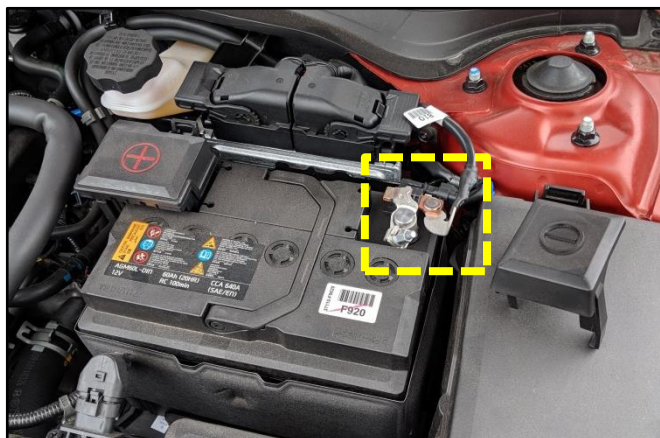
1. Disconnect the negative (-) battery terminal for five (5) seconds with the driver door open and reconnect **before** performing the IBU-BCM logic improvement.

Tightening torque for bolt:
5.9 - 7.4 lb.ft (8 - 10 N.m,
0.8 - 1.0 kgf.m)

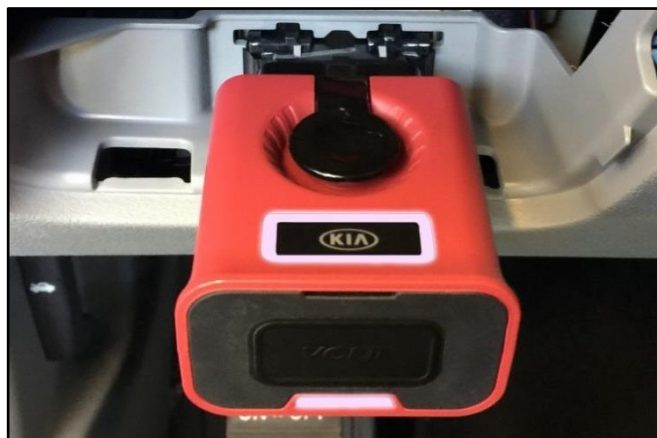
2. Connect the VCI-II to the OBD-II connector, located under the driver's side of the instrument panel.

The ECU upgrade function on KDS operates wirelessly. It is not necessary to perform the upgrade via USB cable.

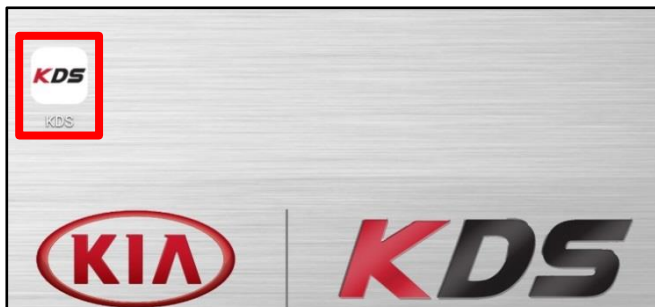
3. With the ignition ON, turn ON the KDS tablet. Select **KDS** from the home screen.

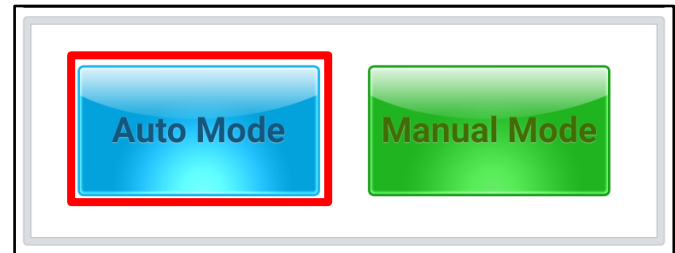
- Select **Auto Mode**.

CAUTION
 Do NOT attempt to perform a Manual Mode upgrade UNLESS Auto Mode fails. Always follow the instructions given on the KDS in either Auto or Manual mode.

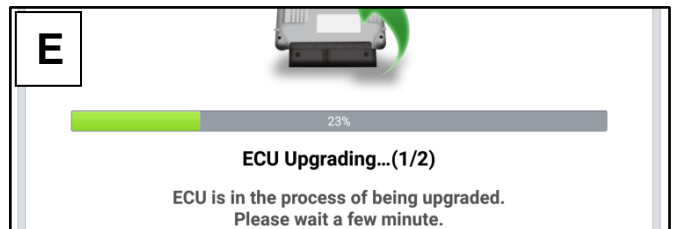
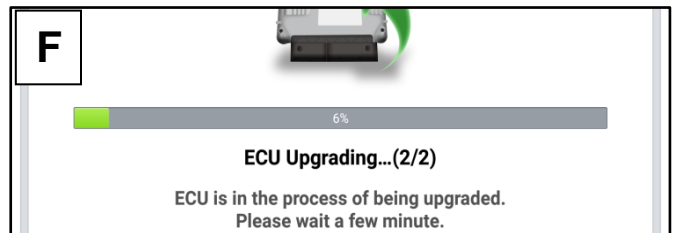
9. The ECU upgrade will begin and the progress of the upgrade will appear on the bar graph. Upgrade part (1/2) (E) will download the upgrade event to the VCI-II. Upgrade part (2/2) (F) will upgrade the ECU.

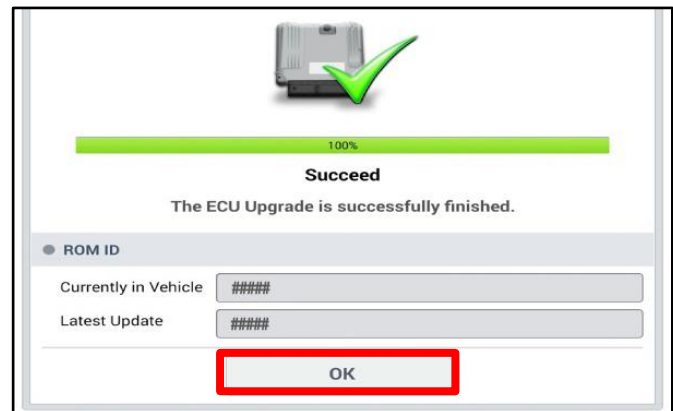
12. Once the upgrade is complete, touch **OK** to finalize the procedure.

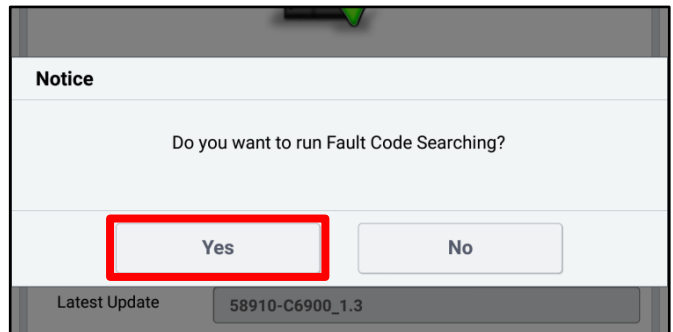
13. When prompted, select **YES** to check for Diagnostic Trouble Codes (DTC) and erase any DTCs stored such as EPS, ESC, and TPMS that may have been set during the upgrade.
