Classification:
EC19-003a

2019 QX50; SPARK KNOCK

APPLIED VEHICLE: 2019 QX50 (J55)

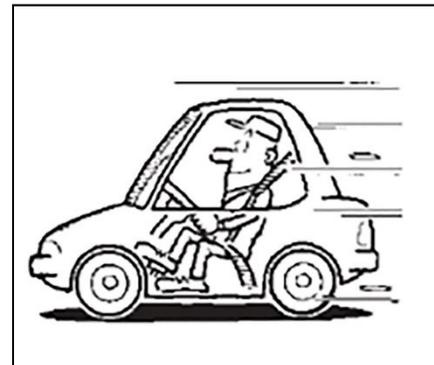
Figure 1

- If you are not familiar with the reprogramming procedure, *click here*. This will link you to the "CONSULT- III plus (C-III plus) Reprogramming" general procedure.
- Take the vehicle for a 10 minute drive in order to meet the following Idle Air Volume Learn (IAVL) conditions:
 - Engine coolant temperature: 70-100°C (158-212°F)
 - Battery voltage: More than 12.9V (At idle)
 - Transmission: Warmed up
- After reprogramming is complete, it is required to perform Throttle Valve Closed Position, Idle Air Volume Learn, Accelerator Closed Position, and DTC Erase.

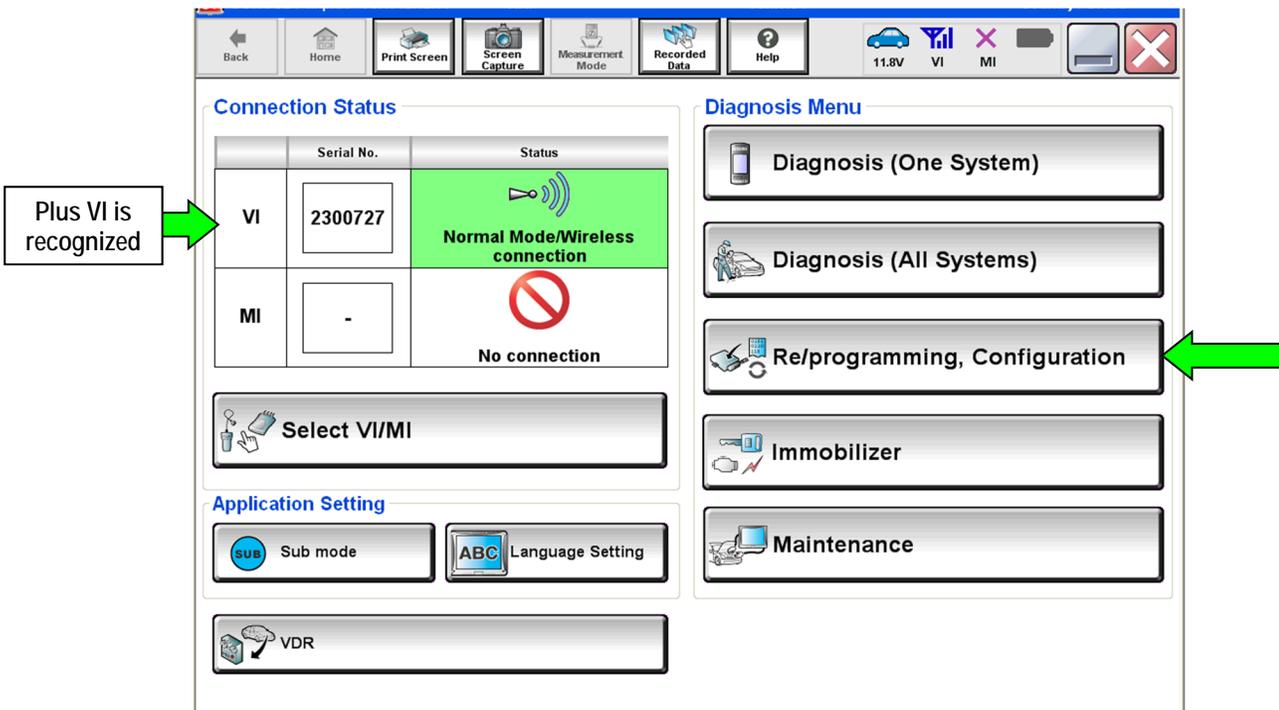
Figure 2

3. Start C-III plus.
4. Wait for the plus VI to be recognized.
 - The serial number will display when the plus VI is recognized.
5. Select **Re/programming, Configuration**.

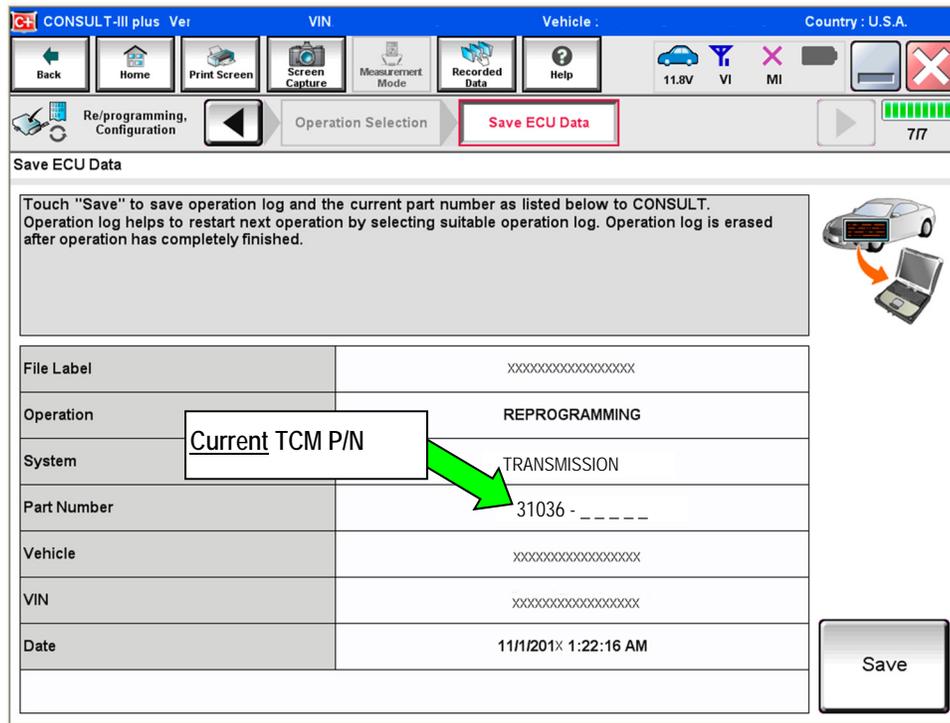
7. When you get to the screen shown in Figure 3, confirm reprogramming applies as follows:
- A. Find the TCM **Part Number** and write it on the repair order.
- NOTE:** This is the current TCM Part Number (P/N).

6. Follow the on-screen instructions and navigate C-III plus to the screen shown in Figure 3 on the next page.

- B. Compare the P/N you wrote down to the numbers in the Current TCM Part Number column in Table B
- If there is a match, continue to step 8 on the next page.
 - If there is not a match, reprogramming is not needed, go back to ASIST for further diagnostic and repair information.

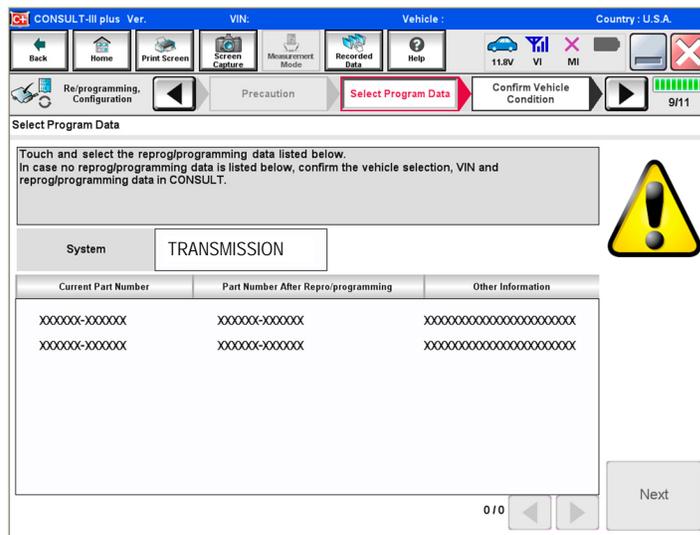
- In some cases, more than one new P/N for reprogramming is available.
 - If more than one new P/N is available, the screen in Figure 4 displays.
 - Select and use the reprogramming option that does **not** have the message "Caution! Use ONLY with NTBXX-XXX".
- If you get this screen and it is blank (no reprogramming listed), it means there is no reprogramming available for this vehicle.

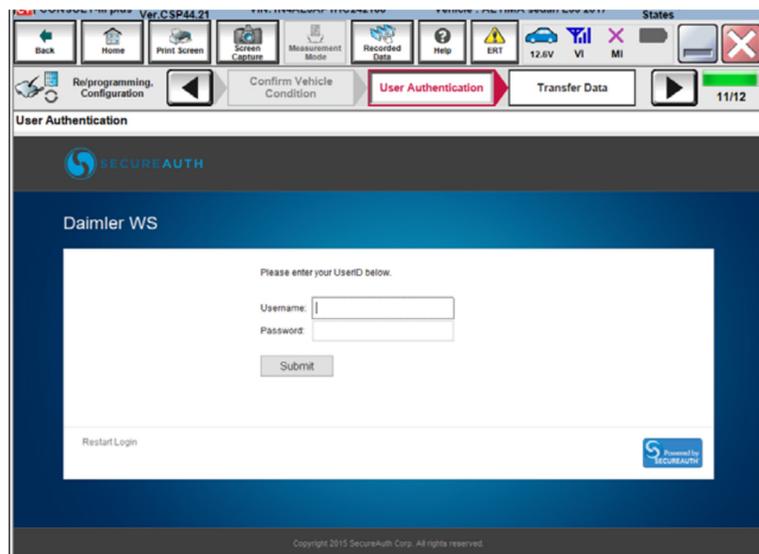
Figure 5

- Before reprogramming will start, you will be required to enter your User Name and Password.
 - The CONSULT PC must be connected to the Internet (Wi-Fi or cable).
 - If you do not know your User Name and Password, contact your Service Manager.

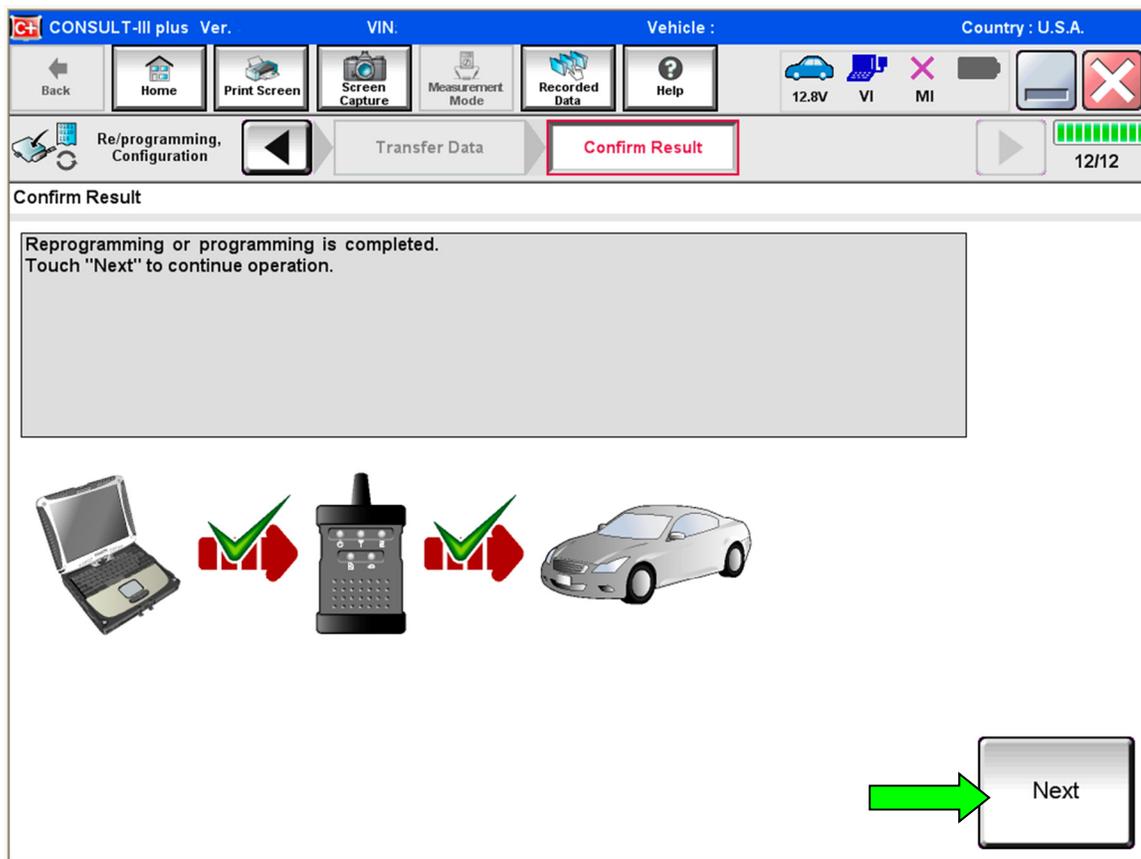
9. When the screen in Figure 6 displays, reprogramming is complete.

NOTE: If the screen in Figure 6 does not display (indicating that reprogramming did not complete), refer to **TCM Recovery** on the next page.

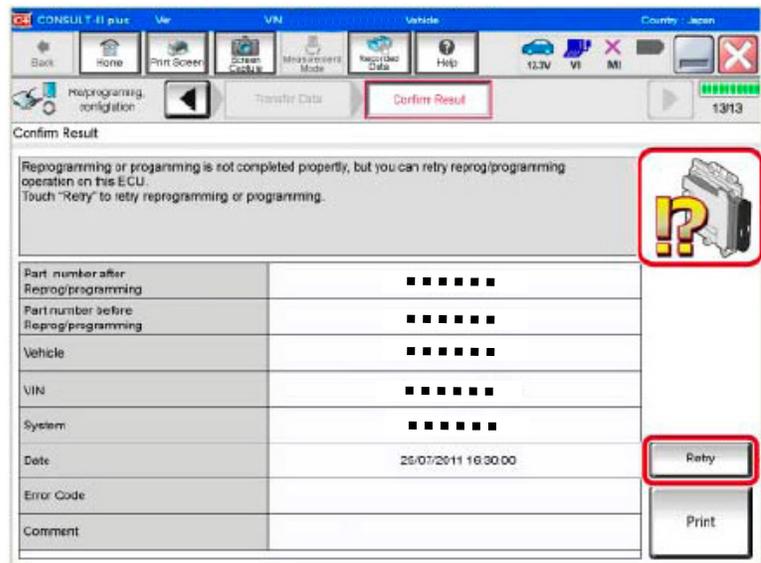
Figure 7

If reprogramming does not complete and the “!?” icon displays as shown in Figure 7:

- Check battery voltage (12.0–15.5 V).
- Ignition is ON, engine OFF.
- External Bluetooth® devices are OFF.
- All electrical loads are OFF.
- Select retry and follow the on screen instructions.
- “Retry” may not go through on first attempt and can be selected more than once.

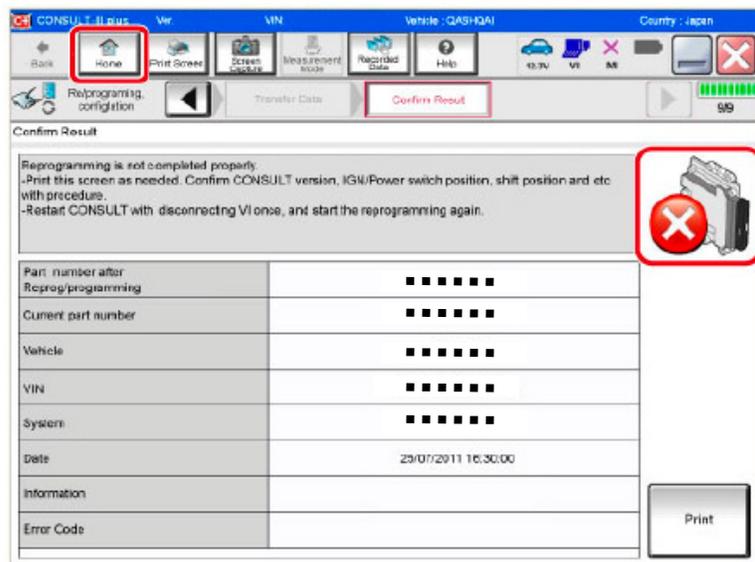
Figure 8

If reprogramming does not complete and the “X” icon displays as shown in Figure 8:

- Check battery voltage (12.0 – 15.5 V).
- CONSULT A/C adapter is plugged in.
- Ignition is ON, engine OFF.
- Transmission is in Park.
- All C-III plus / VI cables are securely connected.
- All C-III plus updates are installed.
- Select Home, and restart the reprogram procedure from the beginning.

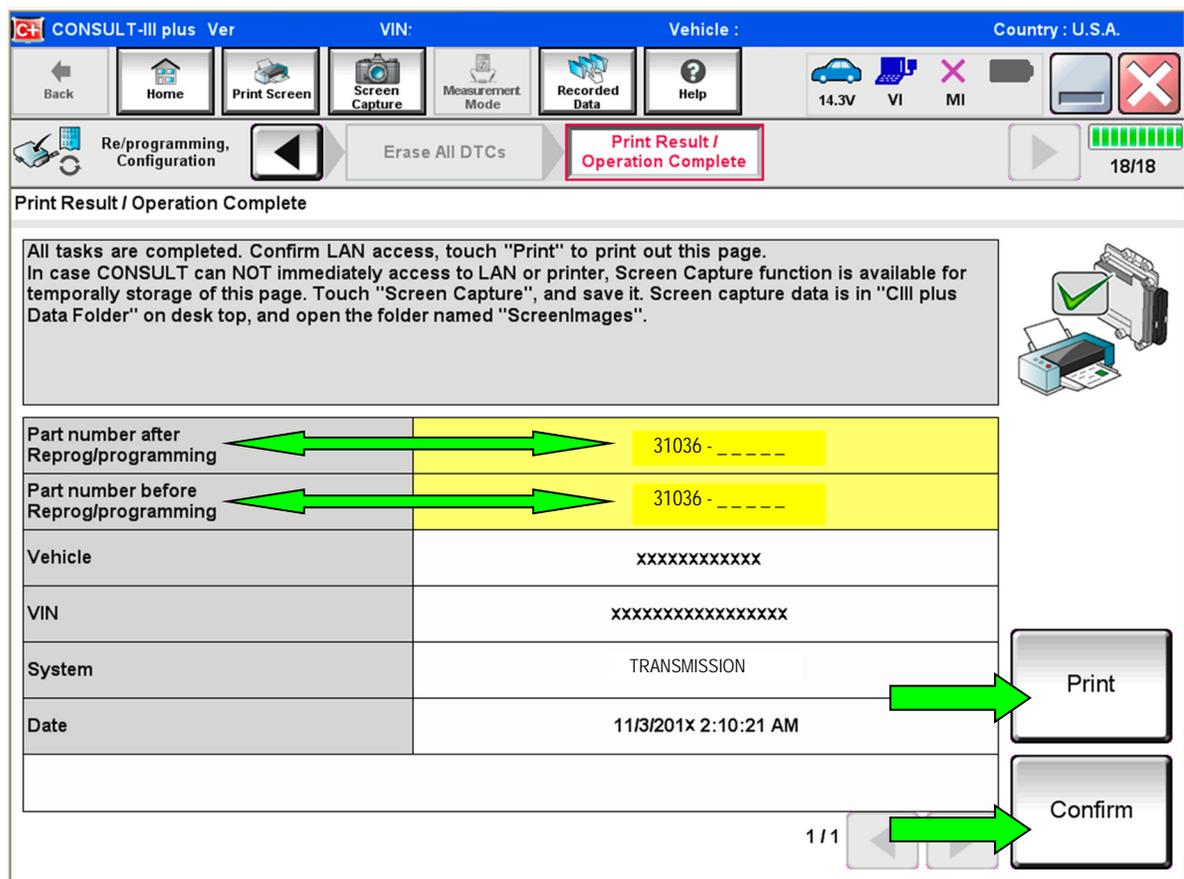
12. Follow the on-screen instructions to **Erase All DTCs**.
13. When the entire reprogramming process is complete, the screen in Figure 9 will display.
14. Verify the before and after part numbers are different.
15. Print a copy of this screen (Figure 9) and attach it to the repair order for warranty documentation.
16. Select **Confirm**.
