# Service Action

## Code: 91U7

<b>Subject</b>	<b>Infotainment System Software – Security Patch</b>
<b>Release Date</b>	September 6, 2019
<b>REVISION SUMMARY</b>	<b>Updated bottom left photo on page 8 to clarify button combination. Added instructions in case another MMI related repair must be performed.</b>
<b>Affected Vehicles</b>	<b>U.S.A. &amp; CANADA: Certain 2015-2017 Model Year Audi Vehicles</b>  <i>Check Campaigns/Actions screen in Elsa on the day of repair to verify that a VIN qualifies for repair under this action. Elsa is the <u>only</u> valid campaign inquiry &amp; verification source.</i> <ul style="list-style-type: none"><li>✓ Campaign status must show “open.”</li><li>✓ If Elsa shows other open action(s), inform your customer so that the work can also be completed at the same time the vehicle is in the workshop for this campaign.</li></ul>
<b>Problem Description</b>	Audi has determined that a software update is needed to improve the security of the vehicle's infotainment system.

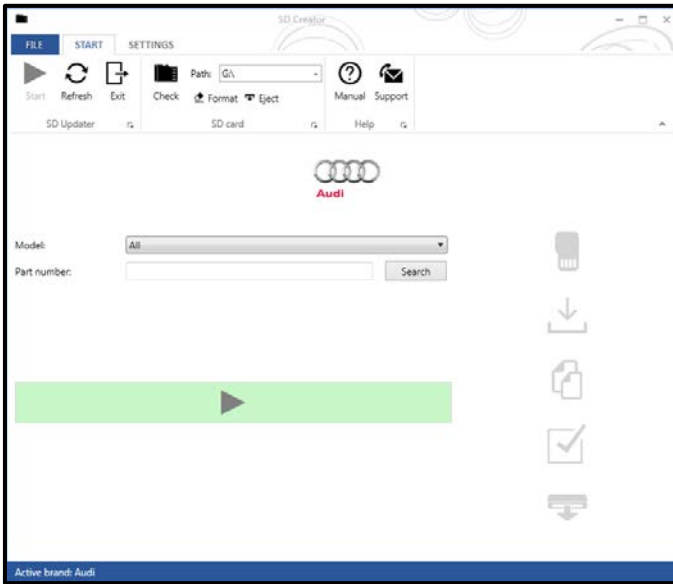
## Required SD Card

- A SD Card will need to be created using the SD Creator program. Refer to the chart below to create the correct card based on VIN criteria.
- Reference the latest version of TSB 2047812 for additional information on the use of the SD Creator program.

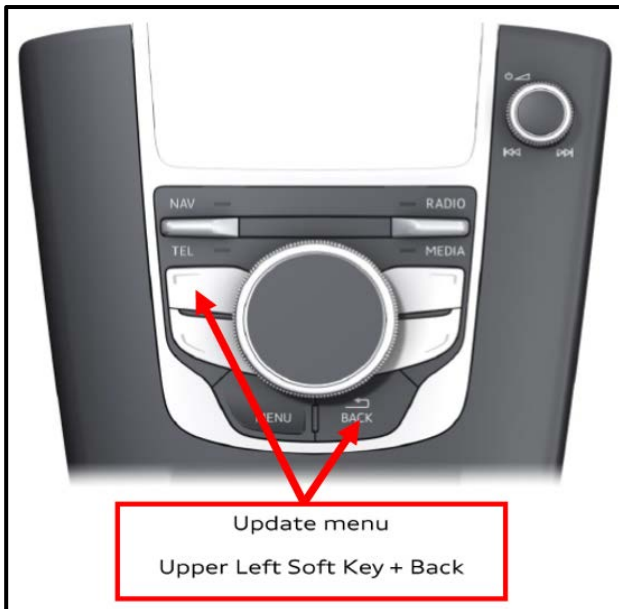
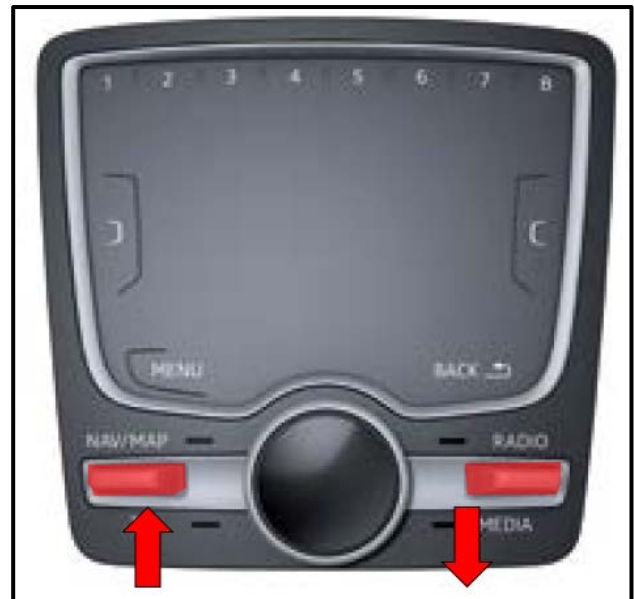
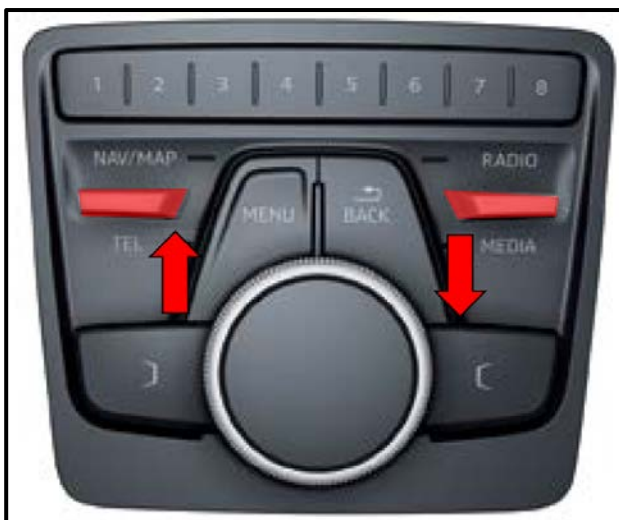
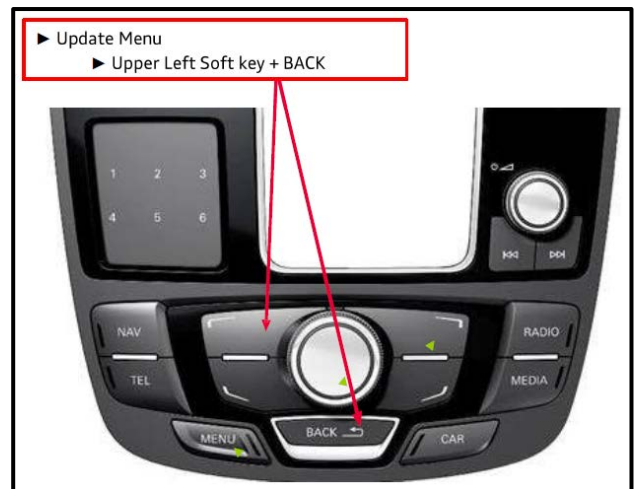
- Insert SD card in SD card reader.
- Initiate software update via the Update Menu (Red Engineering Menu - REM):
  - Press the button combination shown based on what MMI system is installed.
  - The buttons must be pressed simultaneously.
- Navigate the Update Menu using the rotary knob and start the update.

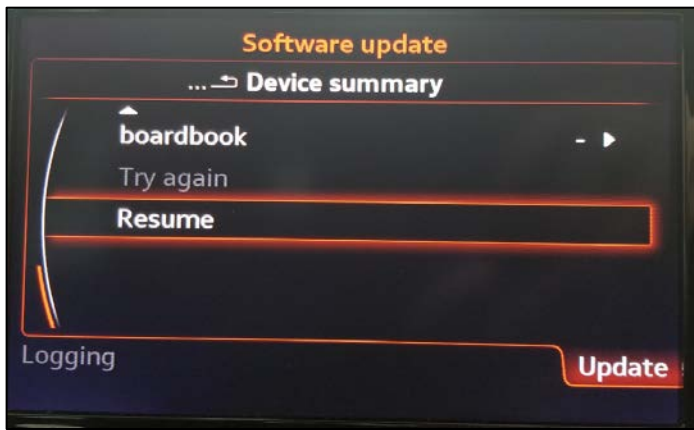
- When the “Device summary” screen appears, scroll down and select “Resume”.

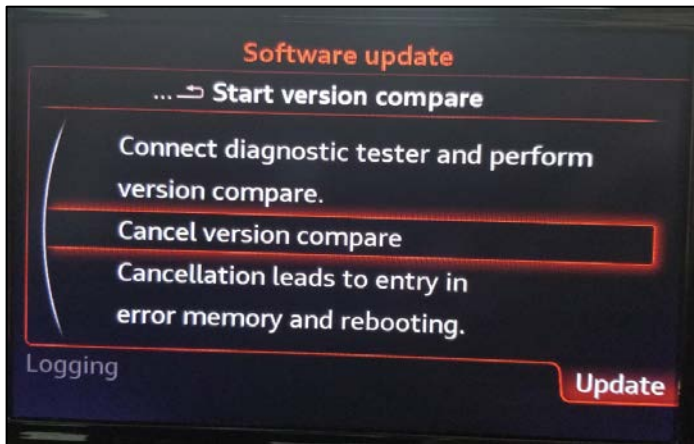
**STOP! STOP!**

- When this message appears, do not make any further selections in the MMI.
- **Proceed to Section C and complete the software update documentation via SVM.**

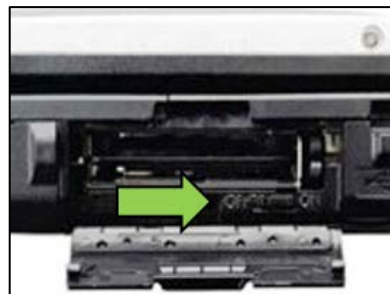
**VAS 6150B**  
(Right side behind WIRELESS door)

- ✓ **The Bluetooth function of the scan tool is physically switched off <see pictures below>.**

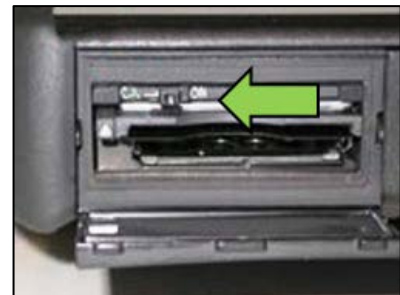
**VAS 6150C**  
(Left side behind SC/EX door)

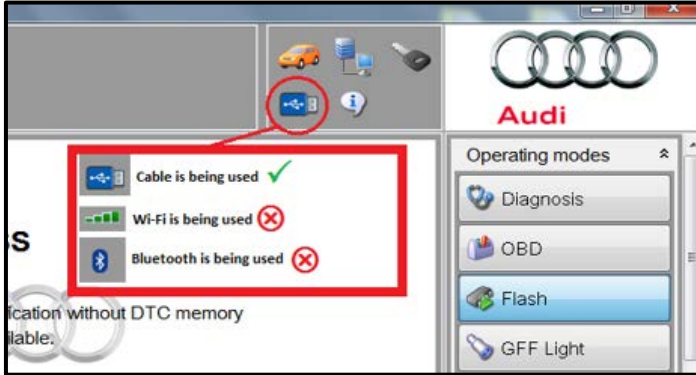
- Confirm that scan tool is communicating with the diagnostic head by USB cable.
  - If the Bluetooth or WiFi symbol is shown, then disconnect the diagnostic head from the vehicle and reconnect the USB cable to the diagnostic head and then reattach to the vehicle.

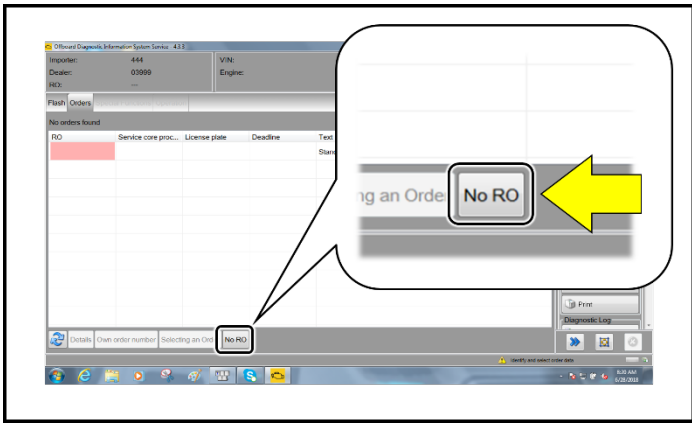
- Select "No RO".

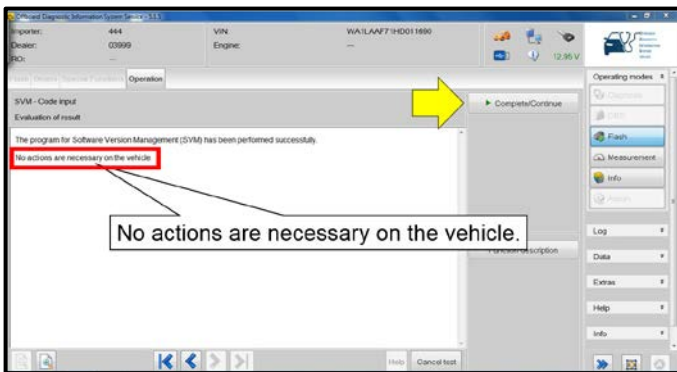
- When the update has completed successfully, this message will appear.
- Select "Complete/Continue" <arrow>.
- Follow the on-screen prompts.

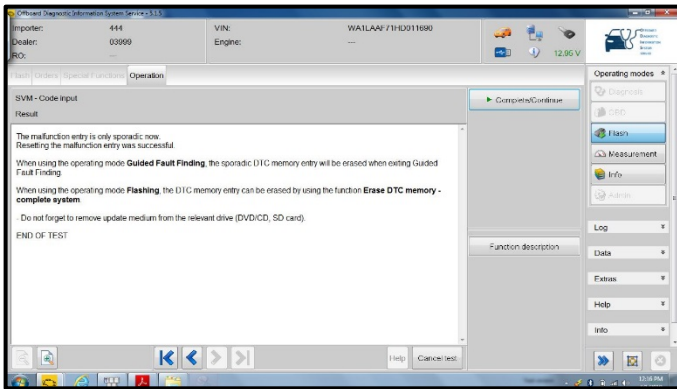
- This message appears after the SVM test plan completes.
- When exiting the Flash program, all faults should clear, including the B201A "Checking software version management" fault that sets during MMI updates.
- There should be no need to clear faults using Guided Fault Finding or by any other method.
