EL18-023c

ITB18-040c

## SOFTWARE UPDATES FOR INFOTAINMENT ISSUES

**APPLIED VEHICLES:** 2016-2018 Q50 (V37)                      2017-2018 QX30 (H15)  
                                 2016-2018 Q50 Hybrid (V37)                      2017-2018 QX60 (L50)  
                                 2017-2018 Q60 (V37)                                      2017-2018 QX60 Hybrid (L50)  
                                 2018 Q70 (Y51)    2018 QX80 (Z62)  
                                 2018 Q70 Hybrid (Y51)

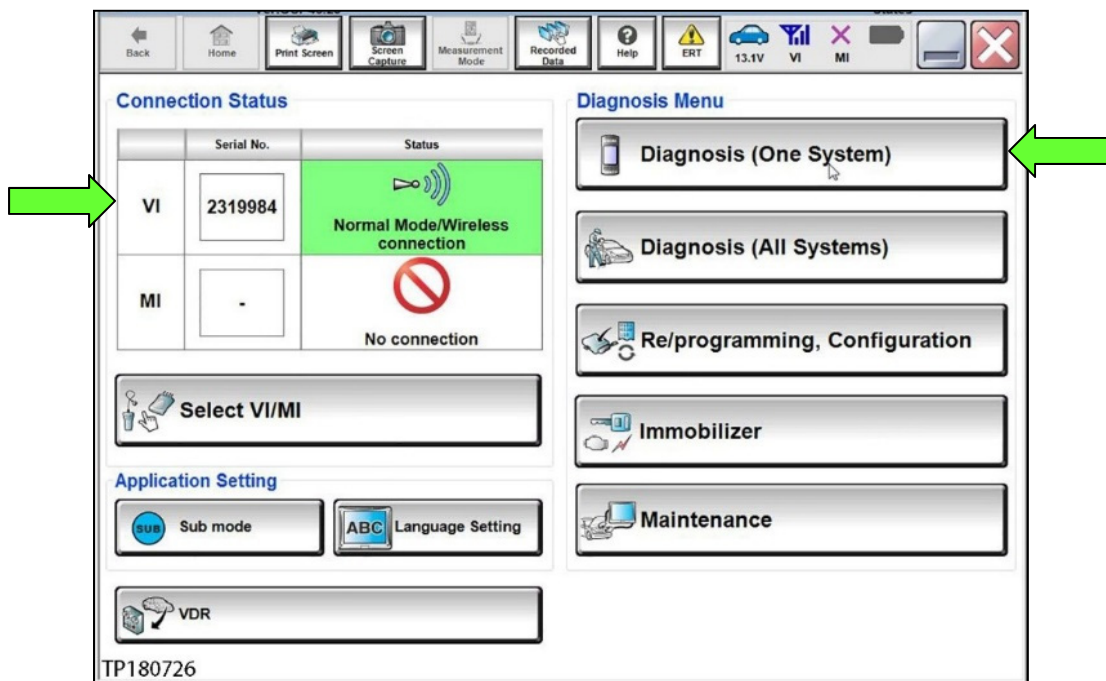
Figure 2

1. Connect the CONSULT PC and plus VI to the vehicle.
2. Start CONSULT-III plus (C-III plus).
3. Turn ON the ignition.
4. Wait for the plus VI to be recognized / connected.
  - The serial number will display when the plus VI is recognized / connected.
5. Select **Diagnosis (One System)**.

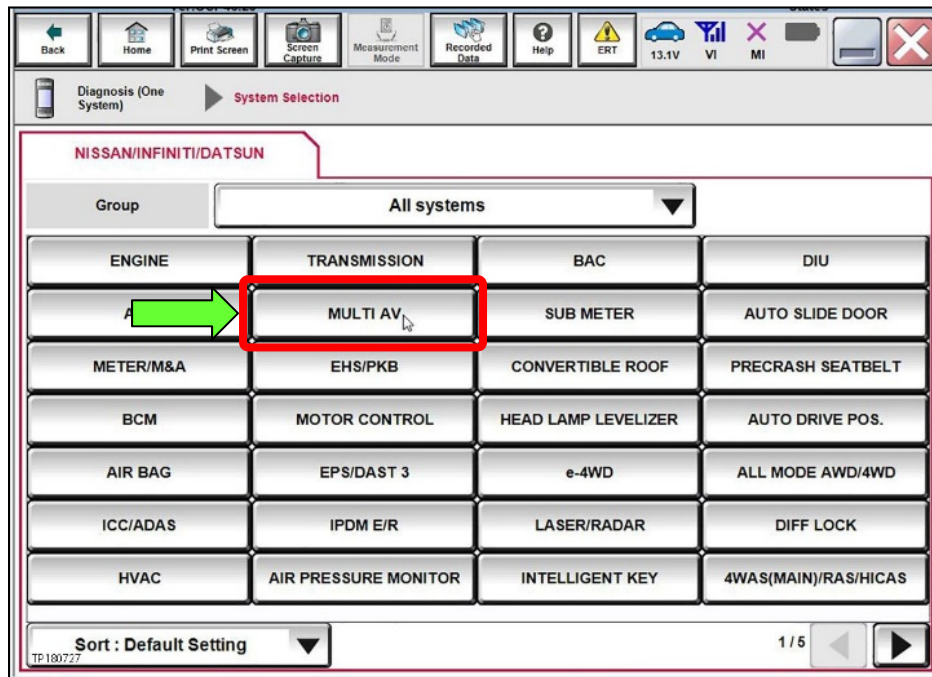
Figure 3

6. Select MULTI AV.

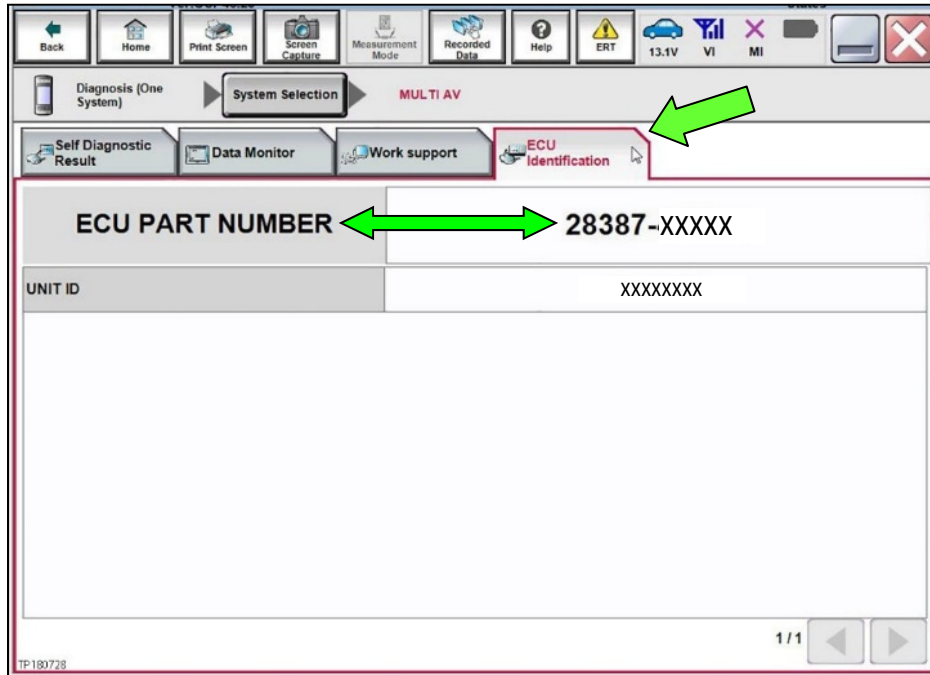
7. Select the **ECU Identification** tab.
8. When the screen in Figure 4 displays, confirm this bulletin applies as follows:
  - a. Write down the **ECU PART NUMBER** on the repair order.

**NOTE:** This is the current DCU part number (P/N).

- b. Compare the P/N written down to the P/Ns in the **CURRENT DCU PART NUMBER** column in **Table A** on the next page.
  - If there is a match, proceed to step 9 on page 6.
  - If there is not a match, DCU updating does not apply. Refer to ASIST for further diagnosis.

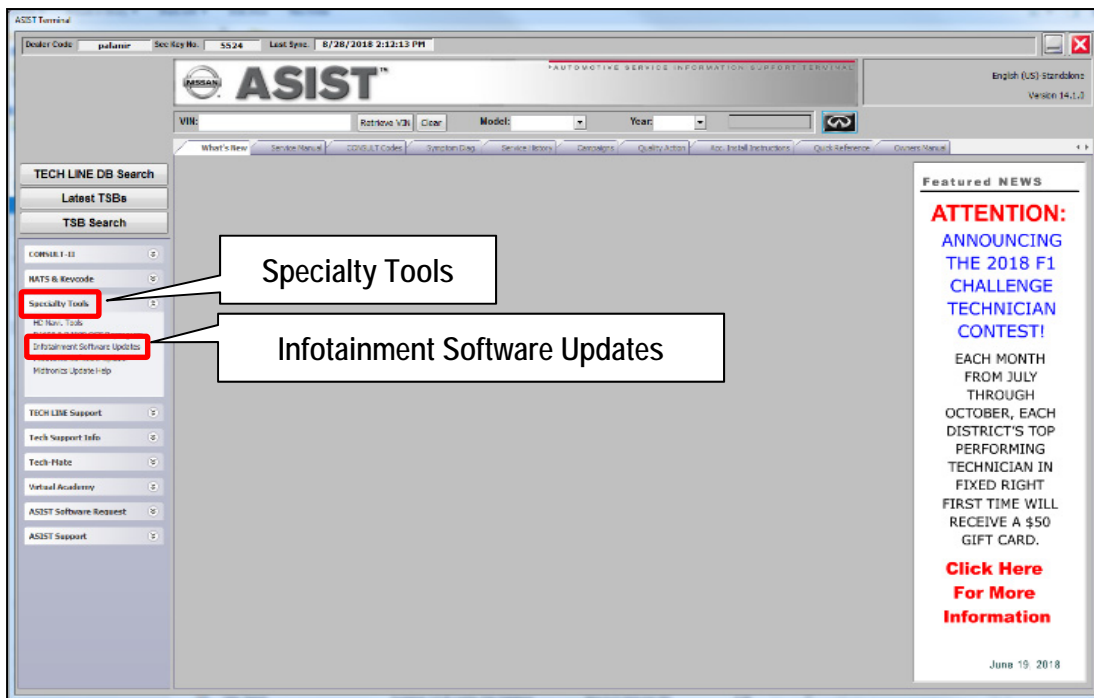
Figure 5

11. Select **Specialty Tools**, and then select **Infotainment Software Updates**.

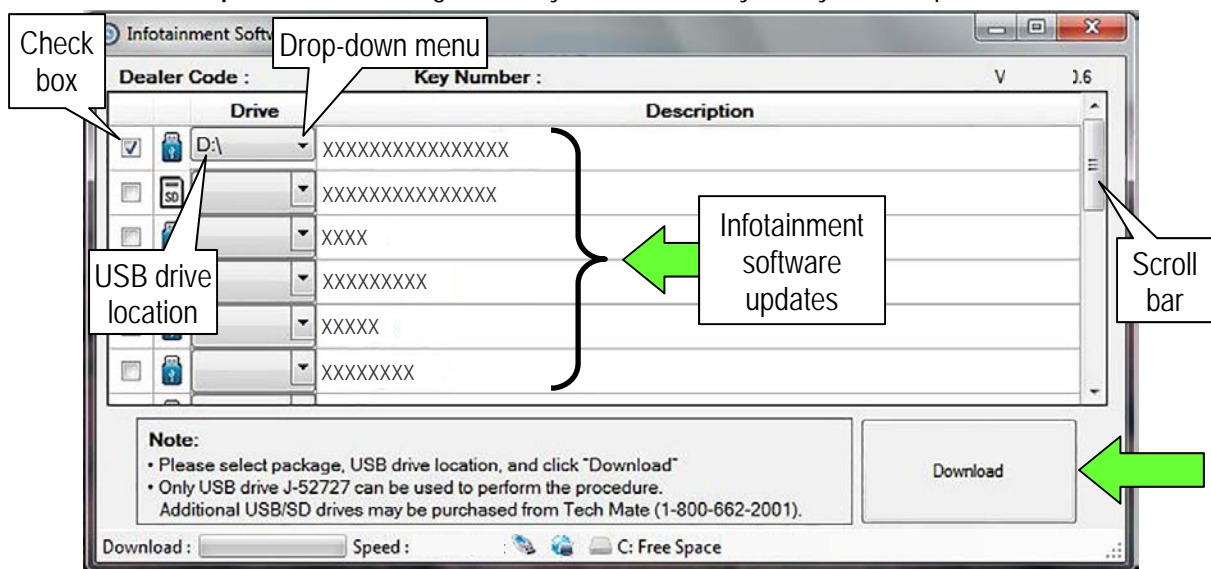
12. Select the check box next to the correct update software package based on **Table B** below (see Figure 6).  
**HINT:** Use the scroll bar, if needed, to find the correct update software package.

13. Use the drop-down menu and select the location of the USB drive that was inserted in step 9.  
**HINT:** The **Description** section in Figure 6 may show differently than your C-III plus screen.

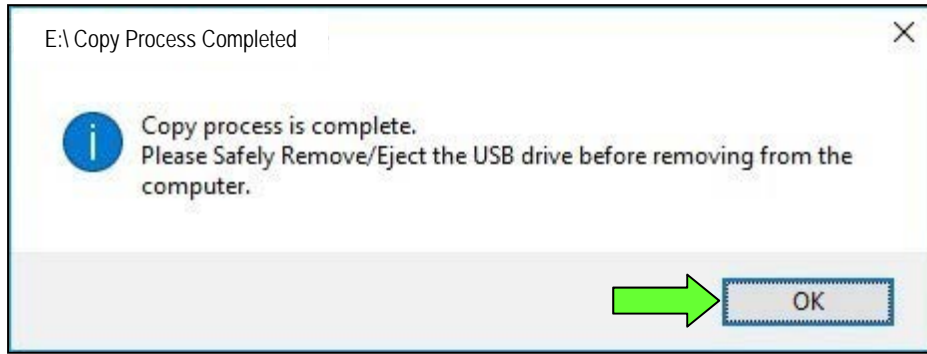
Figure 7

14. Select **Download**, and then wait for the download to complete.

15. Select **OK**.

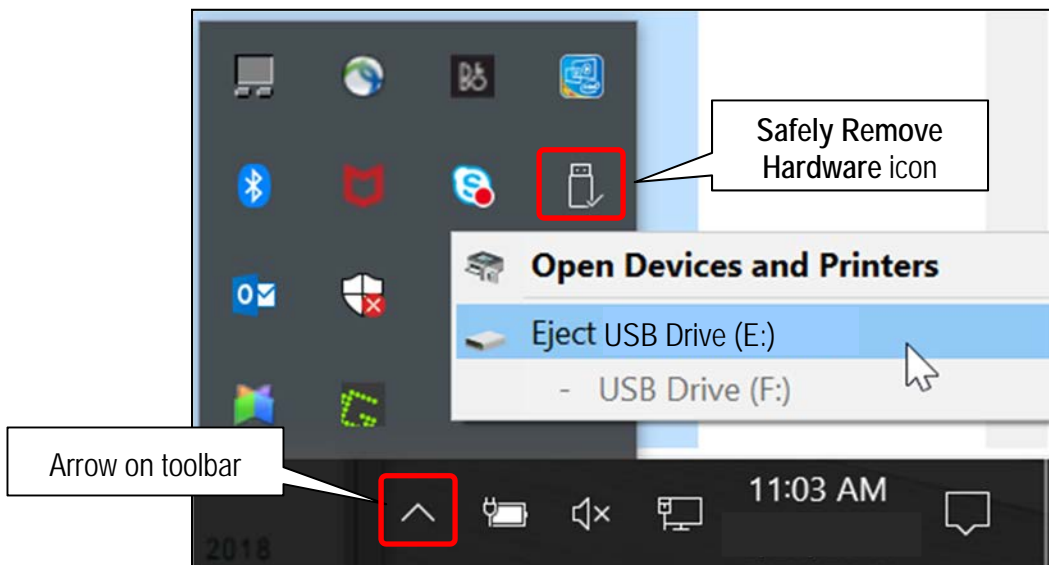
Figure 8

16. Once the transfer is complete, safely remove the USB drive from the ASIST Station.

- a. From the PC toolbar, select the **Safely Remove Hardware** icon.
  - The icon is on the toolbar, or to be found after selecting the arrow.
- b. Select the USB drive to be removed, and then remove the USB drive from the ASIST Station.

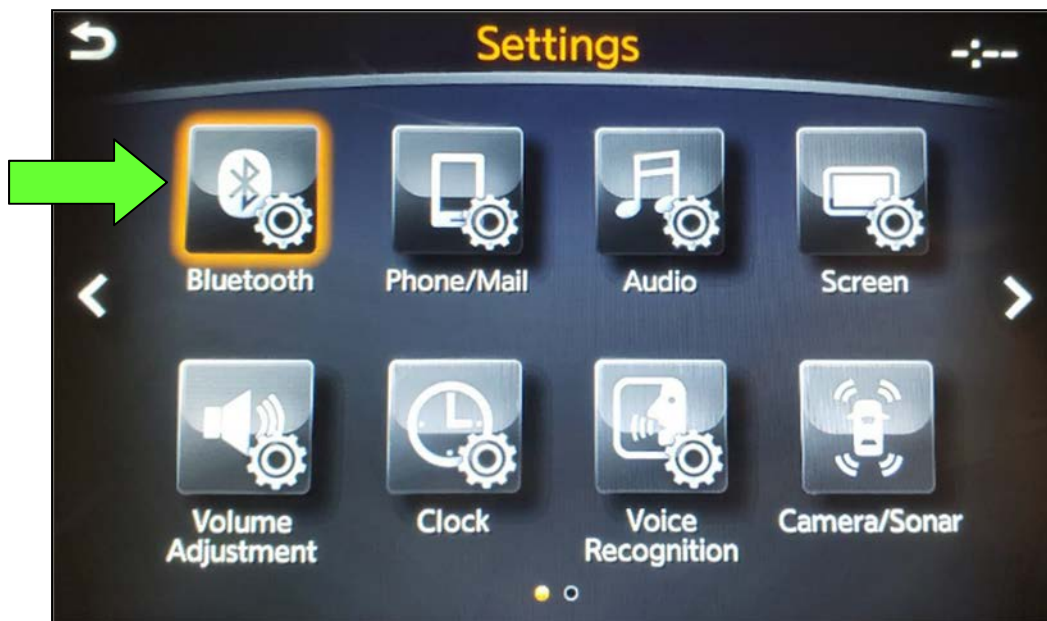
Figure 9

19. Open the Settings Menu, and then select **Bluetooth**.

- The **Settings** menu is accessed with the hard button located under the display.

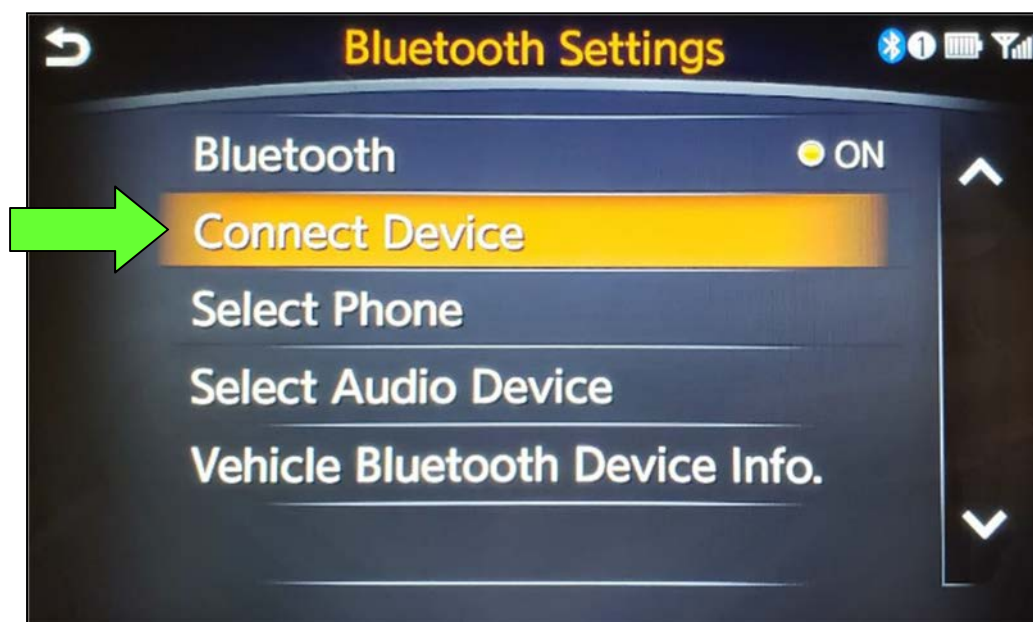
Figure 10

20. Select **Connect Device** from the **Bluetooth Settings** menu.

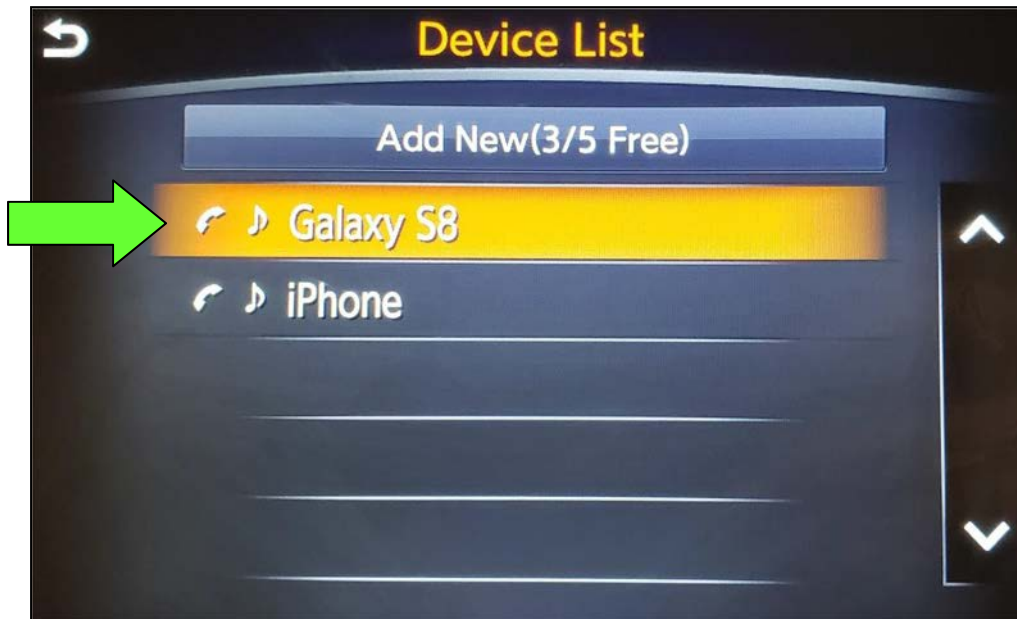
Figure 11

21. Check for devices in the **Device List**:

- **YES**, one or more devices are listed: Select a device, and then proceed to step 22.
- **NO**, there are no listed devices: Skip to step 24.

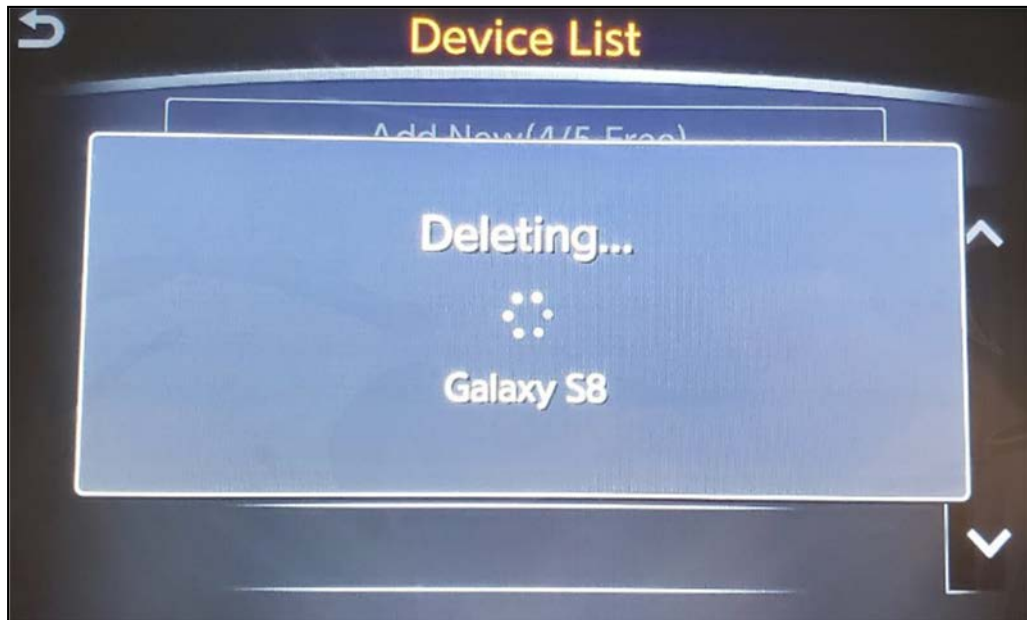
- The first screen will show "Deleting..." followed by the device name.

22. Select **Delete** and confirm the screens in Figure 13 and then Figure 14 are displayed.

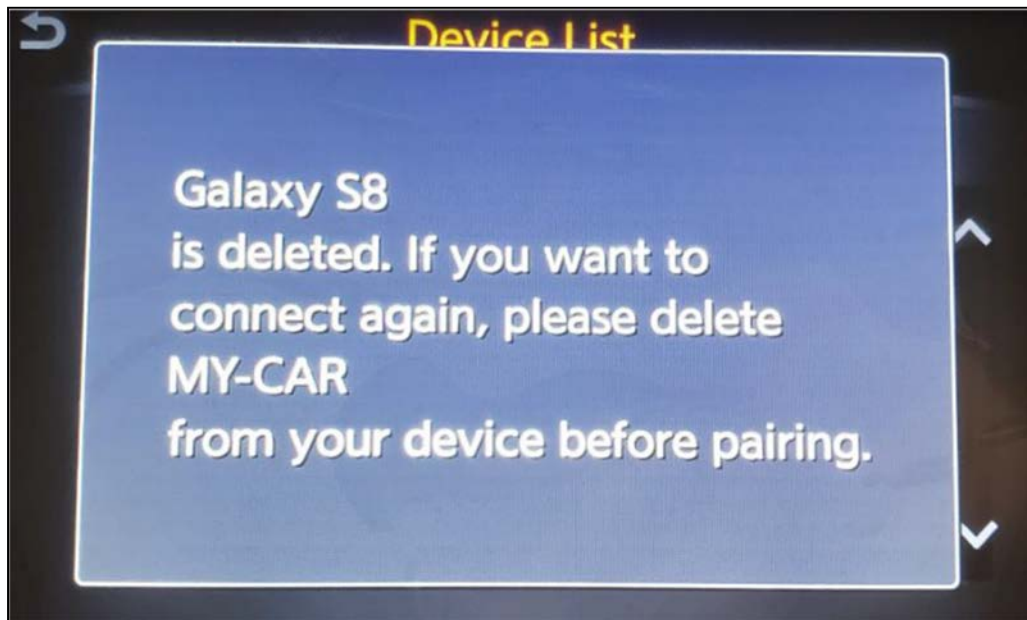
Figure 14

- The second screen will show information regarding repairing the Bluetooth® device.

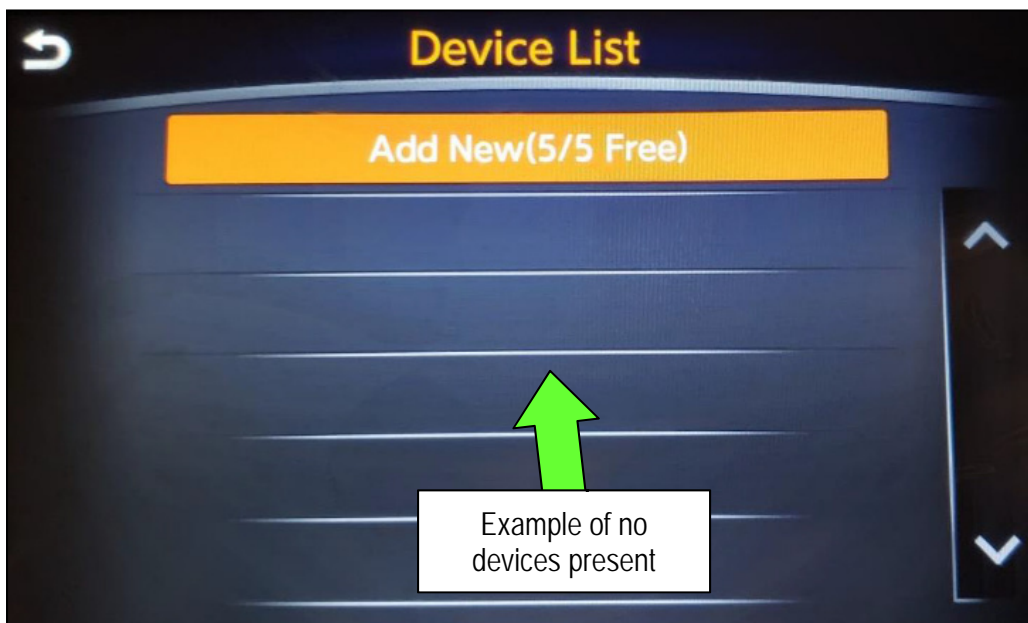
- Figure 16 will be displayed when all listed devices have been deleted.

**HINT:** If no connected devices are present, Figure 16 (page 12) will display.

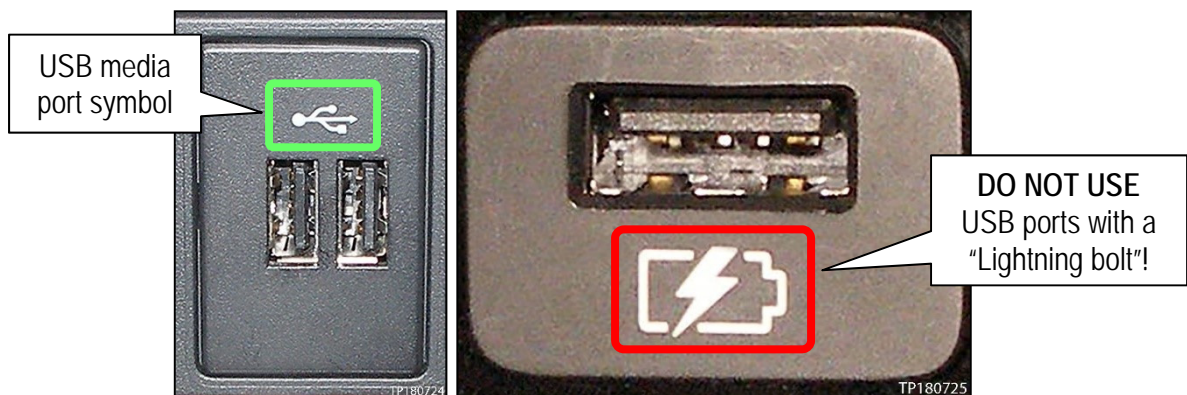
Figure 17

24. Insert the USB drive with infotainment update software into the vehicle's USB media port (see Figure 17).

**HINT:** Charging ports are marked in the vehicle with a "lightning bolt" symbol.

Do not insert the USB drive into a charging port. If used, the update software and/or USB drive may become damaged. Only insert the USB drive in a USB media port.

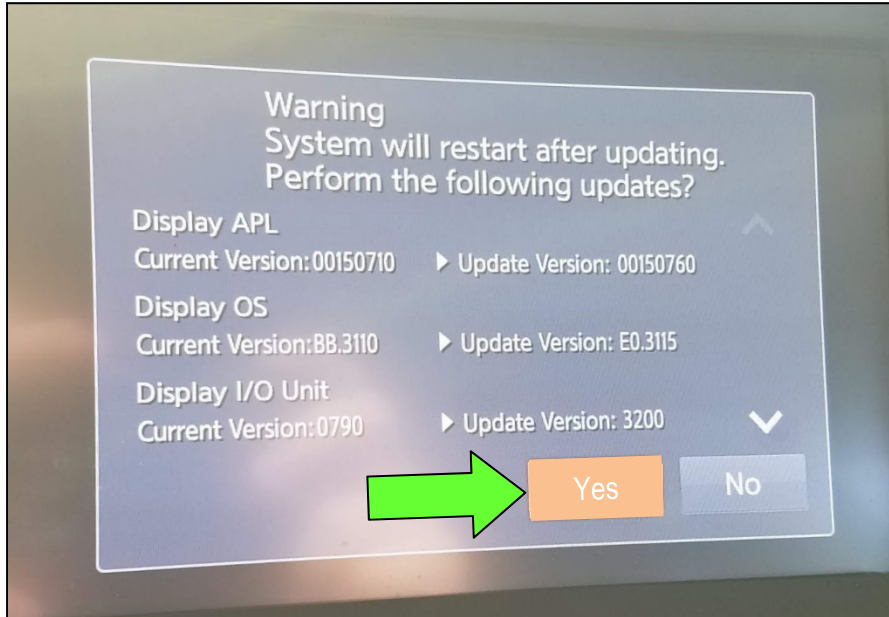
25. Wait approximately 10-30 seconds for the screen in Figure 19 or Figure 20 to appear.

- If the screen shown in Figure 19 appears, proceed to step 26 below.
- If the screen shown in Figure 20 appears, then no software update is available. Refer to ASIST for further diagnostic information.

1. To confirm an update applies to the Display Control Unit (DCU) of the vehicle being worked on, you **MUST** refer to page 4, step 8, **AND** page 14, Figure 19 in the **SERVICE PROCEDURE**.

1. Comparing the DCU part number with those listed in **Table A** on page 5,  
**AND**
2. Verifying new software is required as shown on page 14, Figure 19.

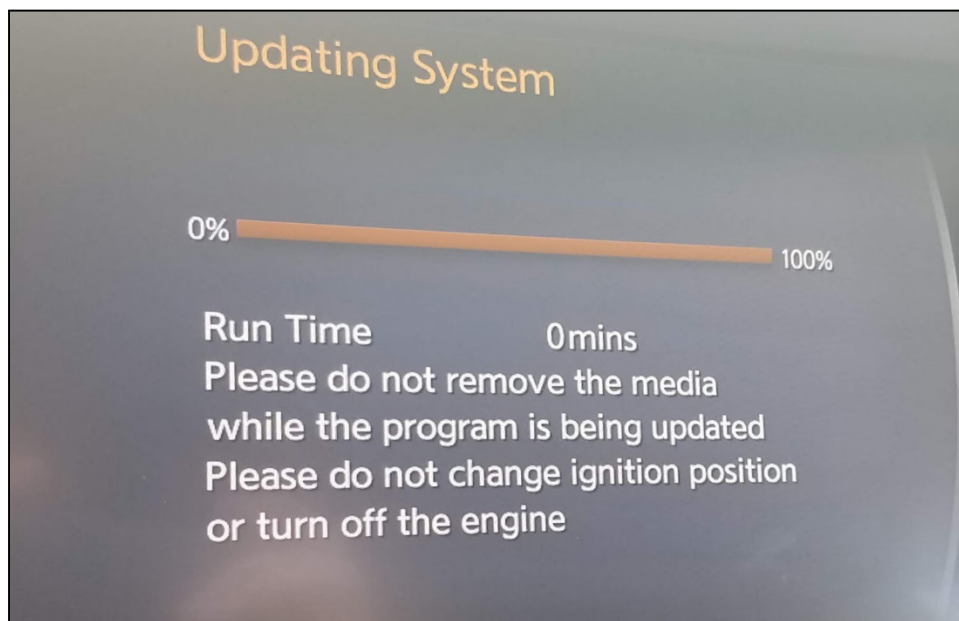
Figure 21

26. Select **Yes** to begin the software update.

27. Wait for the update to complete.

**HINT:** The update lasts 10-70 minutes.

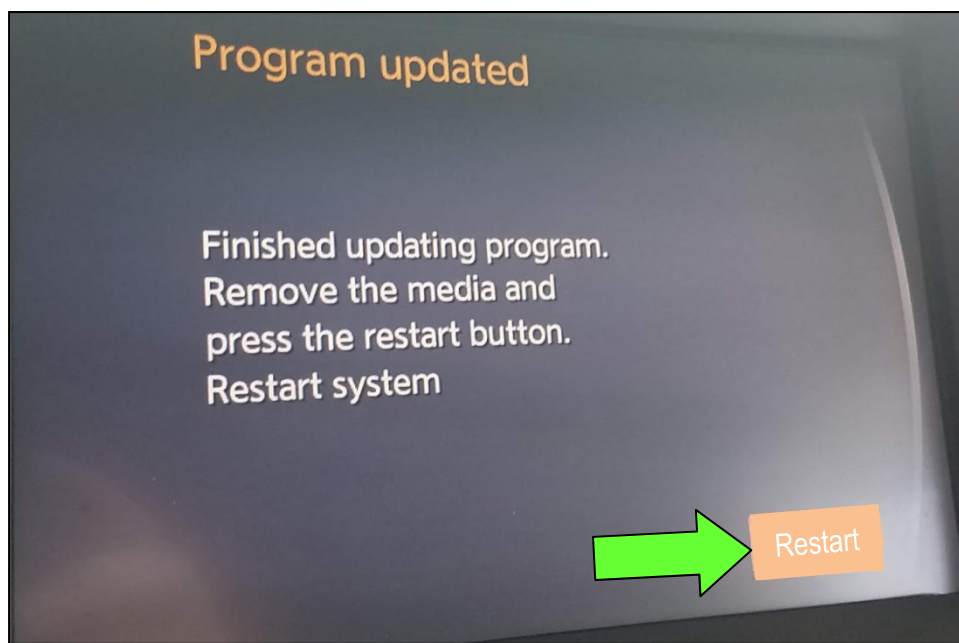
Figure 22

28. Once the update is complete, remove the USB drive, and then select **Restart**.
