SERVICE BULLETIN

EL18-022c

2017-2018 PATHFINDER AND 2018 ARMADA; SOFTWARE UPDATES FOR INFOTAINMENT ISSUES

APPLIED VEHICLES: 2017-2018 Pathfinder (R52)
2018 Armada (Y62)

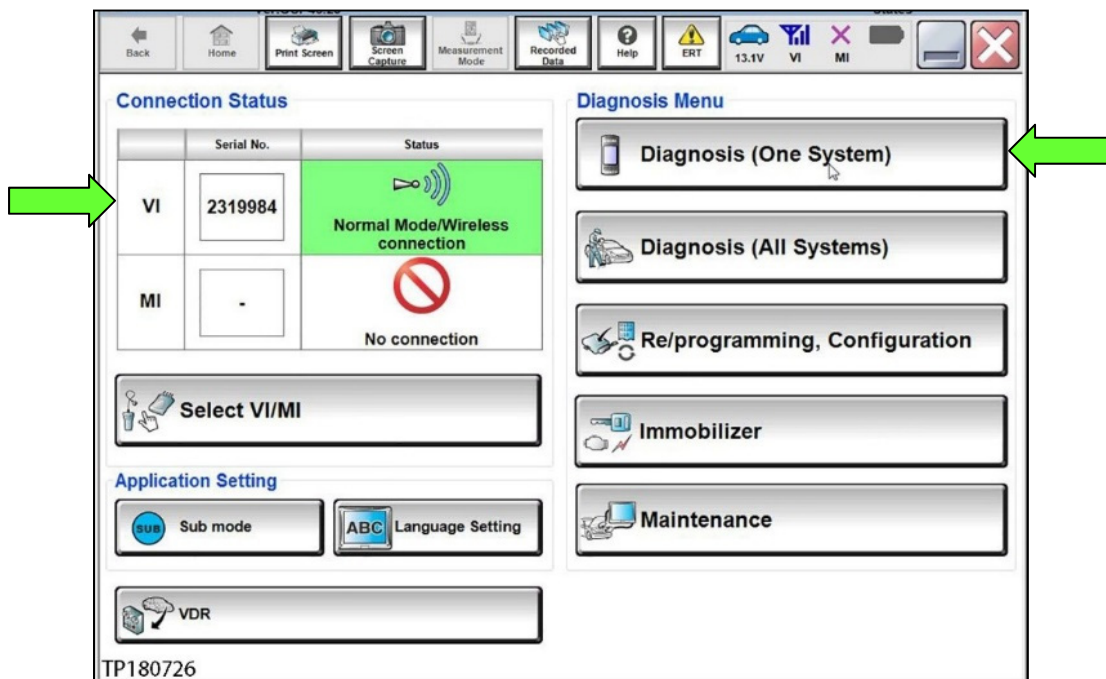
Figure 2

1. Connect the CONSULT PC and plus VI to the vehicle.
2. Start CONSULT-III plus (C-III plus).
3. Turn ON the ignition.
4. Wait for the plus VI to be recognized / connected.
 - The serial number will display when the plus VI is recognized / connected.
5. Select **Diagnosis (One System)**.

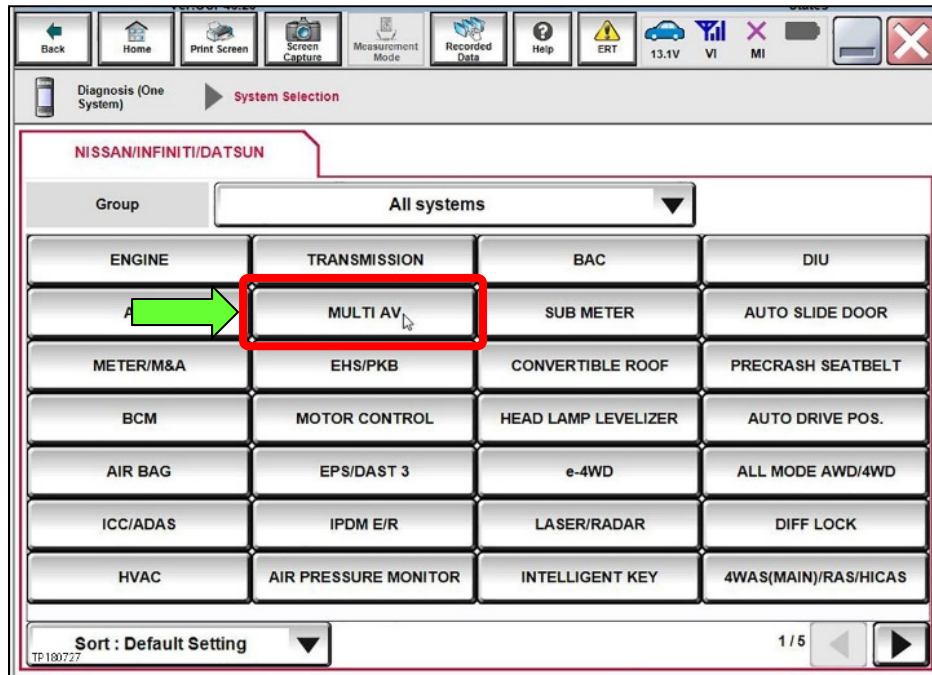
Figure 3

6. Select **MULTI AV**.

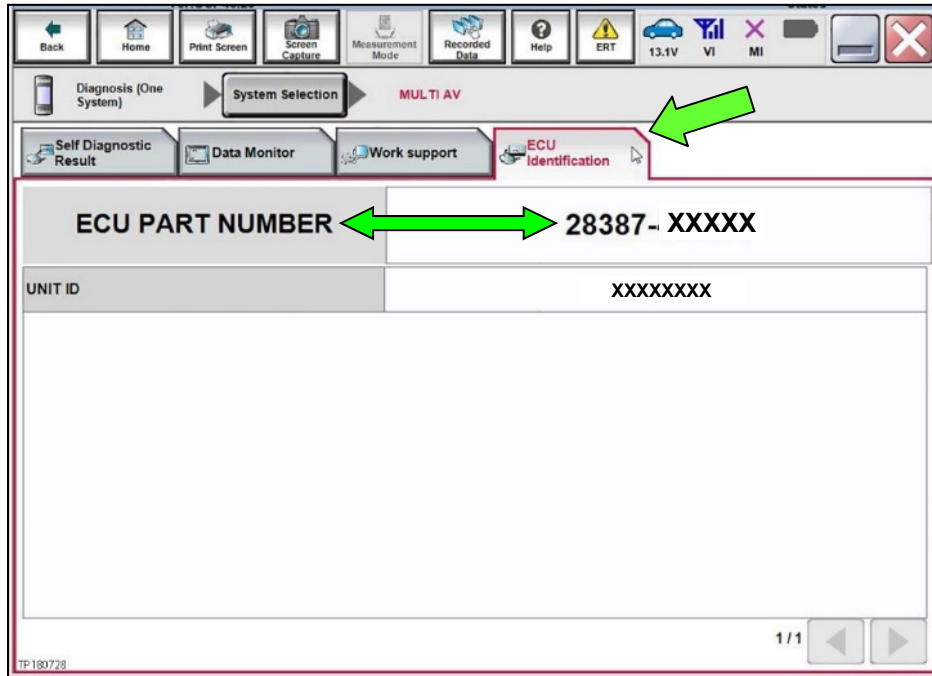
7. Select the **ECU Identification** tab.
8. When the screen in Figure 4 displays, confirm this bulletin applies as follows:
 - a. Write down the **ECU PART NUMBER** on the repair order.

NOTE: This is the current DCU part number (P/N).

1. To confirm an update applies to the Display Control Unit (DCU) of the vehicle being worked on, you **MUST** refer to page 4, step 8, **AND** page 13, Figure 19 in the **SERVICE PROCEDURE**.

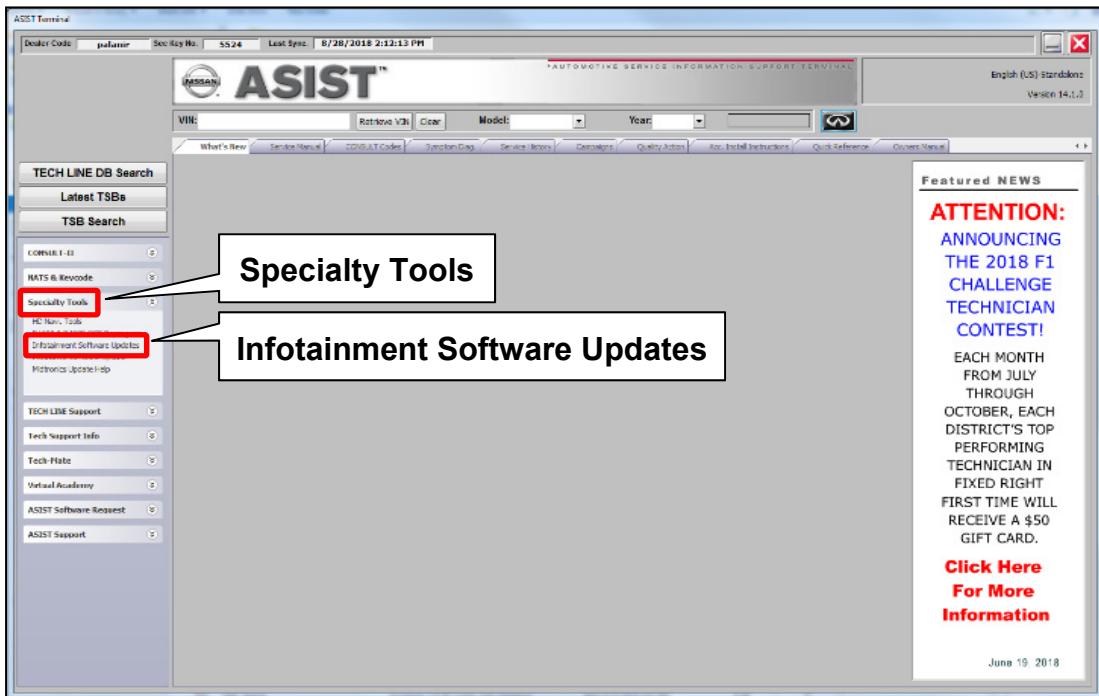
Figure 5

11. Select **Specialty Tools**, and then select **Infotainment Software Updates**.

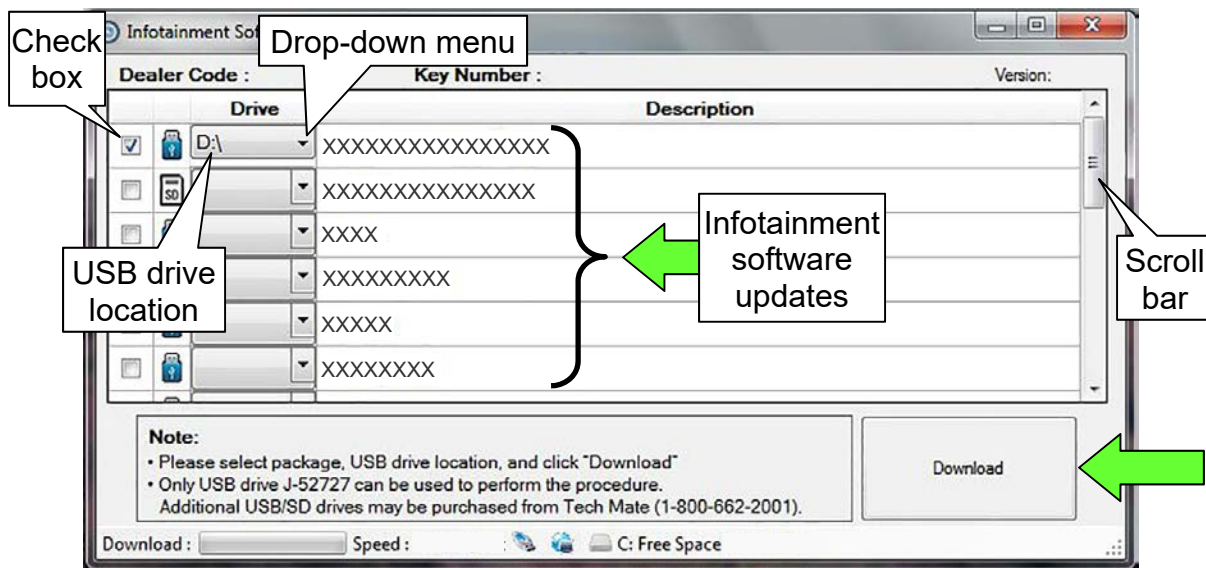
- Select the check box next to the correct update software package based on **Table B** below (see Figure 6).

HINT: The **Description** section in Figure 6 may show differently than your C-III plus screen.

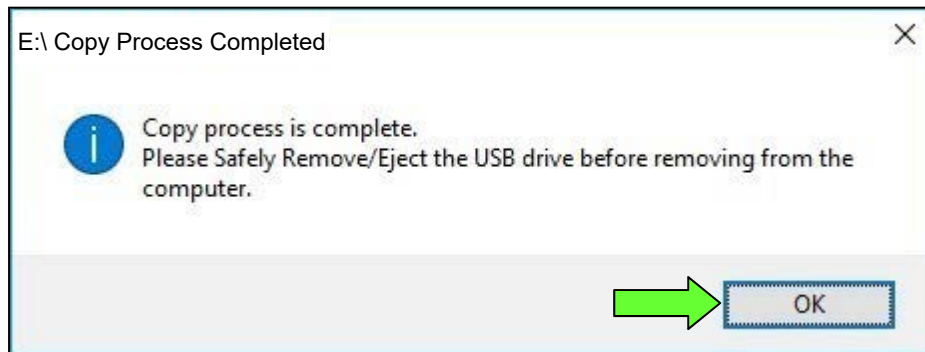
Figure 7

15. Select **OK**.

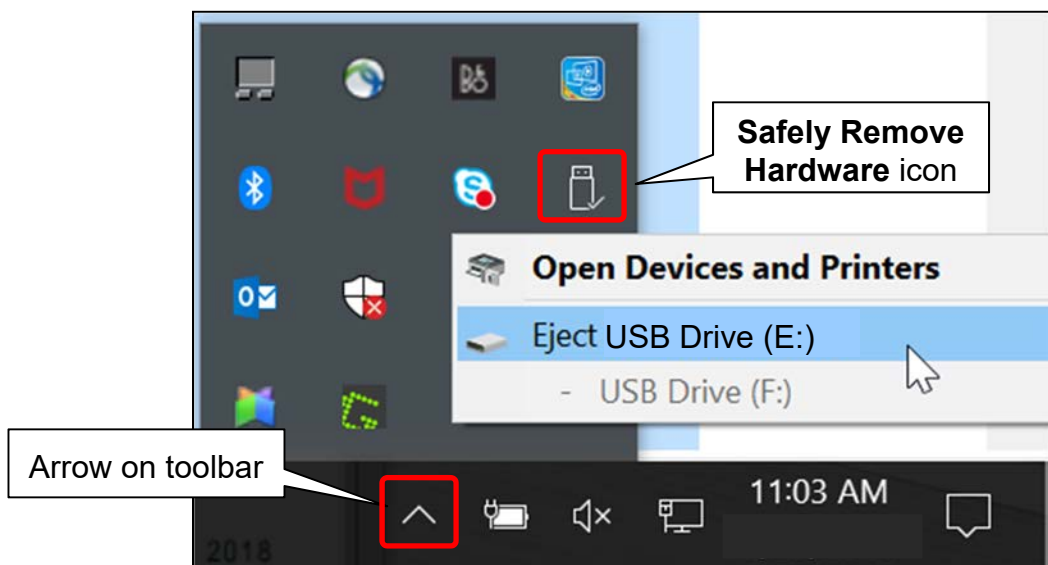
Figure 8

16. Once the transfer is complete, safely remove the USB drive from the ASIST Station.

- a. From the PC toolbar, select the **Safely Remove Hardware** icon.
 - The icon is on the toolbar, or to be found after selecting the arrow.
- b. Select the USB drive to be removed, and then remove the USB drive from the ASIST Station.

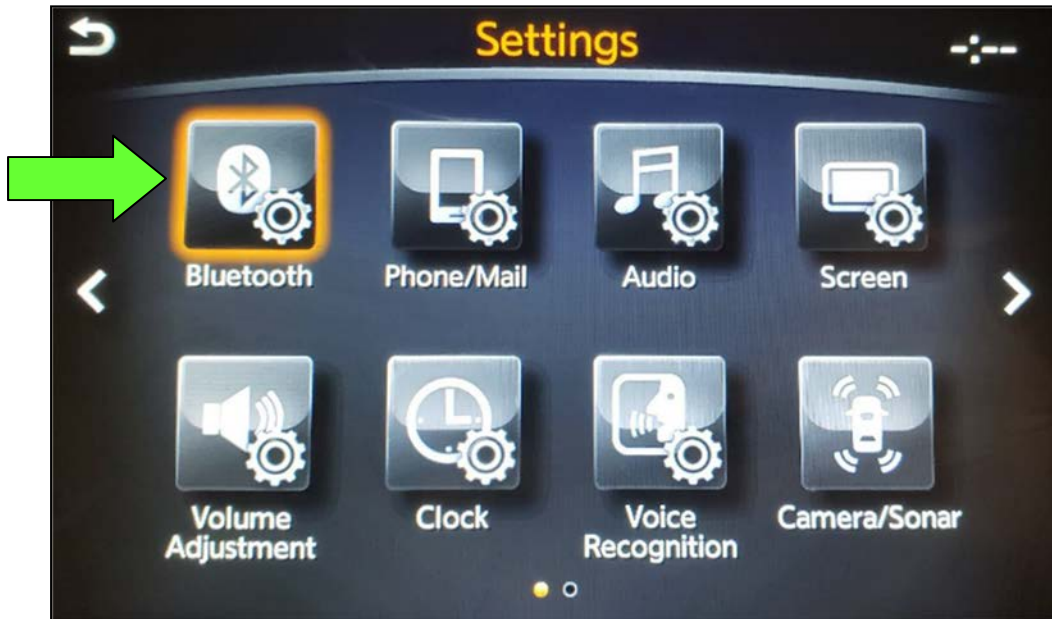
Figure 9

19. Open the Settings Menu, and then select **Bluetooth**.
- The **Settings** menu is accessed with the hard button located under the display.

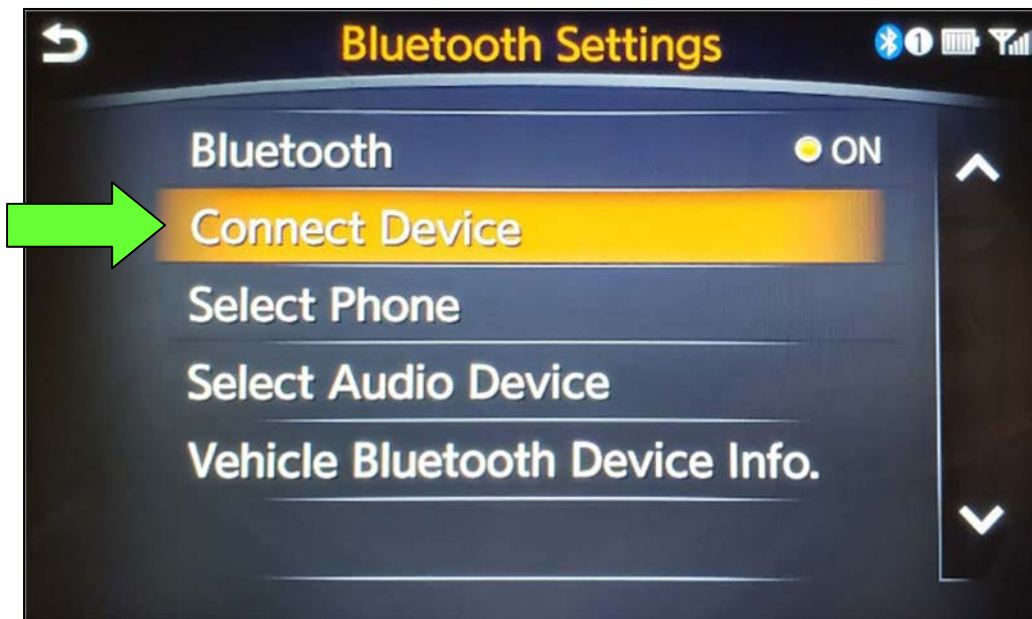
Figure 10

20. Select **Connect Device** from the **Bluetooth Settings** menu.

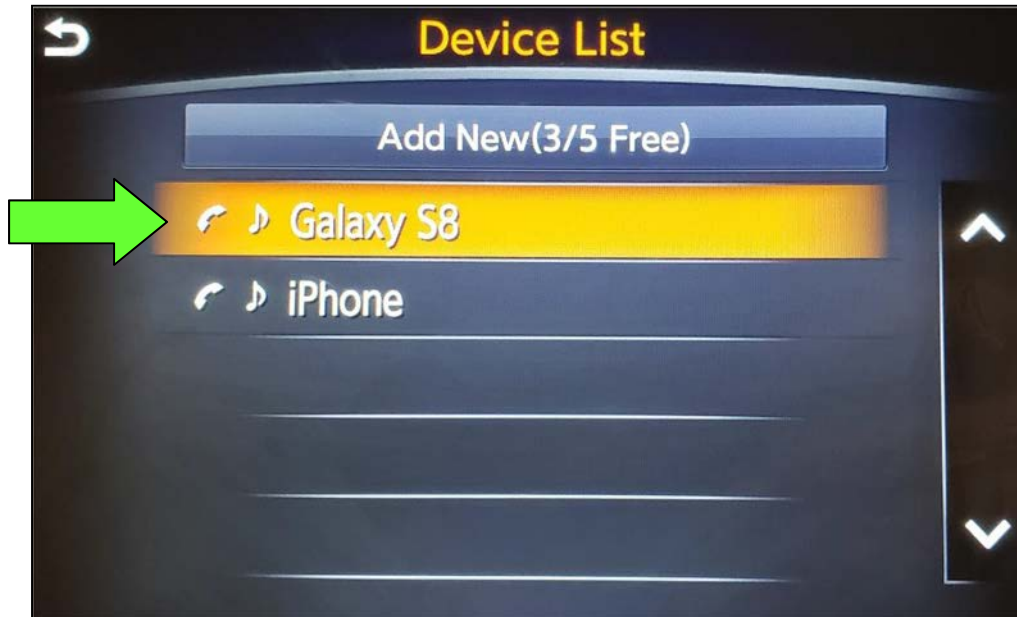
Figure 11

21. Check for devices in the **Device List**:

- **YES**, one or more devices are listed: Select a device, and then proceed to step 22.
- **NO**, there are no listed devices: Skip to step 24.

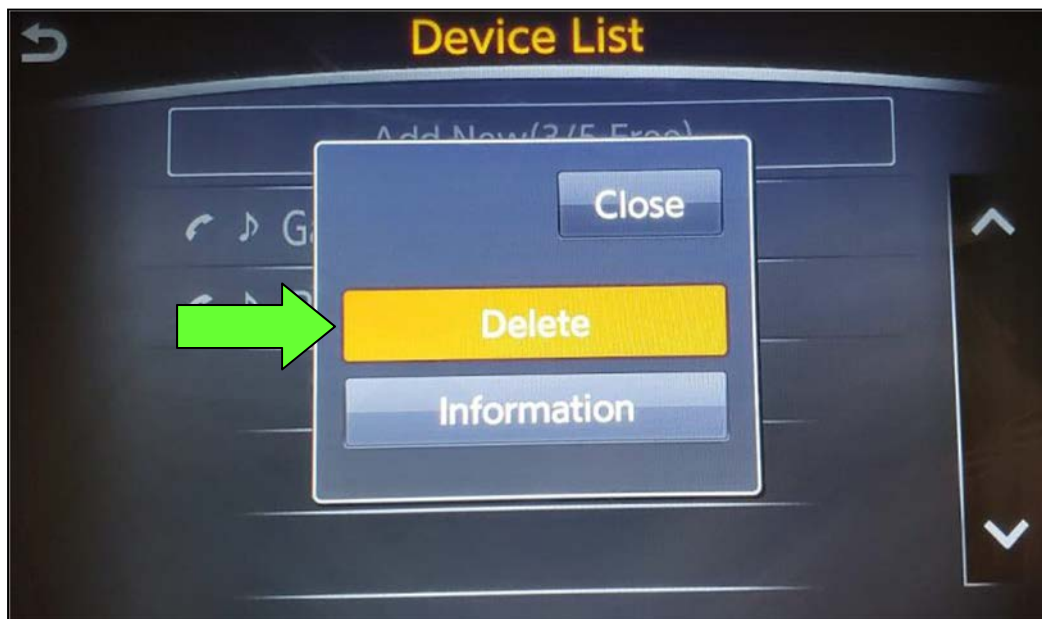
Figure 12

22. Select **Delete** and confirm the screens in Figure 13 and then Figure 14 are displayed.

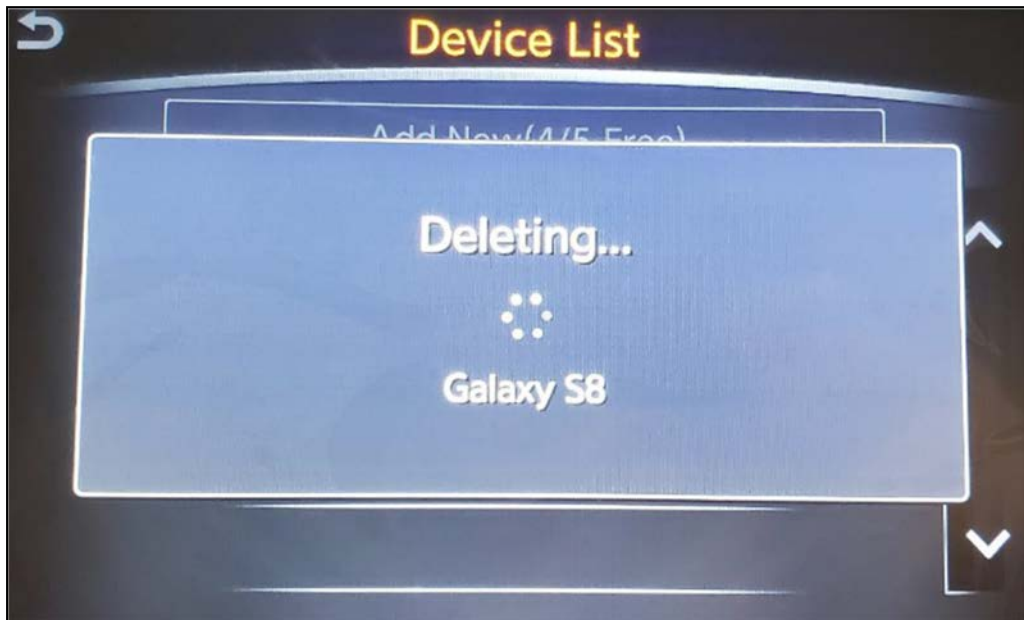
Figure 13

- The first screen will show “Deleting...” followed by the device name.

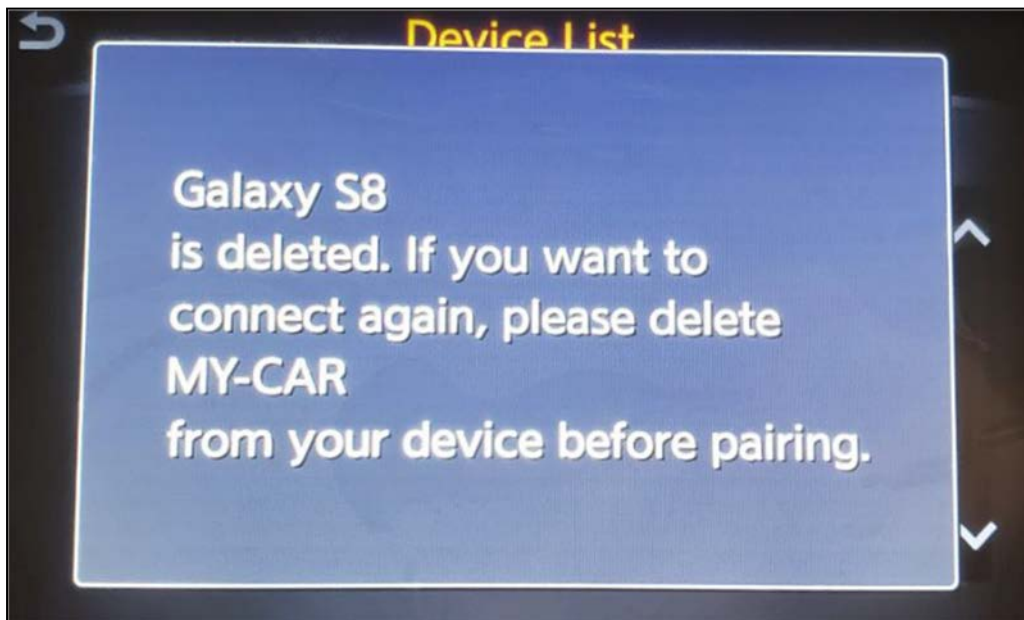
Figure 14

- The second screen will show information regarding repairing the Bluetooth® device.

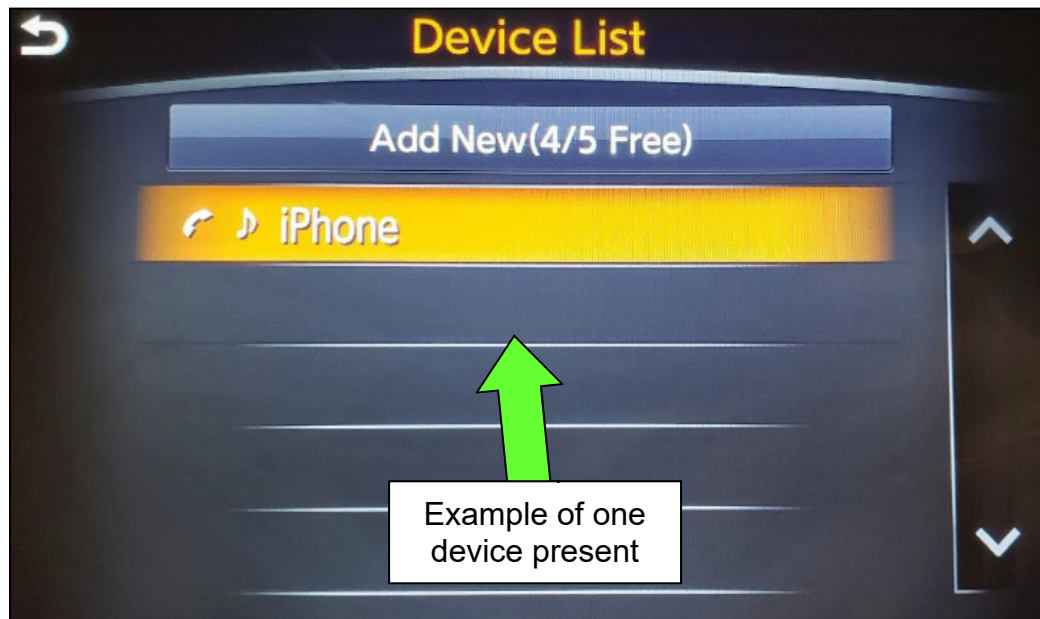
Figure 15

23. Check for additional devices in the **Device List**:

- **YES**, there are more listed devices: Perform steps 21 and 22 until all listed devices are deleted.
- **NO**, there are no listed devices: Proceed to step 24.

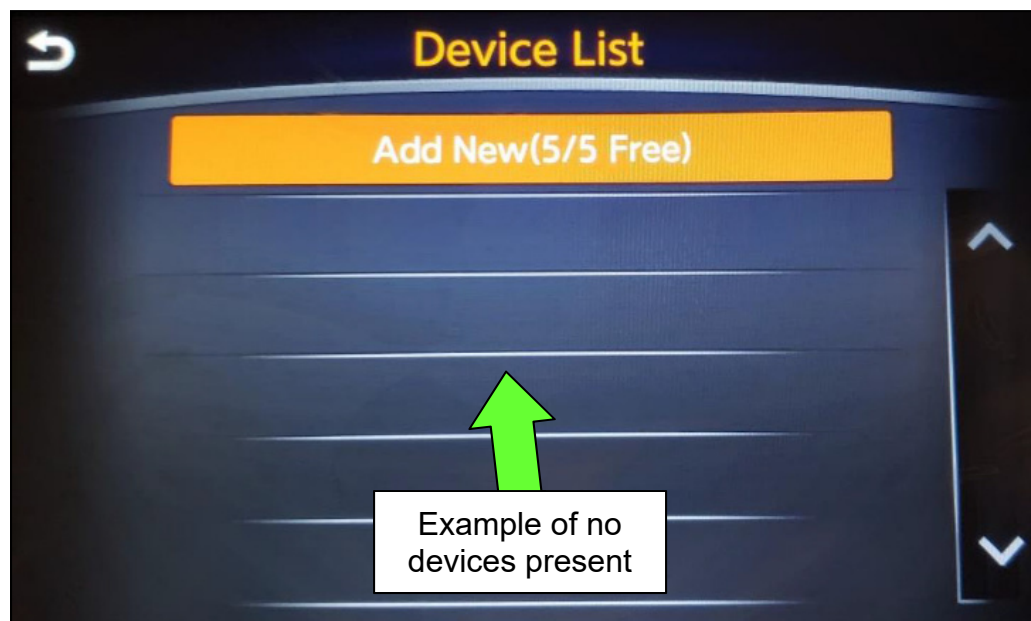
- Figure 16 will be displayed when all listed devices have been deleted.

HINT: If no connected devices are present, Figure 16 (page 11) will display.

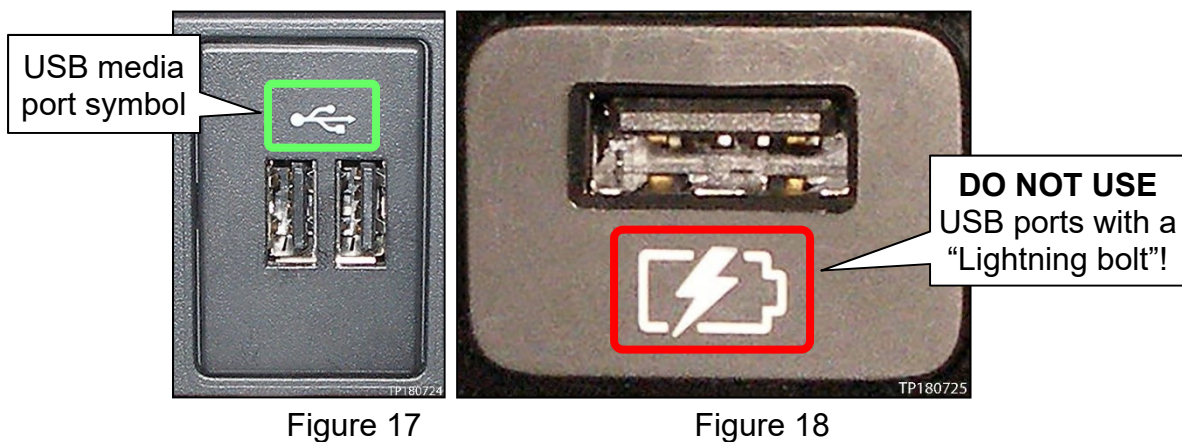
24. Insert the USB drive with infotainment update software into the vehicle's USB media port (see Figure 17).

HINT: Charging ports are marked in the vehicle with a “lightning bolt” symbol.

Do not insert the USB drive into a charging port. If used, the update software and/or USB drive may become damaged. Only insert the USB drive in a USB media port.

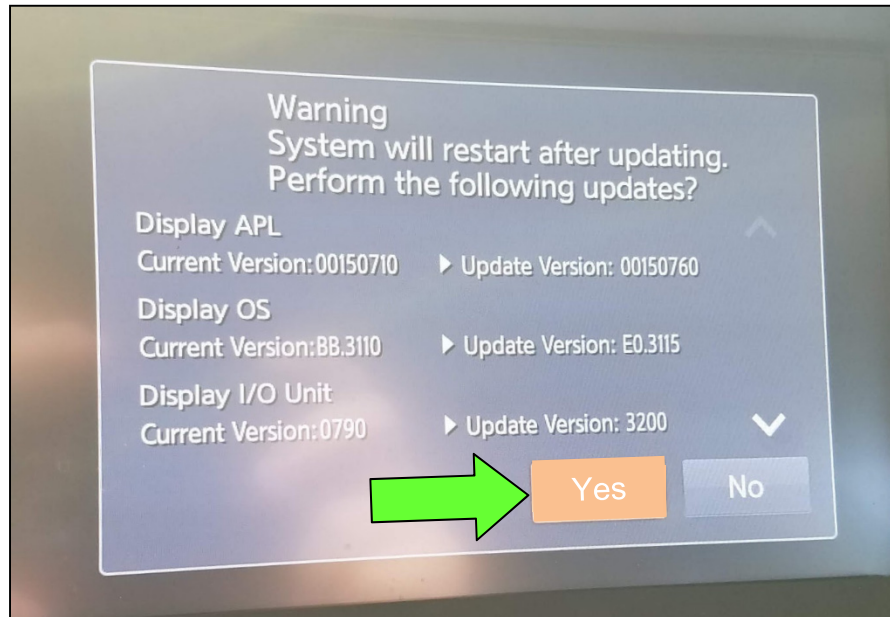
25. Wait approximately 10-30 seconds for the screen in Figure 19 or Figure 20 to appear.

- If the screen shown in Figure 19 appears, proceed to step 26 below.
- If the screen shown in Figure 20 appears, then no software update is available. Refer to ASIST for further diagnostic information.

1. Comparing the DCU part number with those listed in **Table A** on page 4, **AND**
 2. Verifying new software is required as shown on page 13, Figure 19.

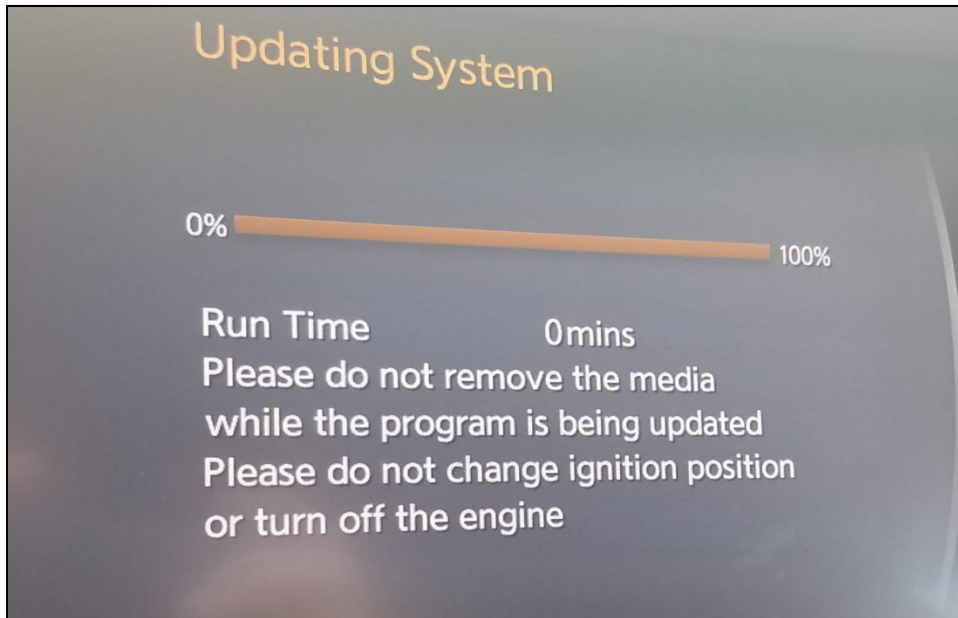
Figure 21

27. Wait for the update to complete.
- Follow the on-screen instructions while waiting.
- HINT:** The update lasts 10-70 minutes.

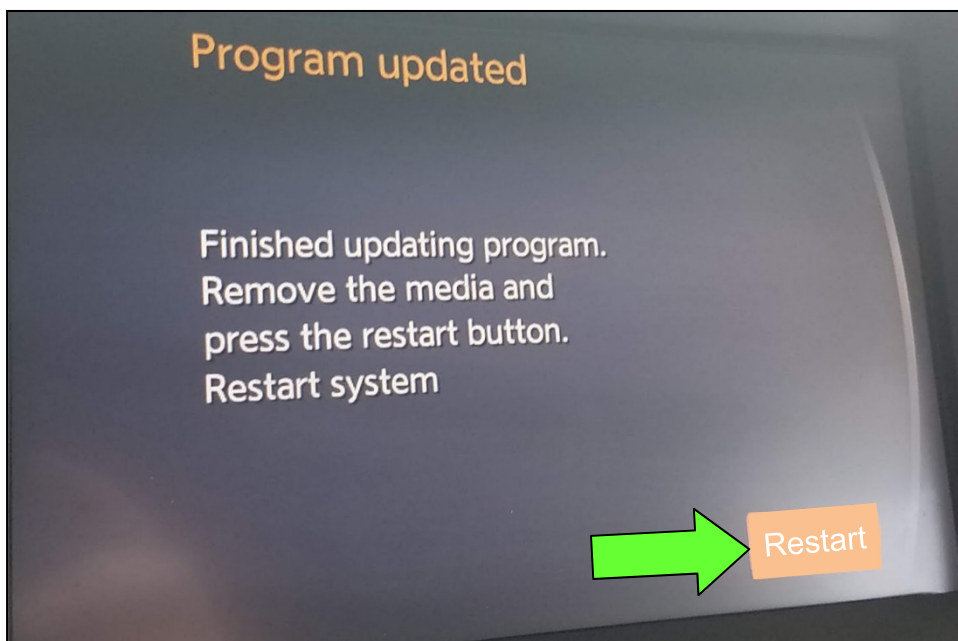
Figure 22

28. Once the update is complete, remove the USB drive, and then select **Restart**.
