EC19-027

ITB19-027

MIL ON WITH DTC P0087, P0101, P0448, OR P2008

APPLIED VEHICLES: 2016 – 2019 Q50 (V37)
 2017 – 2019 Q60 (CV37)
 2015 – 2019 QX60 (L50)

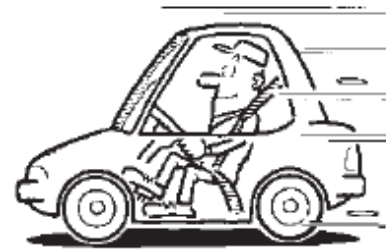
Figure 1

- If you are not familiar with the reprogramming procedure, *click here*. This will link you to the "CONSULT- III plus (C-III plus) ECM Reprogramming" general procedure.
- Take the vehicle for a 10 minute drive in order to meet the following Idle Air Volume Learn (IAVL) conditions:
 - Engine coolant temperature: 70 -100°C (158 - 212°F)
 - Battery voltage: More than 12.9V (At idle)
 - Transmission: Warmed up
- After reprogramming is complete, you will be required to perform Throttle Valve Closed Position, Idle Air Volume Learn, Accelerator Closed Position, and DTC erase.
