**TECHNICAL INSTRUCTIONS**  
**FOR**  
**LIMITED SERVICE CAMPAIGN**  
**SAFETY CONNECT SYSTEM – VEHICLE LOCATION INACCURATE**  
**CERTAIN**

**2011 – 2017 MODEL YEAR LS, 2013 – 2016 MODEL YEAR LS Hybrid,  
2011 – 2017 MODEL YEAR GS, 2016 – 2017 MODEL YEAR GS-F,  
2013 – 2017 MODEL YEAR GS Hybrid, 2010 – 2017 MODEL YEAR IS,  
2011 – 2015 MODEL YEAR IS-C, 2013 – 2014 MODEL YEAR IS-F,  
2015 – 2017 MODEL YEAR RC, 2015 – 2017 MODEL YEAR RC-F,  
2011 – 2017 MODEL YEAR CT, 2010 – 2017 MODEL YEAR RX,  
2010 – 2017 MODEL YEAR RX Hybrid, 2015 – 2017 MODEL YEAR NX,  
2015 – 2017 MODEL YEAR NX Hybrid, 2013 – 2017 MODEL YEAR LX,  
2013 – 2018 MODEL YEAR GX, 2010 – 2017 MODEL YEAR ES,  
2013 – 2017 MODEL YEAR ES Hybrid**

The Data Communication Module (DCM) in the subject vehicles are equipped with software to identify the location of the vehicle using the Global Positioning System (GPS) to support features of the Safety Connect system. Due to incorrect programming in the DCM software, after November 2<sup>nd</sup>, 2019, the GPS coordinates for this system will be calculated incorrectly. This will cause the system to use incorrect vehicle coordinates if one of the system's features is activate

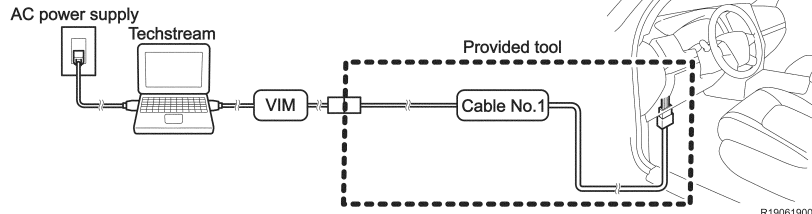
- a) Turn the IG OFF.
- b) Using a Cable No.1 (provided tool), connect the Techstream to the vehicle.

- Turn off the screen saver and power saving mode of the PC.
- Use the external power supply for the PC. (**DO NOT** use the PC's internal battery or vehicle's battery.)
- Ensure that the communication cable connectors are securely connected, the cable is in good condition, and the connection is stable.

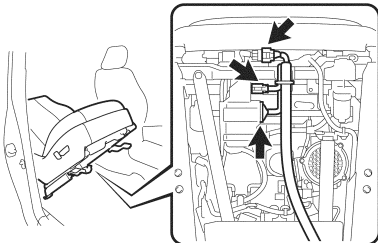
**Be sure to disconnect each connector after disconnect the negative battery terminal**

This illustration uses GS for reference

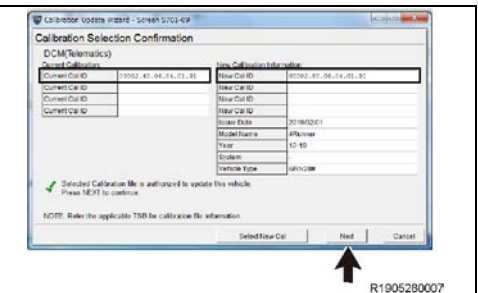
- d) Confirm that "Current Cal ID" and "New Cal ID" are correct, and then click on "Next".

**NOTE: The calibration IDs will be displayed as shown on the left. Please make sure you *DO NOT* mistake where to check to confirm the IDs.**

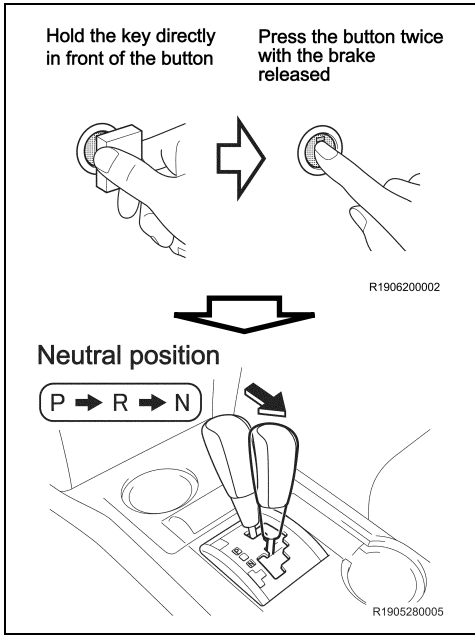
**Vehicle condition before reprogramming  
DO NOT start the engine.**

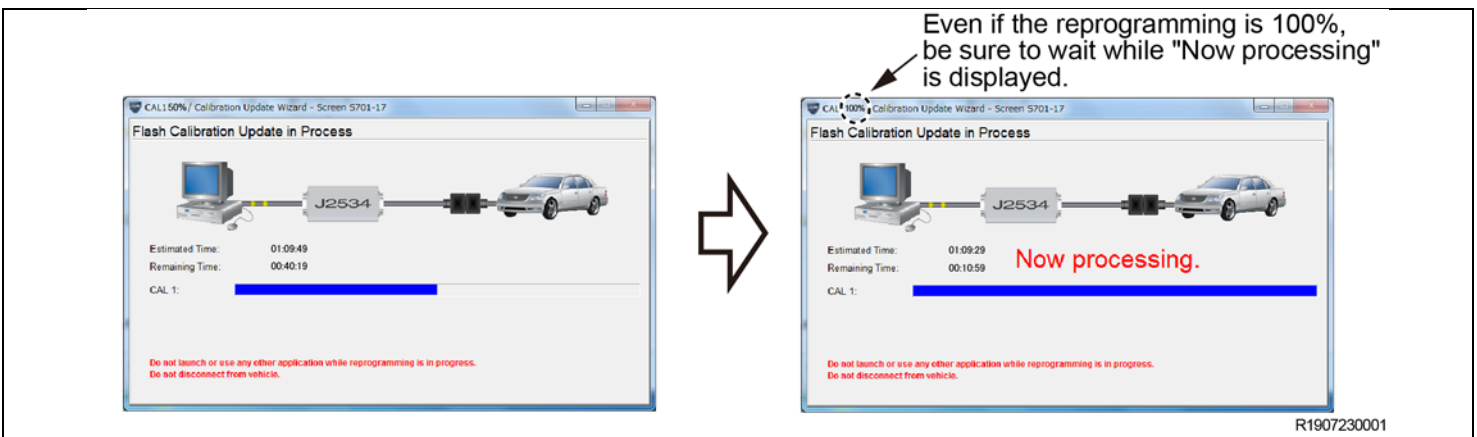
i) While reprogramming, the screen shown on the below is displayed.

- As reprogramming completes within approximately 75 minutes, stay near the vehicle and **DO NOT** allow any third parties to operate the vehicle or Techstream in order to prevent issues from occurring. The following phenomena may be observed while reprogramming due to interrupted communication. However, there is no problem.
  - Vehicle proximity alarming sound.
  - Blackout navigation screen (black).
  - Indication of a warning lamp or error message in the meter.
- "Now processing" is displayed for about 10 minutes. **DO NOT** finish reprogramming until the screen changes.

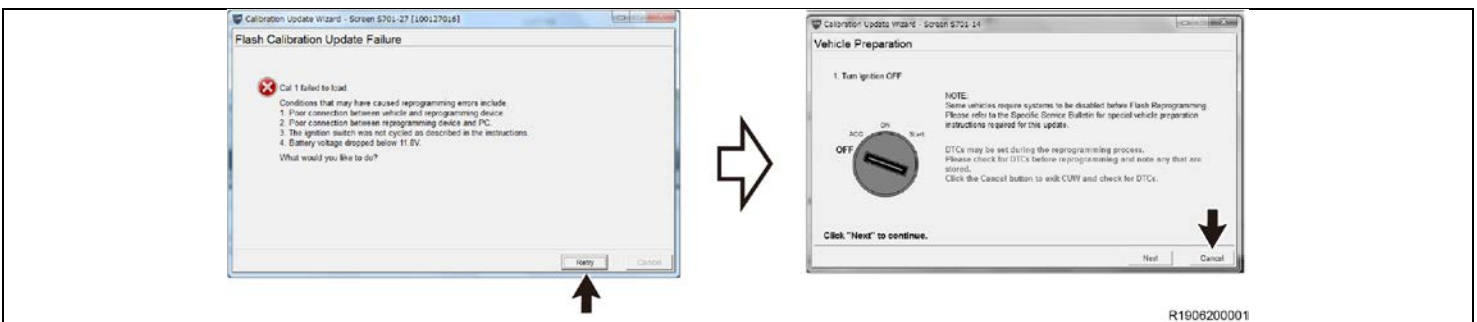
**STOP** If the following window is displayed and the reprogramming has failed, click on "Retry" and then "Cancel" to finish the reprogramming process. Remove the DCM (telematics transceiver) from the vehicle and perform the reprogramming procedure again only to the DCM (telematics transceiver). Refer to Section XIII

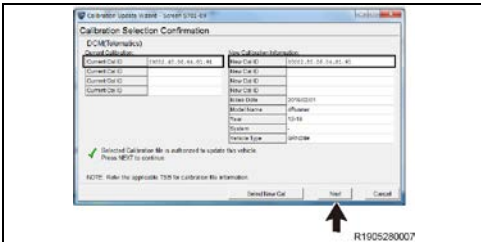
g) Confirm that "Current Cal ID" and "New Cal ID" are correct, and then click on “Next”.

**NOTE:** The calibration IDs will be displayed as shown on the left. Please make sure you **DO NOT** mistake where to check to confirm the IDs.

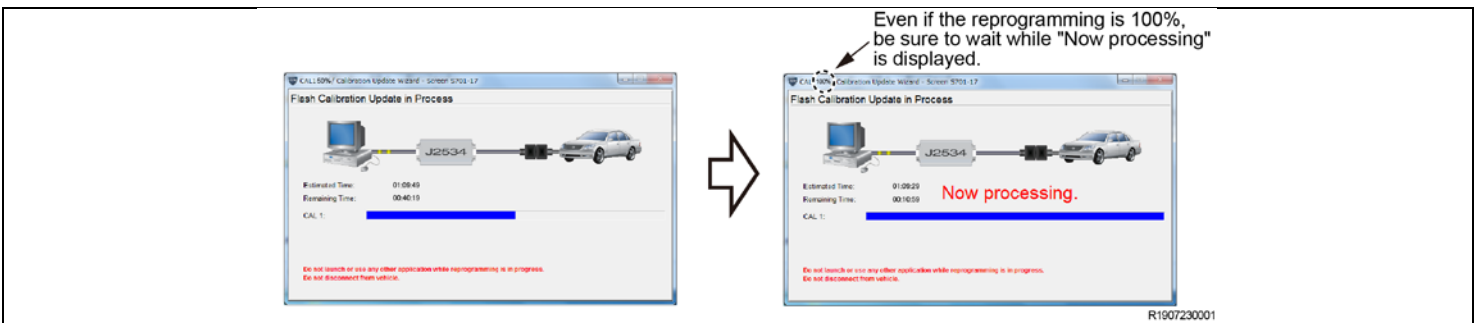
l) While reprogramming, the screen shown on the below is displayed.

- As reprogramming completes within approximately 85 minutes, stay near the vehicle and **DO NOT** allow any third parties to operate the vehicle or Techstream in order to prevent issues from occurring. The following phenomena may be observed while reprogramming due to interrupted communication. However, there is no problem.
  - Vehicle proximity alarming sound.
  - Blackout navigation screen (black).
  - Indication of a warning lamp or error message in the meter.
- "Now processing" is displayed for about 10 minutes. **DO NOT** finish reprogramming until the screen changes.

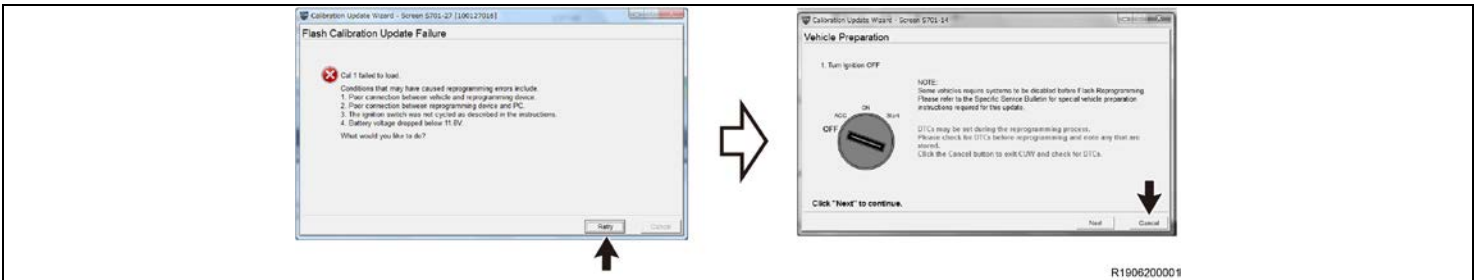
If the following window is displayed and the reprogramming has failed, click on "Retry" and then "Cancel" to finish the reprogramming process. Remove the DCM (telematics transceiver) from the vehicle and perform the reprogramming procedure again only to the DCM (telematics transceiver). Refer to Section XIII

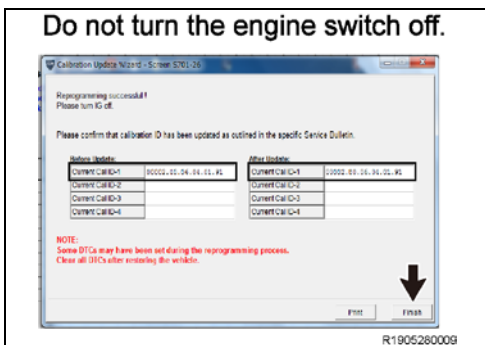
- o) After reprogramming, make sure that the "After update "Current Cal ID" is correct.

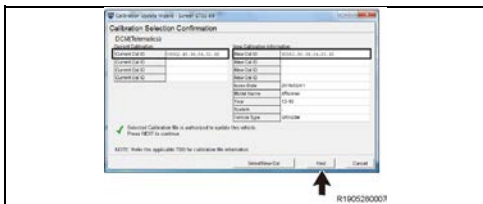
d) Confirm that "Current Cal ID" and "New Cal ID" are correct, and then click on "Next".

**NOTE:** The calibration IDs will be displayed as shown on the left. Please make sure you **DO NOT** mistake where to check to confirm the IDs.

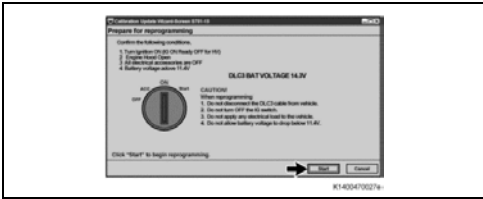
e) Click on "Next".

**NOTE:** It is **NOT** necessary to follow the instructions on the screen of Techstream.

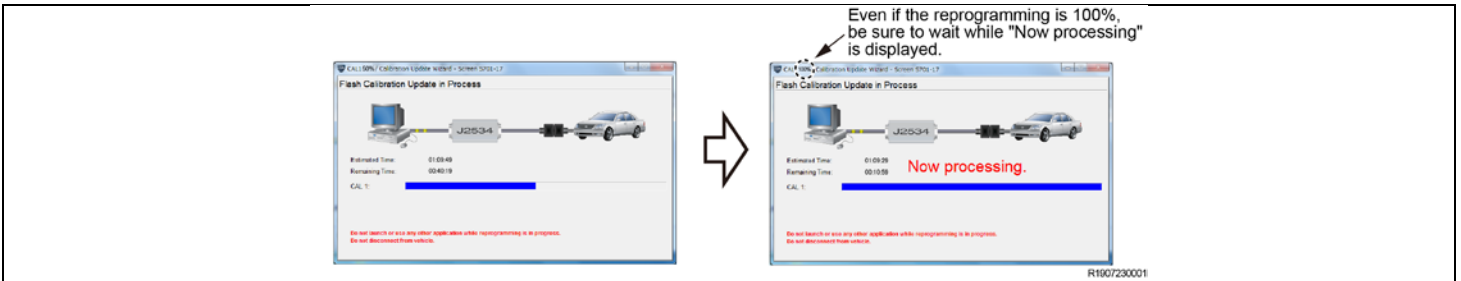
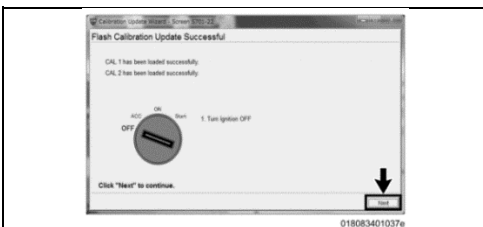
**The following phenomena may be observed while reprogramming due to interrupted communication.**

- “Now processing” is displayed for about 10 minutes. ***DO NOT*** finish reprogramming until the screen changes.

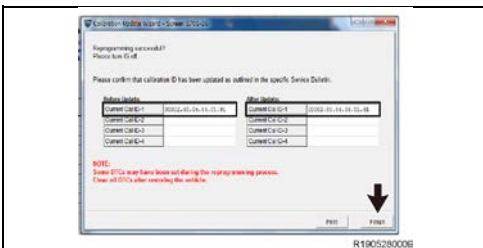
i) Click the “Next” button.

**NOTE: It is *NOT* necessary to follow the instructions on the screen of Techstream.**

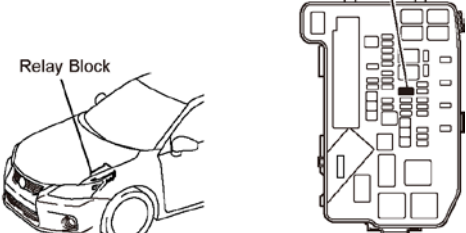
<p><b>CT200h (ZWA10)</b></p> <p>Remove this Short Pin</p>

- The reprogramming may fail if you perform it without disconnecting the "D/C CUT" or "SHORT PIN". Please make sure to disconnect the "D/C CUT" or "SHORT PIN" before performing the reprogramming.
- Refer to Section XIV for the location of "D/C CUT" and "SHORT PIN" of each vehicle model.

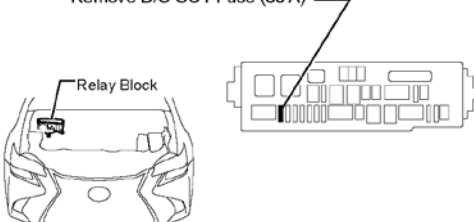
<p><b>GS350 (GRL1#)</b></p> <p>Remove D/C CUT Fuse (30 A)</p>

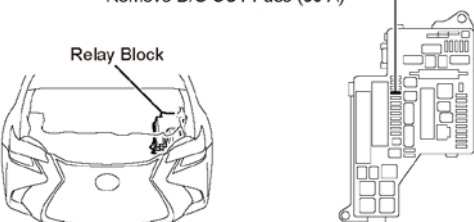
<p><b>GS450h (GWL1#)</b></p> <p>Remove D/C CUT Fuse (30 A)</p>

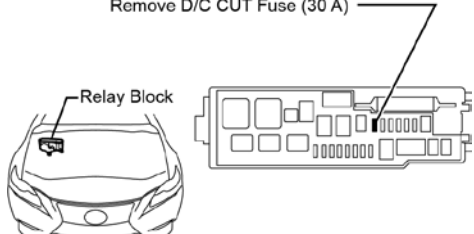
<p><b>IS250,IS350,IS300 (GSE3#,ASE3#)</b></p> <p>Remove D/C CUT Fuse (30 A)</p>

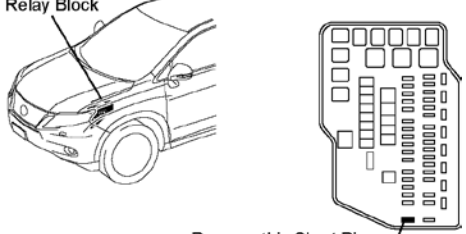
<p><b>RX350/450h (GGL1#,GYL1#)</b></p> <p>Relay Block</p> <p>Remove this Short Pin</p>

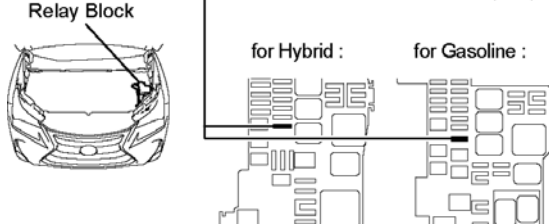
<p><b>NX200t,NX300,NX300h (AGZ1#,AYZ1#)</b></p> <p>Relay Block</p> <p>Remove this D/C CUT FUSE (20A)</p> <p>for Hybrid :      for Gasoline :</p>

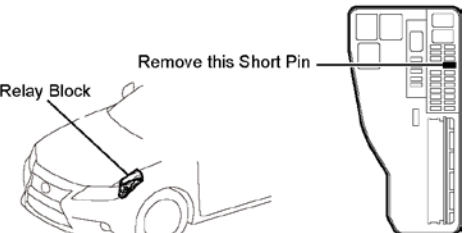
<p><b>ES350,ES300h (GSV6#,AVV6#)</b></p> <p>Relay Block</p> <p>Remove this Short Pin</p>

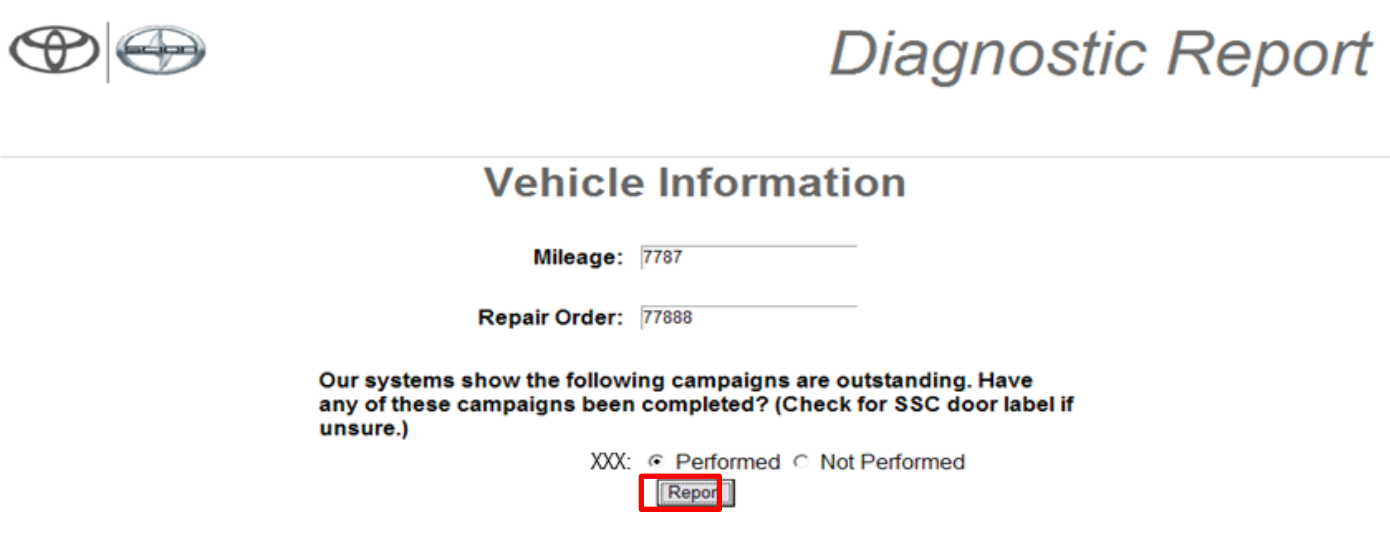
**Diagnostic Report**

- b) Log in to TIS.  
 c) Input Vehicle Mileage and Repair Order number.  
 d) Check the "Performed" campaign button for campaign KLG.  
 e) Select the Report button.

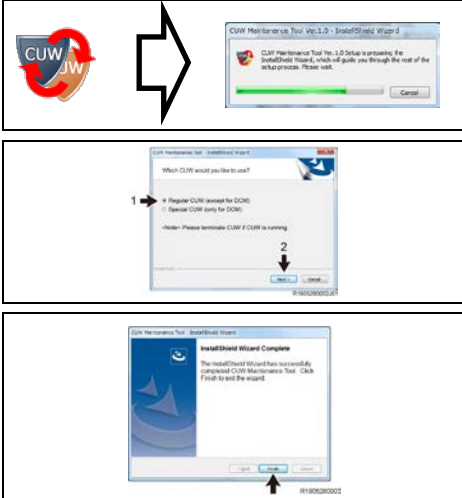
1. **RUN THE INSTALLER**
2. **SELECT THE REGULAR CUW APPLICATION**
  - a) Select "Regular CUW (except for DCM)".
  - b) Click on the "Next" button to install the regular CUW application.
3. **COMPLETE INSTALLATION**
  - a) Click on the "Finish" button to finish.
